This report is published by the Rail Accident Investigation Branch, Department for Transport.

# Container train accident near Althorpe Park, Northamptonshire, 18 July 2011

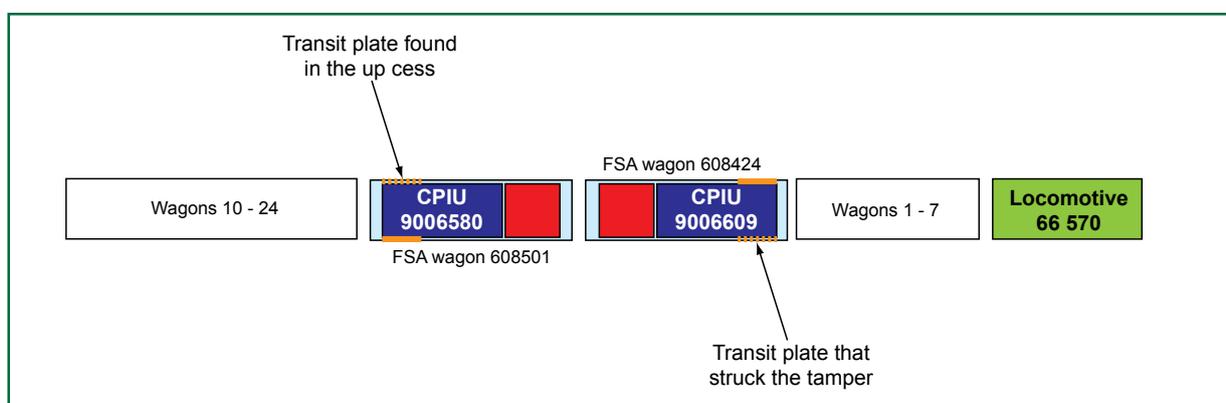
- 16 Train 4L68 comprised a class 66 diesel electric locomotive and 24 container flat wagons. One of the power-generation unit containers was loaded on the leading end of wagon 8; the other, on the trailing end of wagon 9. Both wagons were FSA-type wagons. The containers had ISO identification marks<sup>2</sup>, CPIU 9006609 and CPIU 9006580.
- 17 Figure 3 shows key aspects of the train configuration and position of the containers.

Figure 3: Configuration of train 4L68

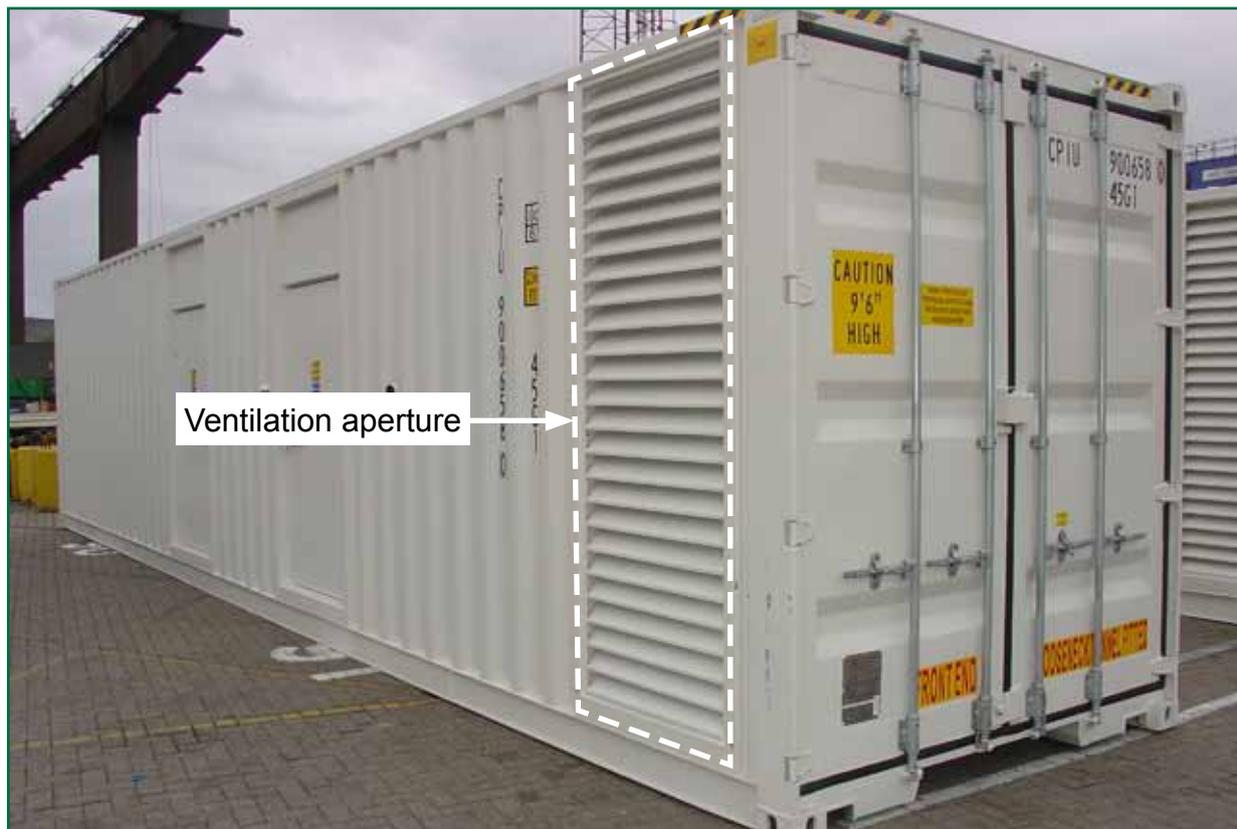
- 21 Two of the apertures, one in each container side, were to allow the necessary airflow into the enclosure when the power-generation equipment was running. These side ventilation apertures were fitted with open horizontal louvres (figure 4).

Figure 4: Container CPU 9006580 showing the location of the side ventilation aperture

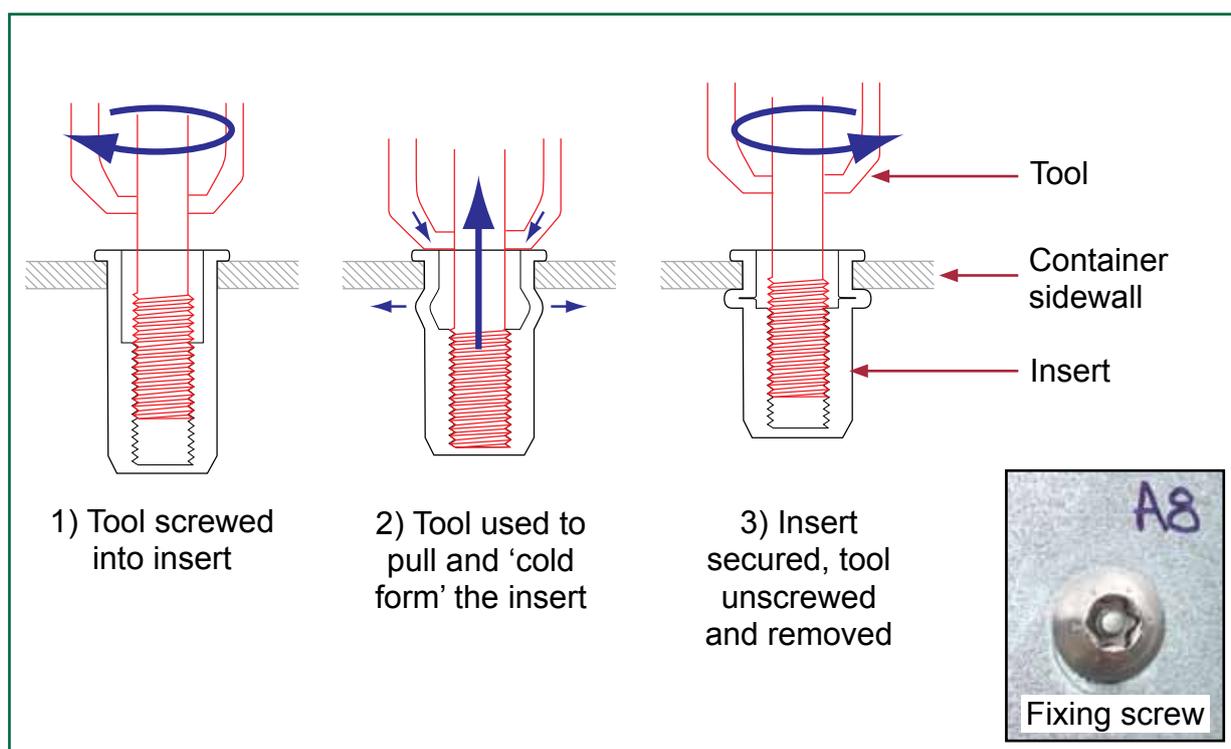
Figure 6: Threaded insert and fixing screw used to secure the transit plate

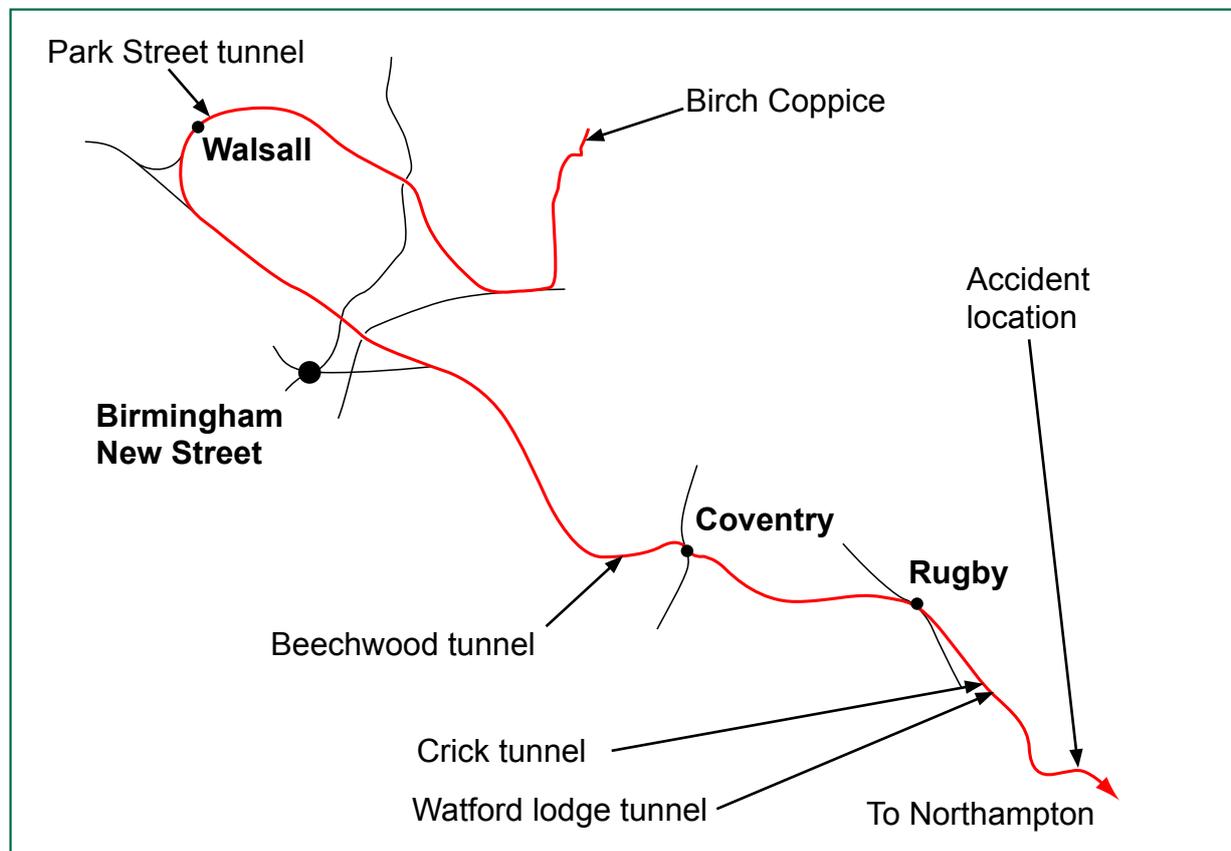
- 30 On its journey to Rugby station, train 4L68 passed 22 other trains and went through two tunnels: Park Street (Walsall) and Beechwood. At Rugby it spent just over an hour in a *goods loop*. Figure 8 shows the route the train took to Rugby, and then to Althorpe Park.

Figure 8: Route of train 4L68

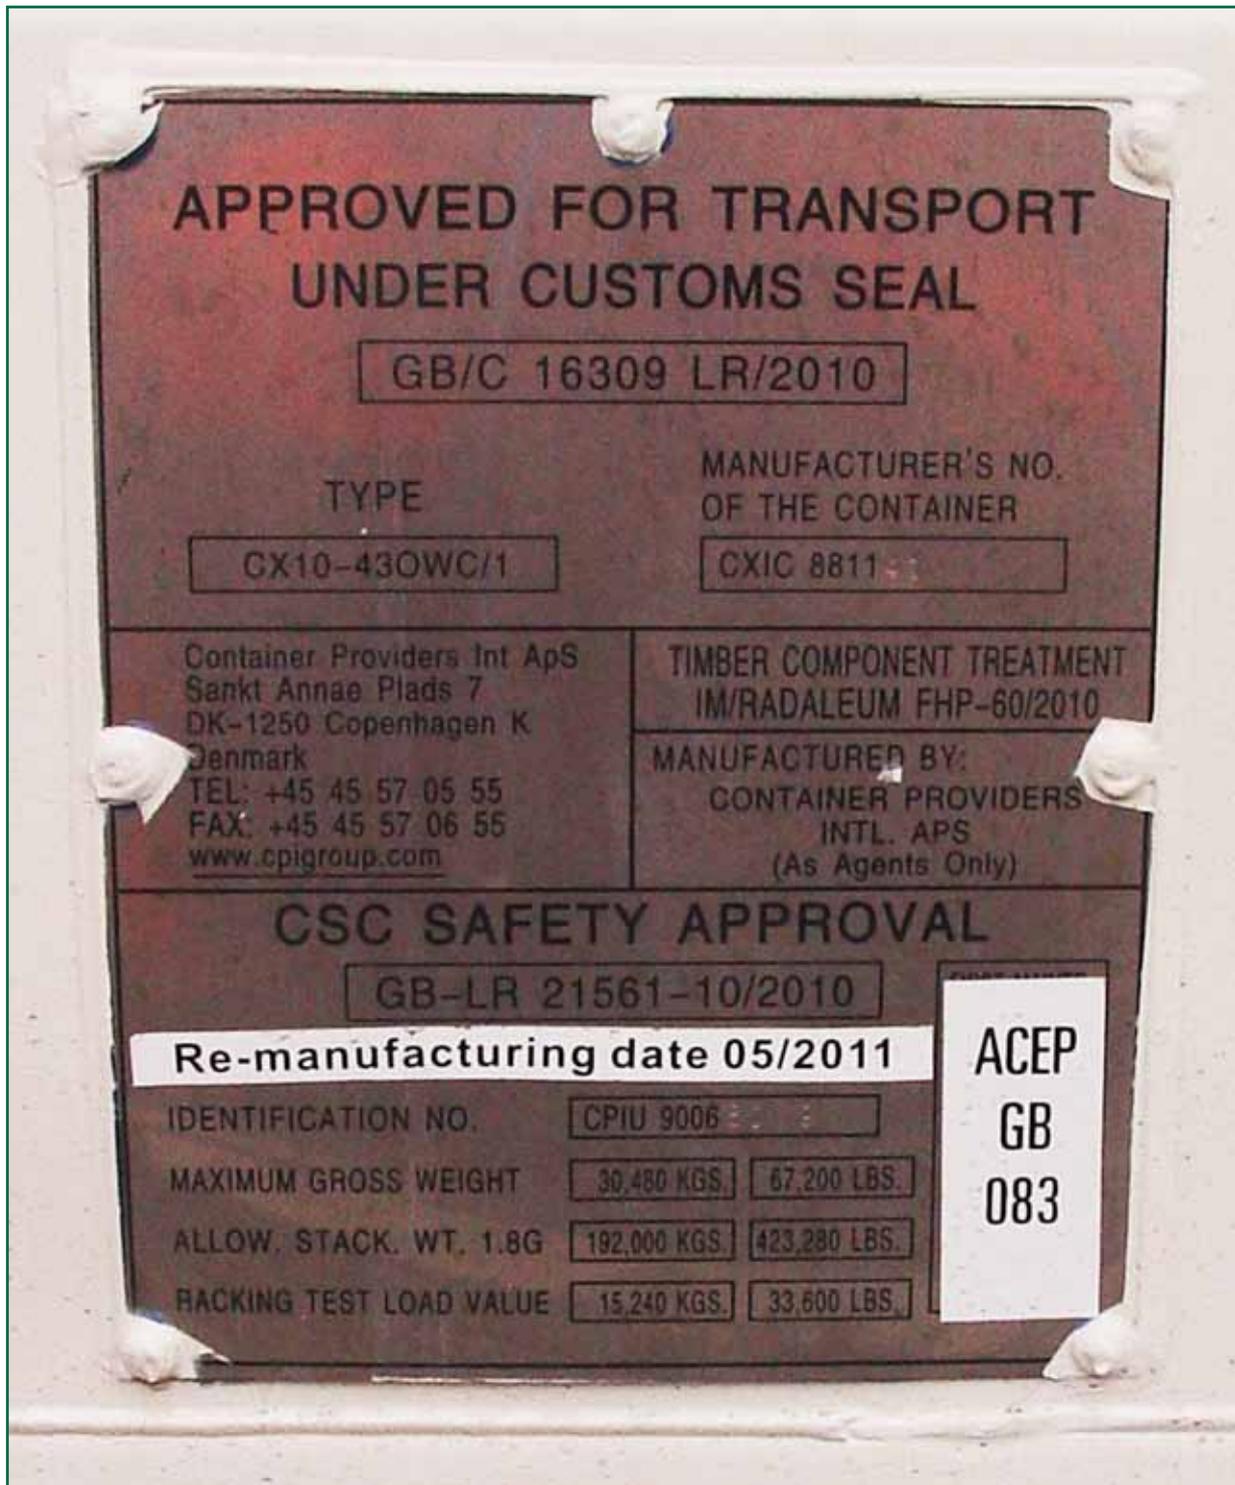
Figure 10 shows the safety approval plate fixed to container CPIU 900609.

Figure 10: Safety approval plate fixed to container CPIU 9006609. The RAIB understand that the white decal, entitled 'Re-manufacturing date 05/2011', was affixed when the container was modified (paragraph 20). Note: Recognised by the CSC as acceptable practice, the safety approval plate has been grouped with other official plates on one base plate
