Rail Accident Investigation Branch

Rail Accident Report

Fatal accident at Piccadilly Gardens, Manchester, 5 June 2011

Report 08/2012
May 2012

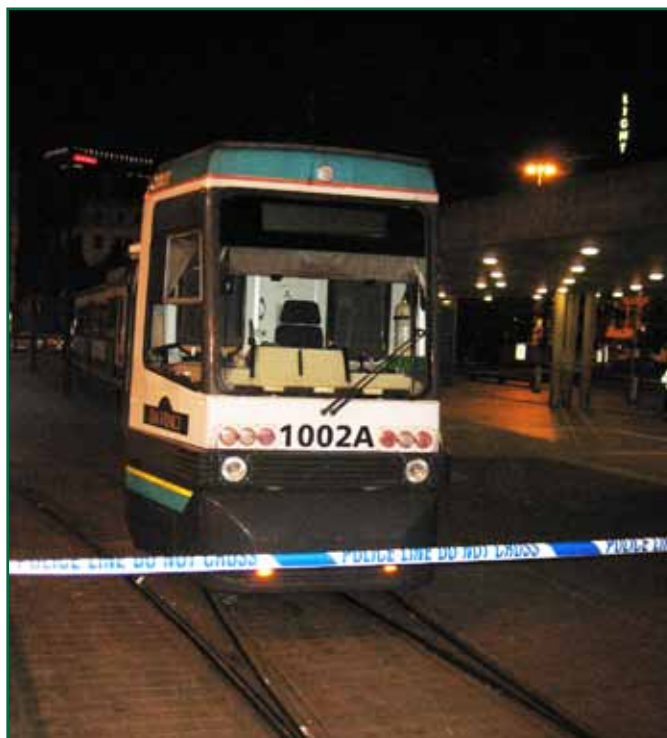
- 11 The tram involved in the accident was a T68 type, number 1002 (figure 3). This was one of the fleet of 32 T68 trams, built by Ansaldo, Italy, first introduced in 1992. It was travelling from Bury to Piccadilly Gardens tram stop.

Figure 3: The 'A'-end of tram 1002 at the accident site
