Rail Accident Investigation Branch

# Rail Accident Report

**Train passed over Lydney level crossing with  
crossing barriers raised  
23 March 2011**

# Train passed over Lydney level crossing with crossing barriers raised, 23 March 2011

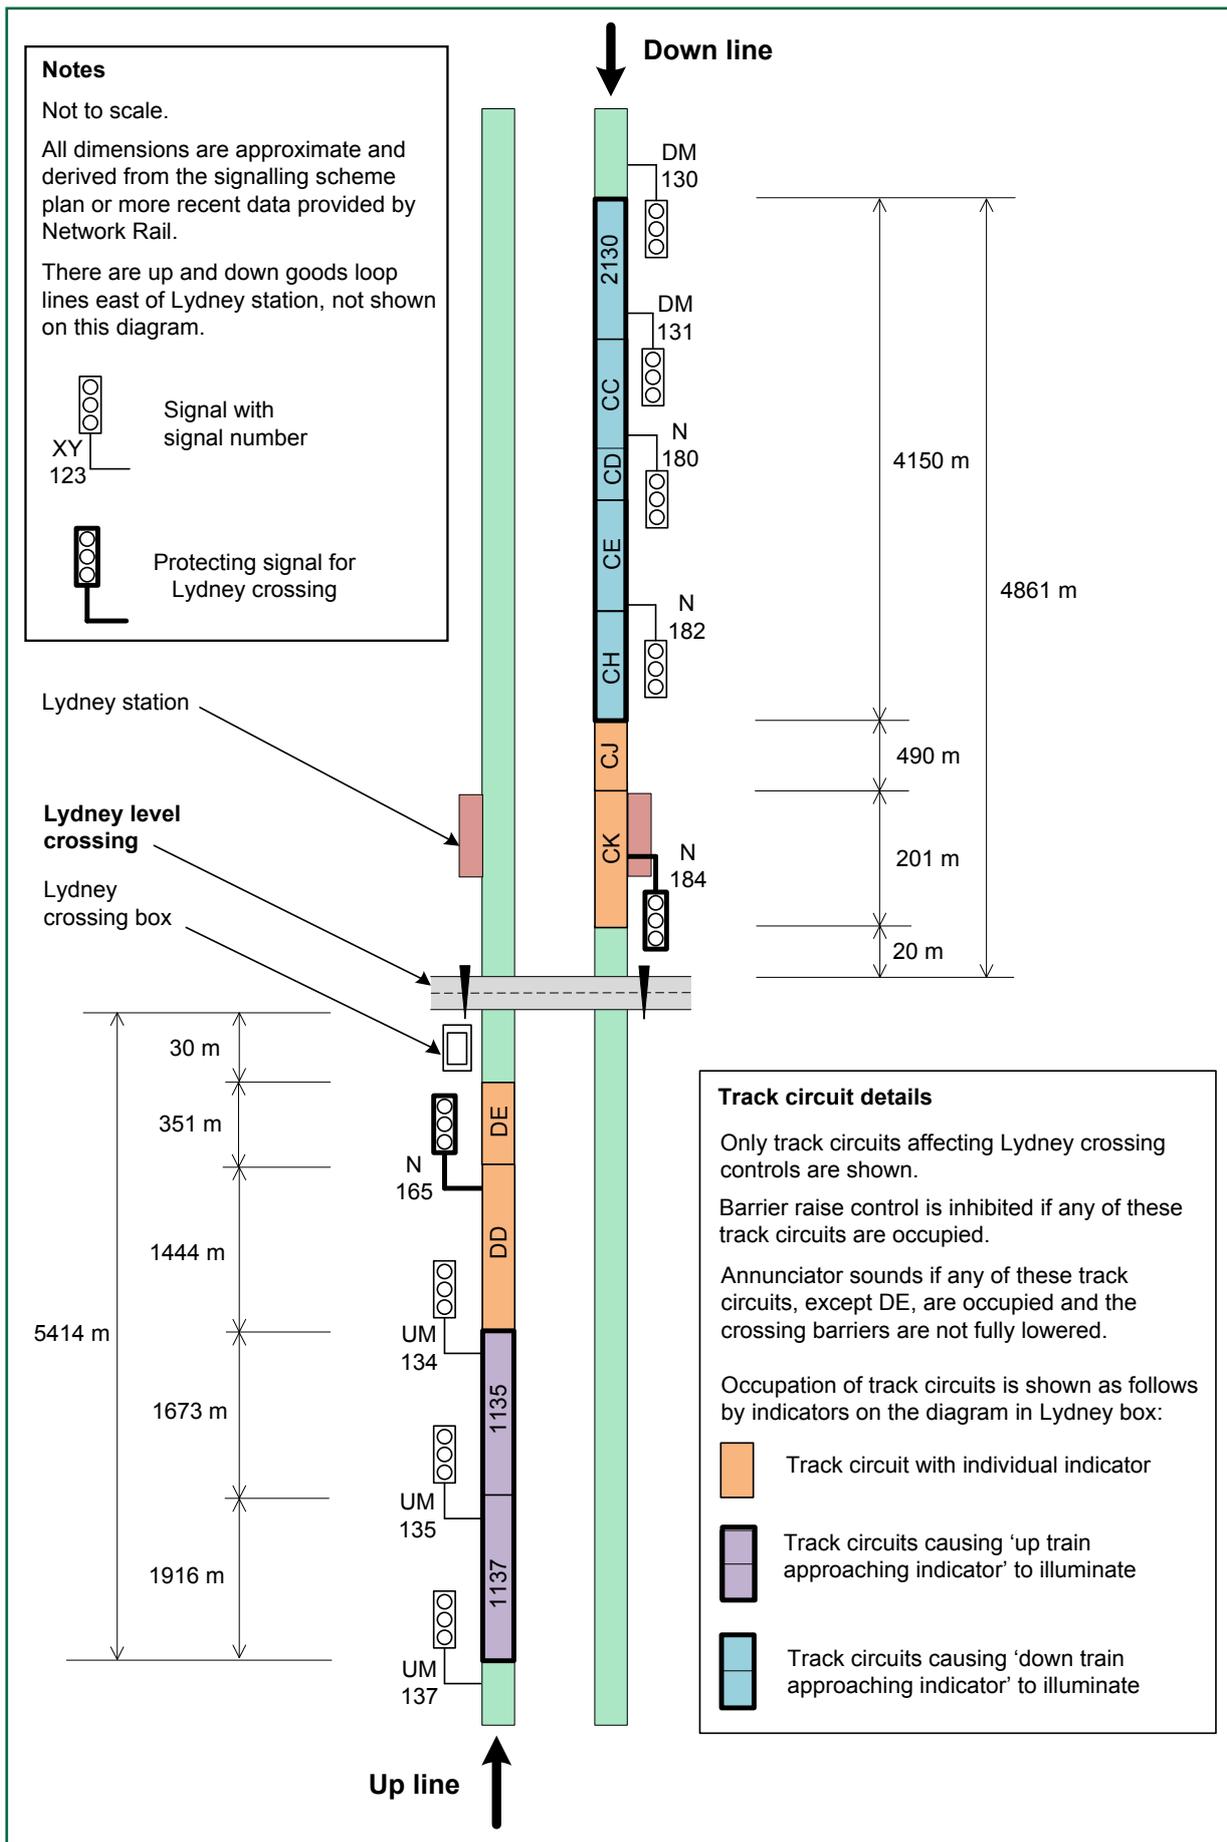
Figure 4: Lydney crossing signalling layout

- 22 The signals protecting Lydney crossing (signal number N165 on the up line and signal number N184 on the down line, figure 4) were operating automatically at the time of the incident. In this condition, they return to danger after the passage of each train. They *clear* (change from a red aspect to a proceed aspect) when another train approaches if the interlocking detects:

- the annunciator is triggered when an up train enters track circuit 1137 (or a down train enters track circuit 2130, figure 4);
- the keeper presses the lower button on the control pedestal;
- amber lights are displayed to road vehicles for approximately three seconds before flashing red lights are illuminated (figure 3);
- the barriers begin to lower about five seconds after the red lights start flashing;
- when the barriers are fully lowered, the annunciator stops sounding;
- when the barriers are fully lowered, the protecting signal clears without any further action by the crossing keeper;
- after the train passes the protecting signal, it returns to red; and
- after the train has passed over the crossing, the keeper presses the raise button, the barriers return to the fully raised position and the road warning lights stop flashing.

- 39 Before the raise button was pressed, train 1M68 had occupied track circuit 1137 on the up line at 14:21:46 hrs. As usual when the barriers were already lowered, this had caused the up line protecting signal (signal N165) to clear without the annunciator sounding.

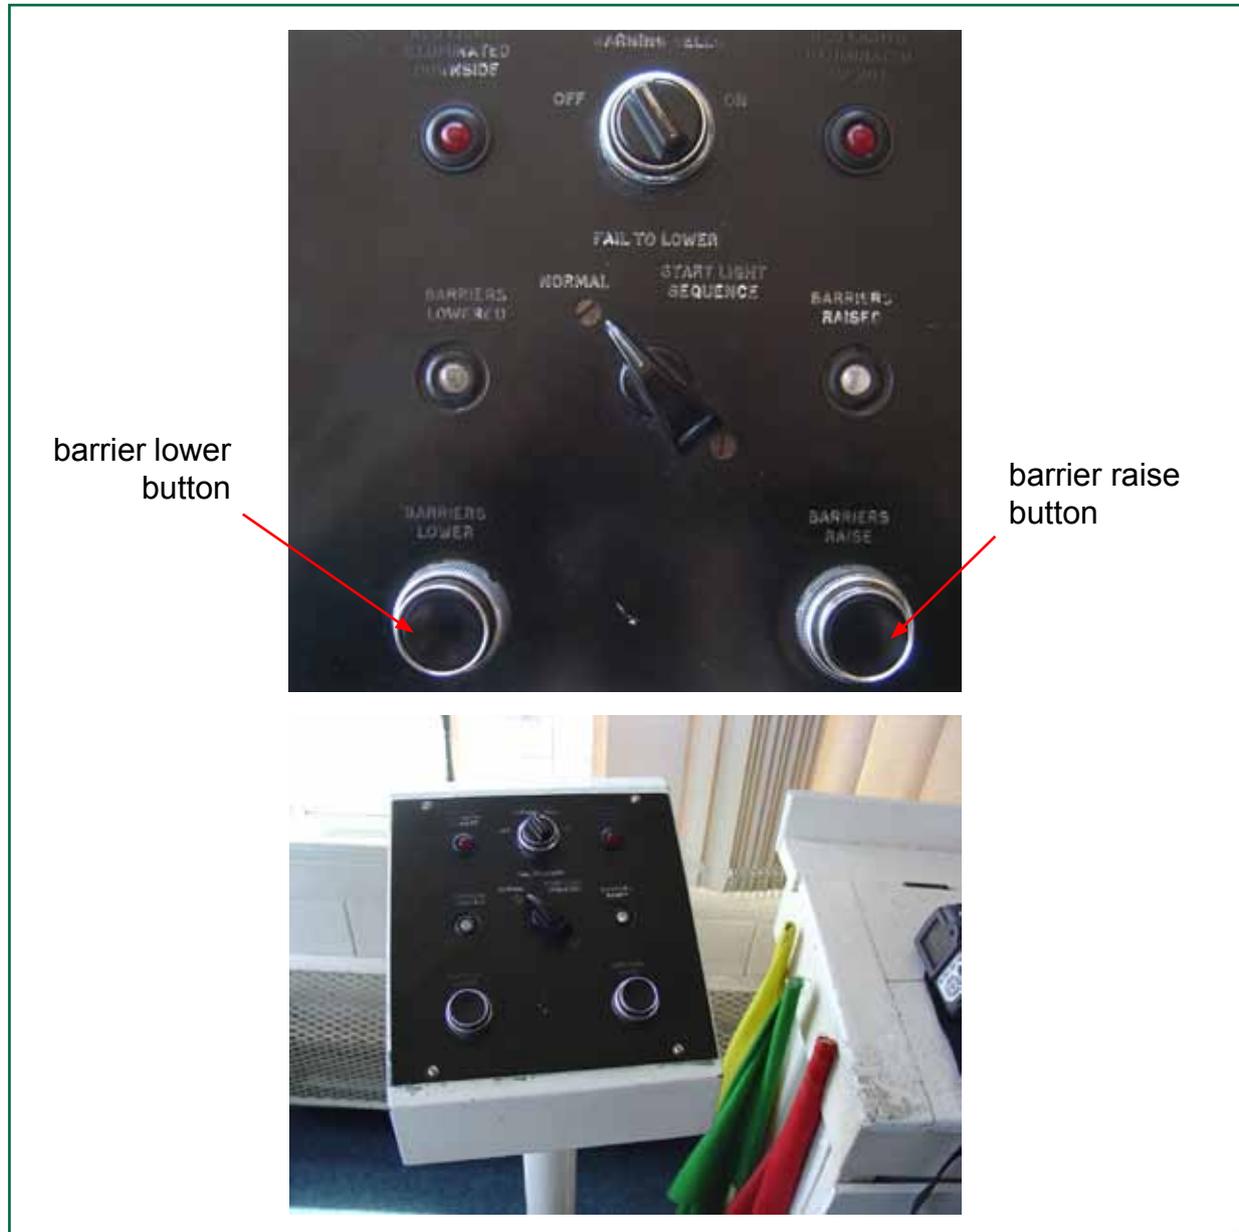
Figure 5: Lydney crossing control pedestal

- 23 The equipment in the crossing keeper's box for controlling Lydney crossing includes:
  - lower and raise buttons on a *control pedestal* adjacent to a window which allows the crossing keeper to observe the crossing when operating the controls (figures 5 and 6);

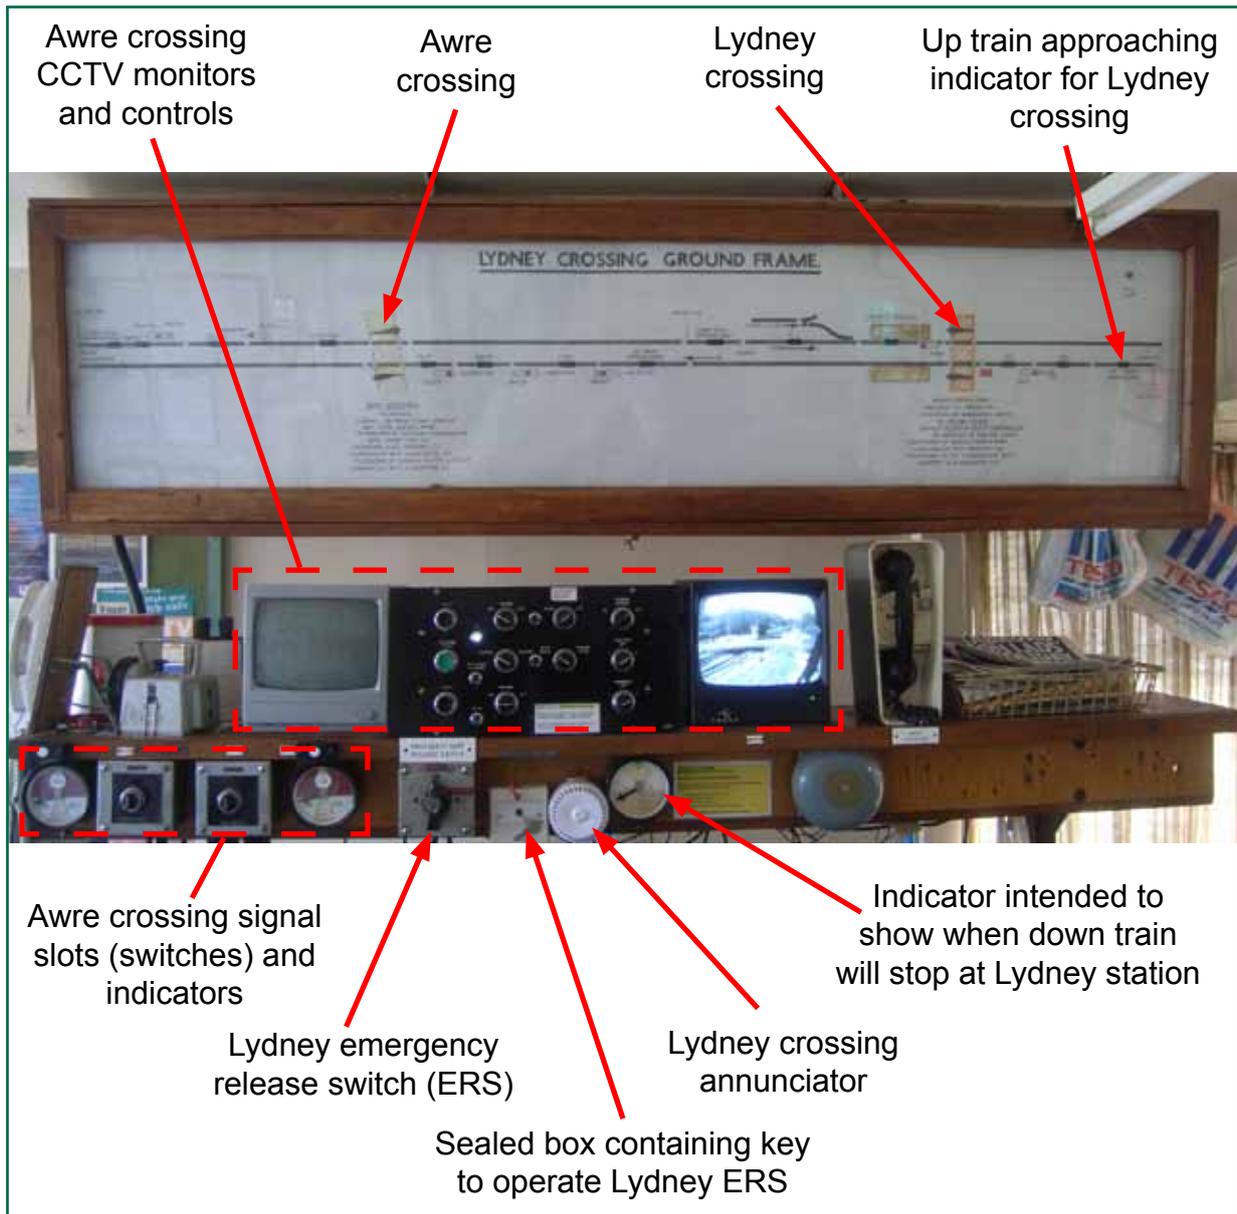
Figure 7: Diagram and instrument shelf

- a diagram showing the track layout, the location of signals and, by using indicator lamps, the position of trains near the crossing (figure 7); and

- 52 Network Rail undertook full functional testing of the crossing after the incident. This testing was undertaken after the defective contacts on the barrier pedestal were replaced, and before RAIB attended site (RAIB did not attend immediately after the incident because, although a serious incident<sup>9</sup>, Network Rail did not report it to RAIB until the following day). Network Rail's testing did not reveal a fault which would explain why the annunciator failed to sound when expected. Possible reasons include a temporary high resistance electrical contact (ie a dirty electrical contact), or poor connections in the disorganised wiring seen beneath the instrument shelf (figure 8).

- 55 Before leaving the box to raise the barriers after train 2L59 passed, the crossing keeper could have looked at the diagram to determine whether any of the train approaching indicators were illuminated. If the indicators were operating correctly, train 1M68 should have illuminated two lamps in the “up train approaching” indicator (the indicator includes two lamps so that an indication is still provided if one lamp fails, figures 7 and 9). The crossing keeper stated that he looked at the diagram and did not observe any illuminated indicators.
