# RAIB Bulletin 03/2011

## Derailment at Dalchalm level crossing, Highland, Scotland 23 February 2011

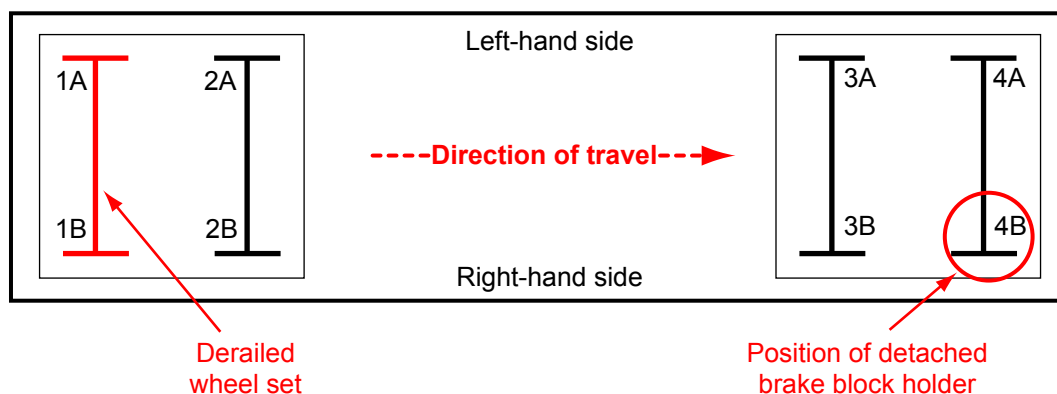
- 3 Train 6E69 consisted of a Class 66 locomotive and 27 unladen BFA and RRA wagons in a configuration known as the 'pipe train'. The train was operated by DB Schenker Rail (UK) Ltd<sup>1</sup> who also maintained and owned the wagons which formed it. The vehicle which derailed was BFA wagon number 950544, the 20<sup>th</sup> wagon from the front of the train. This wagon was equipped with air-operated tread brakes<sup>2</sup>.
- 4 BFA wagons are mounted on two Y25 type bogies, each of which has two wheelsets. The configuration of these wheelsets is shown in figure 1. At the time of the incident, the leading wheelset of wagon 950544 was wheelset 4A/4B.

Figure 1: The wheelset configuration of wagon 950544 during the derailment

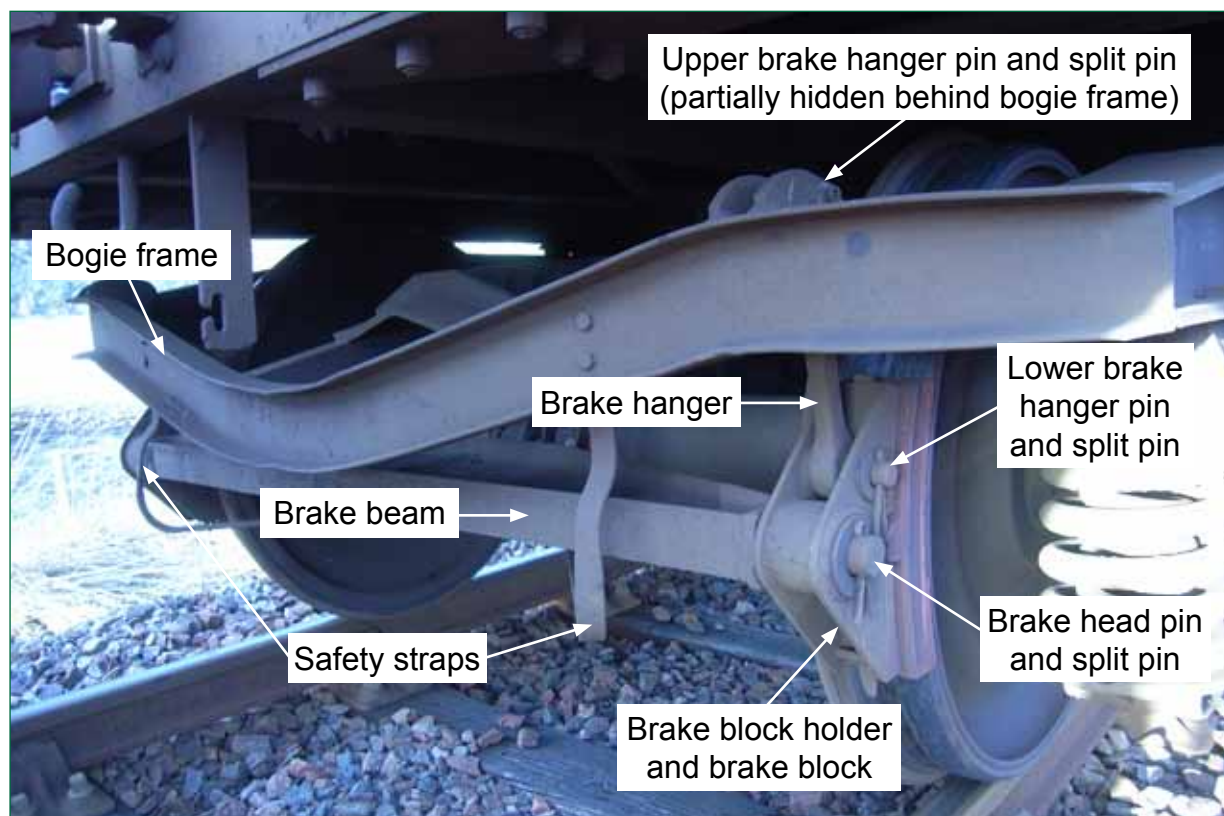
- 5 The braking equipment of a BFA wagon equipped with Y25 type bogies and air-operated tread brakes is shown in figure 2. There are two cast-iron brake blocks at each wheel, one situated at the leading face of the wheel tread and the other at the trailing face. The brake blocks on each face are held within brake block holders (also known as brake heads) which are mounted onto brake head pins, machined onto a brake beam. The brake beam is linked to the wagon's brake cylinder via additional brake rigging components.

Figure 2: The braking equipment of a BFA wagon equipped with tread brakes
