Rail Accident Investigation Branch

Rail Accident Report

Runaway and collision of a road-rail vehicle near Raigmore, Inverness 20 July 2010

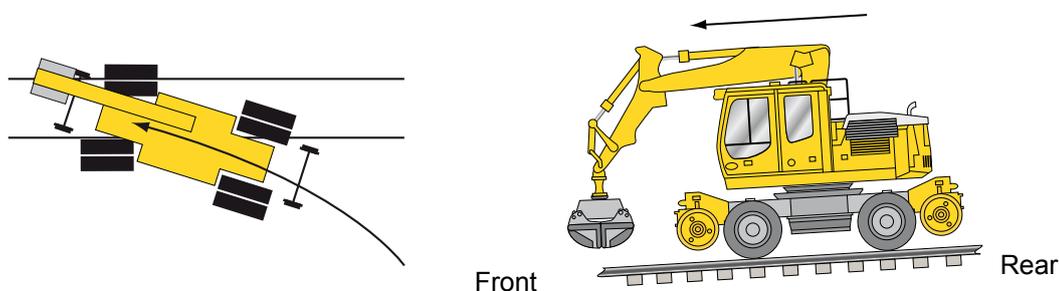
Figure 14 a/b - Rail mode is selected on the ZW box. The RRV is driven onto the RRAP front end first. The machine controller is not present. The RRAP is on a 1 in 50 max gradient

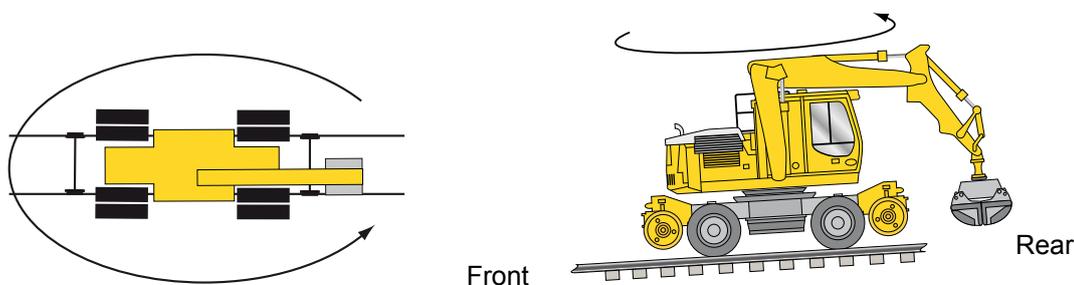
Figure 14 c/d - The cab is swung to the rear of the RRV. The machine operator believes that the rear rail wheels are in line with the track: they are not.

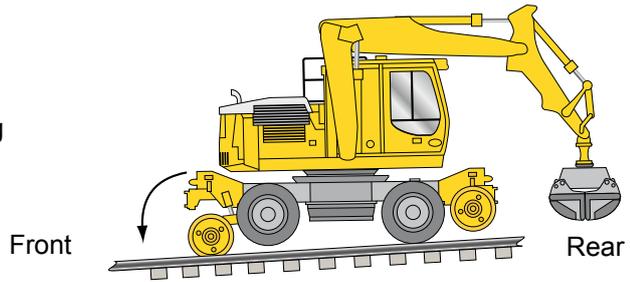
Figure 14e - The machine operator lowers the front rail wheels by mistake. He stops lowering when he feels the front end lift up. Damage is caused to the RRAP (figure 12).

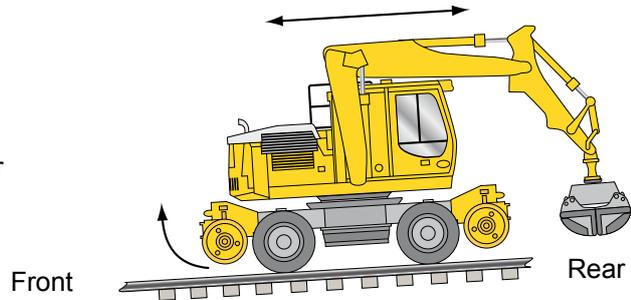
Figure 14 f - The machine operator raises the front rail wheels fully up and manoeuvres the RRV forward and backwards to re-align the rear rail wheels.

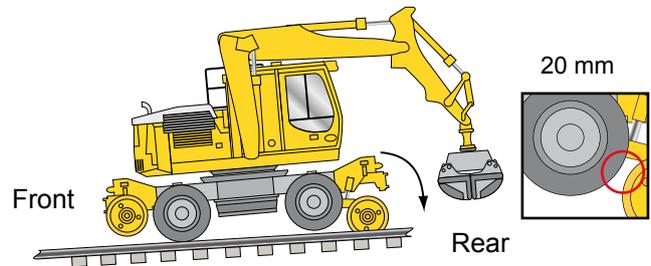
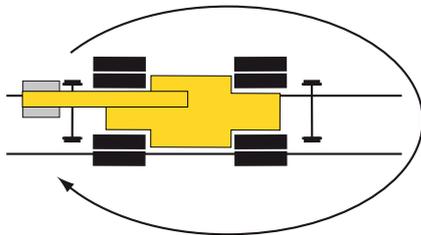
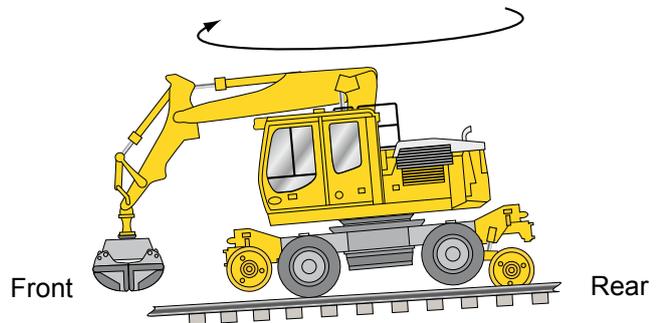
Figure 14 g - The machine operator believes that the rear rail wheels are now in line with the track. They are still not. The machine operator lowers the rear rail wheels onto the RRAP surface causing damage (figure 12). A gap of about 20 mm (inset) (paragraph 106) is left by the machine operator between the rear road and rail wheels (in accordance with the normal process during on-tracking).

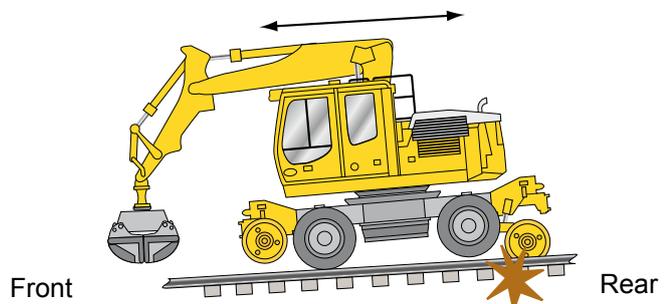
Figure 14 h - i - The machine operator swings the cab to the front of the RRV

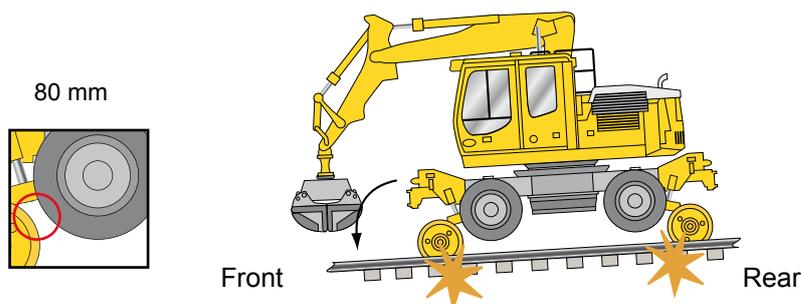
Figure 14 j - k - The machine operator manoeuvres the RRV forwards and backwards to line up the front rail wheels. This causes further damage to the RRAP at the uphill end. A resistance fault occurs to the rear potentiometer or circuit. The new voltage allows the computer system to release the front rail wheels despite the existence of the 20 mm air gap between the rear road and rail wheels. The machine operator does not complete the lowering of the rear rail wheels at this time because he selects the front chassis by mistake and the front wheels move.

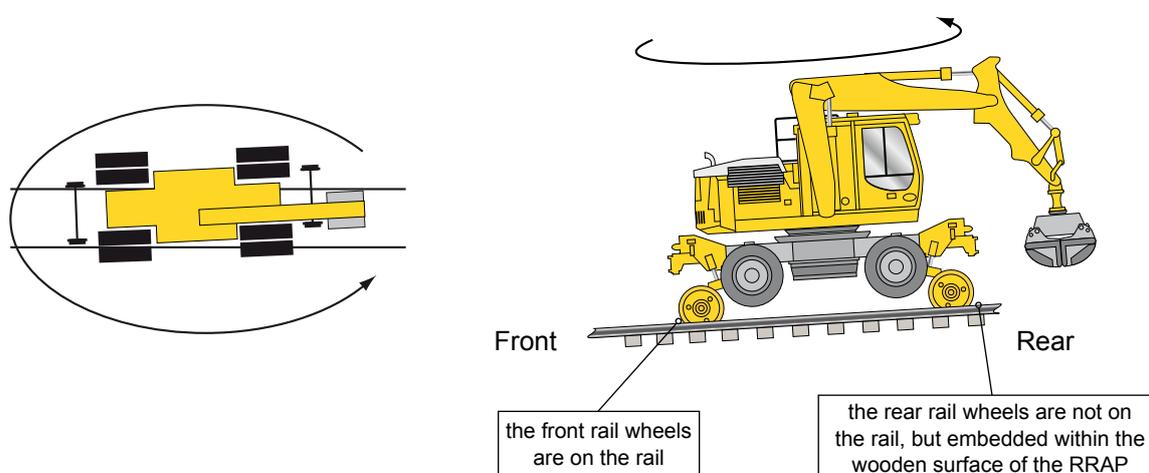
Figure 14 l - The machine operator begins to lower the front rail wheels (they move because of the presence of the electrical fault). However, the disturbance to the rear chassis caused by this movement results in the electrical fault disappearing and the interlock is automatically reinstated (paragraph 128). Consequently the front rail wheels now stop moving with approx 80 mm gap (inset) (paragraph 106) and the machine operator thinks that the rail wheels are fully down. The RRV's rail controls are now locked and the machine is in a free-wheel state.

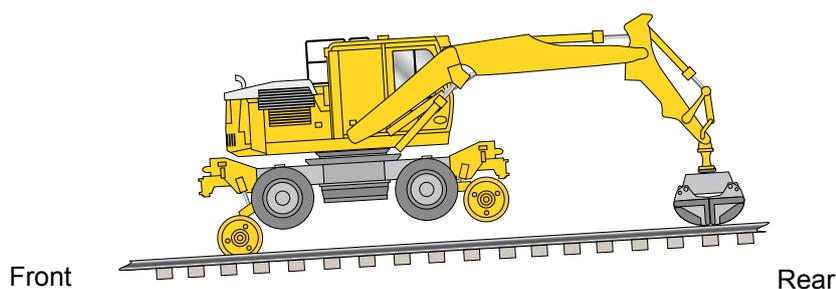
Figure 14 m - n - The machine controller arrives at the RRAP and tells the machine operator that the RRV rear axle wheels are not on the track, but in the wooden surface. The machine operator swings the cab to the rear of the RRV.

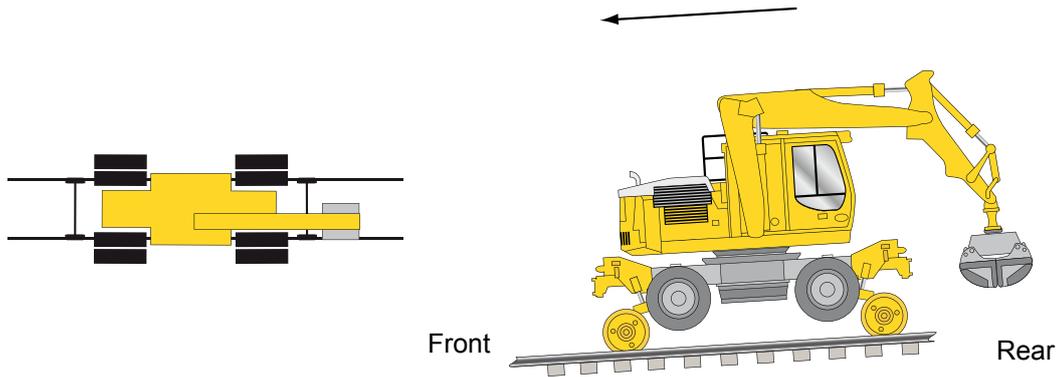
Figure 14 o - The machine operator lowers his boom arm and clam bucket onto the sleepers in the area between the running rails of the down line (at the rear end of the RRV). This lifts the RRV up and the rear rail wheels are then placed onto the track.

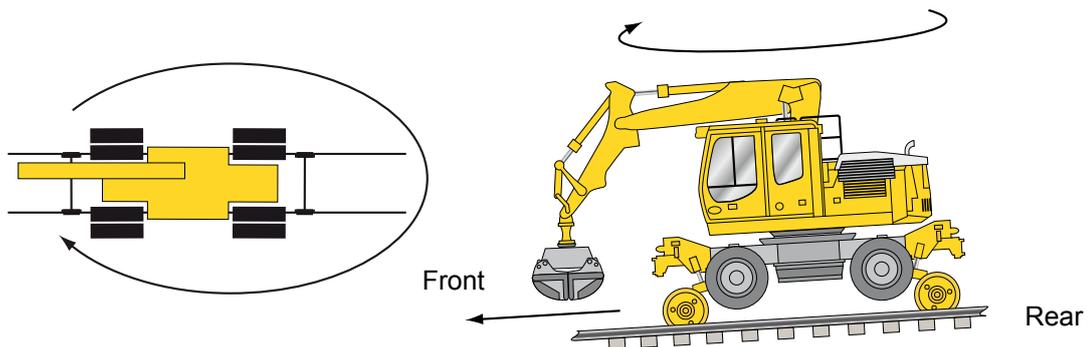
Figure 14 p - q - The RRV begins to run away as it is in a free-wheeled state and on the track.

Figure 14 r - s - The machine operator quickly swings the cab to the front of the RRV (in the direction of travel).
