Rail Accident Investigation Branch

Rail Accident Report

**Collision between train 1C84 and a tree at
Lavington, Wiltshire
10 July 2010**

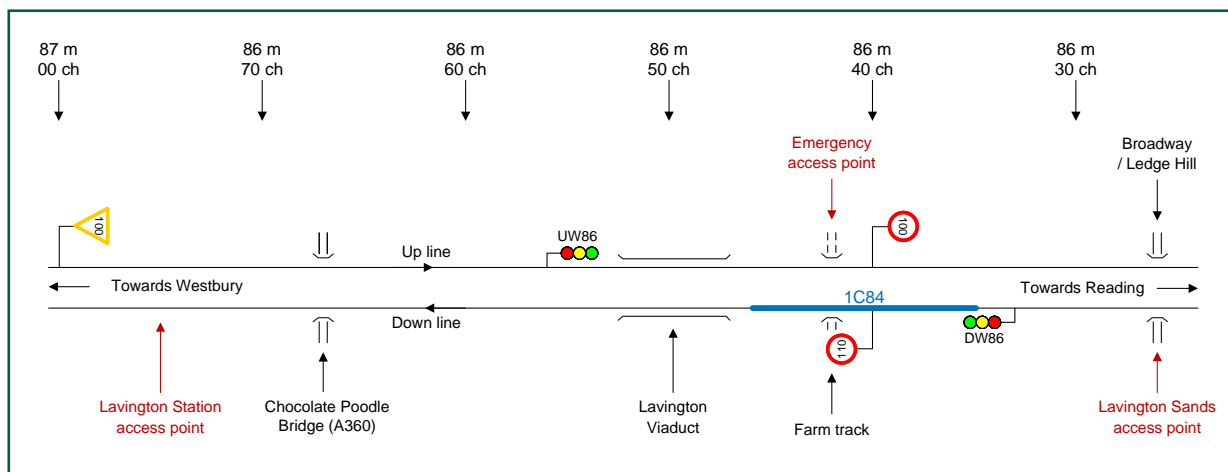
Figure 2: Track layout, showing key features in the vicinity of train 1C84 after the collision

- 15 The collision occurred on the Down Westbury line, between Reading and Taunton, 85 miles and 77 chains² from London Paddington. The tree fell from an area of woodland adjacent to the railway, known as Parham Wood. The front of the train came to a stand at about 86 miles and 46 chains, a few metres from the eastern end of Lavington viaduct (figure 2).

- 17 The nearest *access point* was at Lavington Sands bridge, approximately 200 m from the rear of the train (figure 2). An alternative access point was at the former Lavington station, approximately 600 m from the front of the train and beyond both Lavington viaduct and 'Chocolate Poodle Bridge'.³
- 18 The Lavington Sands access point is about 10½ miles (17 km) from Westbury station and 54 miles (88 km) from Reading station by road.

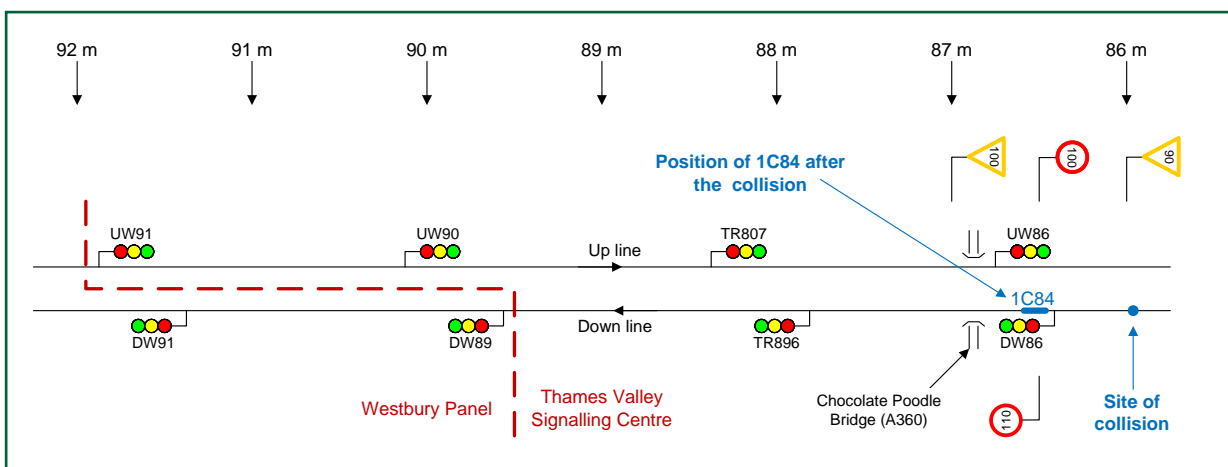
Figure 3: Overview of area showing location of train 1C84 and the signal box boundary

- 16 After the collision, the train came to a stand *beyond* signal number DW86, within the associated *signal overlap*. This was about three miles east of the boundary between the areas controlled by the Thames Valley signalling centre (TVSC) and Westbury signal box, ie it was still in the area controlled by TVSC (figure 3).
