Rail Accident Report

Derailment of an engineering train between Gloucester Road and Earl's Court stations on London Underground 12 May 2010

Report 05/2011
March 2011

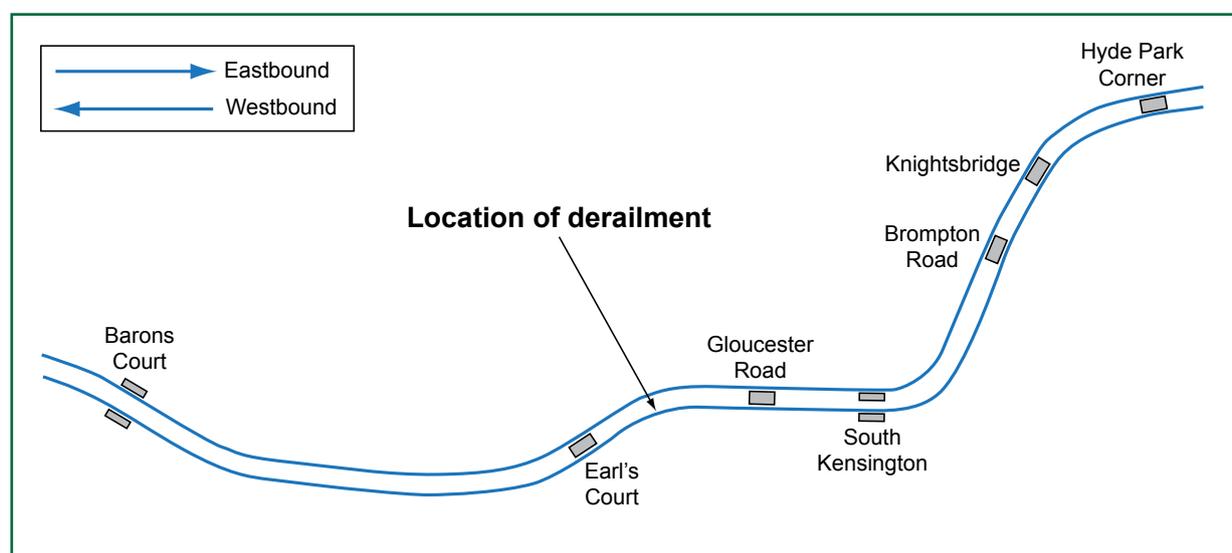
Figure 1: Section of Piccadilly Line showing location of derailment

- 5 On 12 May 2010, at approximately 05:30 hrs, the leading wheelset of a locomotive hauling a train consisting of engineering wagons and a *ballast* machine derailed as it was travelling between Gloucester Road and Earl's Court stations in a tunnel section of the London Underground (LU) network. The train was travelling westbound on the Piccadilly Line (figure 1).

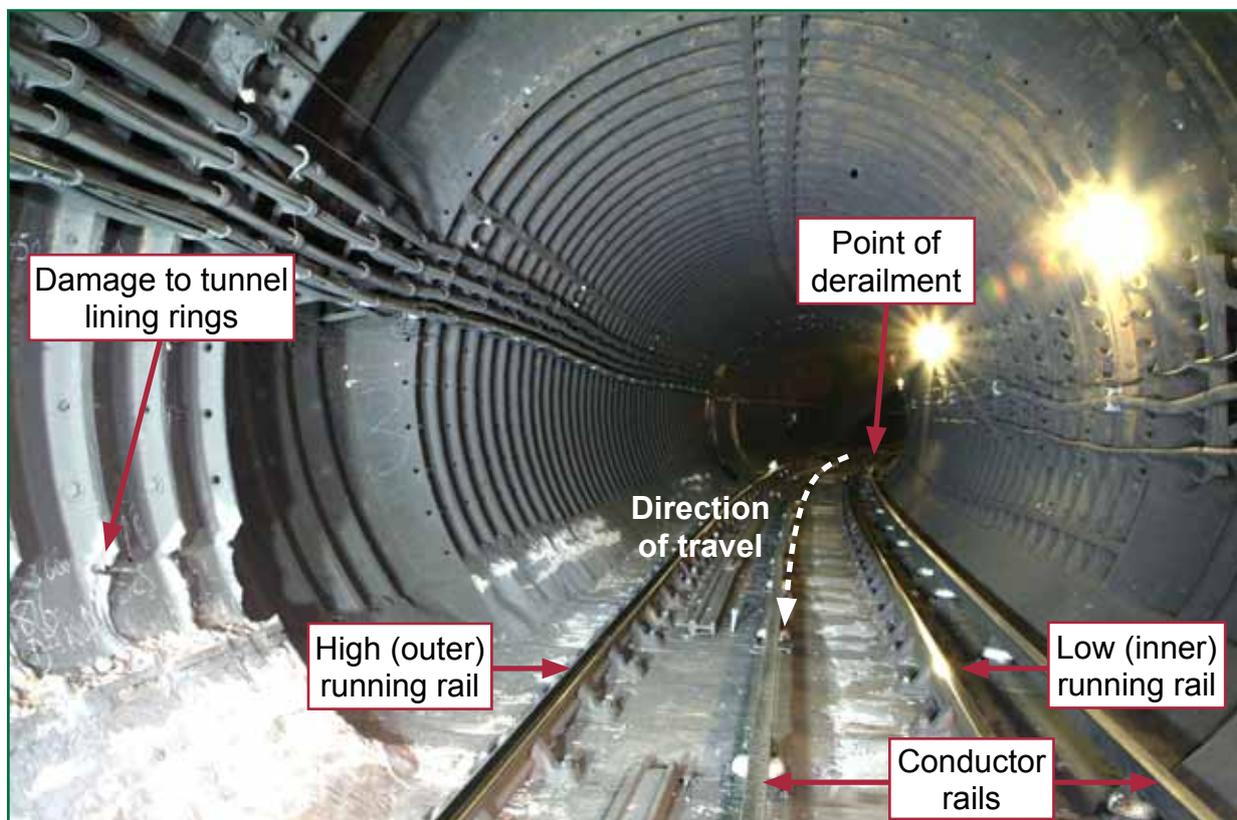
Figure 2: The westbound Piccadilly Line in the vicinity of point of derailment

- 11 The railway between Gloucester Road and Earl's Court consists of two parallel *single-bore* tube tunnels, one for the westbound line and one for the eastbound line. The distance between the station *headwalls* at Gloucester Road and Earl's Court is 705 metres (figure 2).
- 12 The *track geometry* at the location of the derailment consists of a left-hand curve of 305 metres radius. The *cant* on the approach to the point of derailment is 86 mm. The maximum permitted line speed is 45 mph (72 km/h).
- 13 The point of derailment was 397 metres from the headwall of Gloucester Road station.

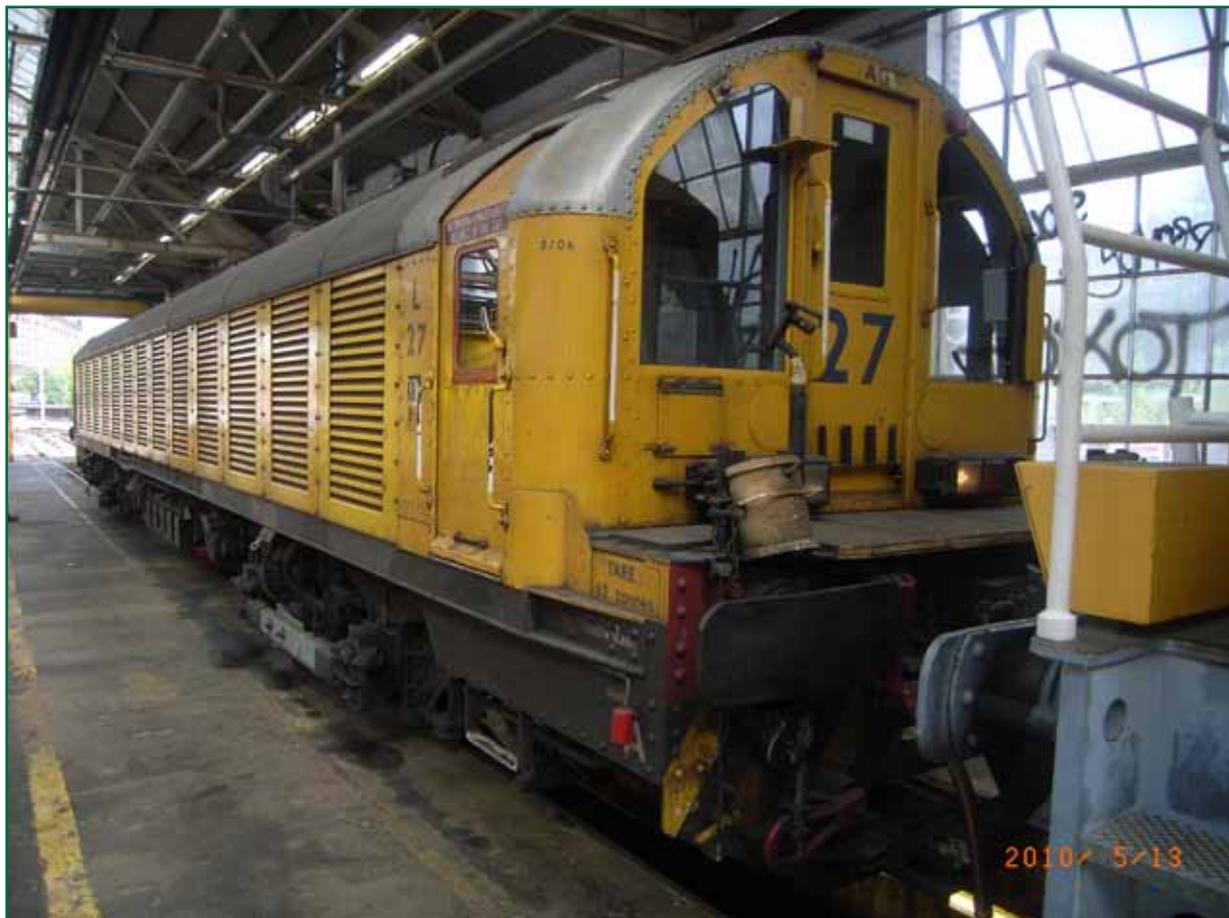
Figure 3: Battery locomotive involved in the derailment

- 16 The RAIB has found no evidence that the condition of the locomotive hauling the train, or the way in which it was driven contributed to the derailment.
