Rail Accident Investigation Branch

Rail Accident Report

**Near-miss on Victory level crossing, near
Taunton, Somerset
19 December 2009**

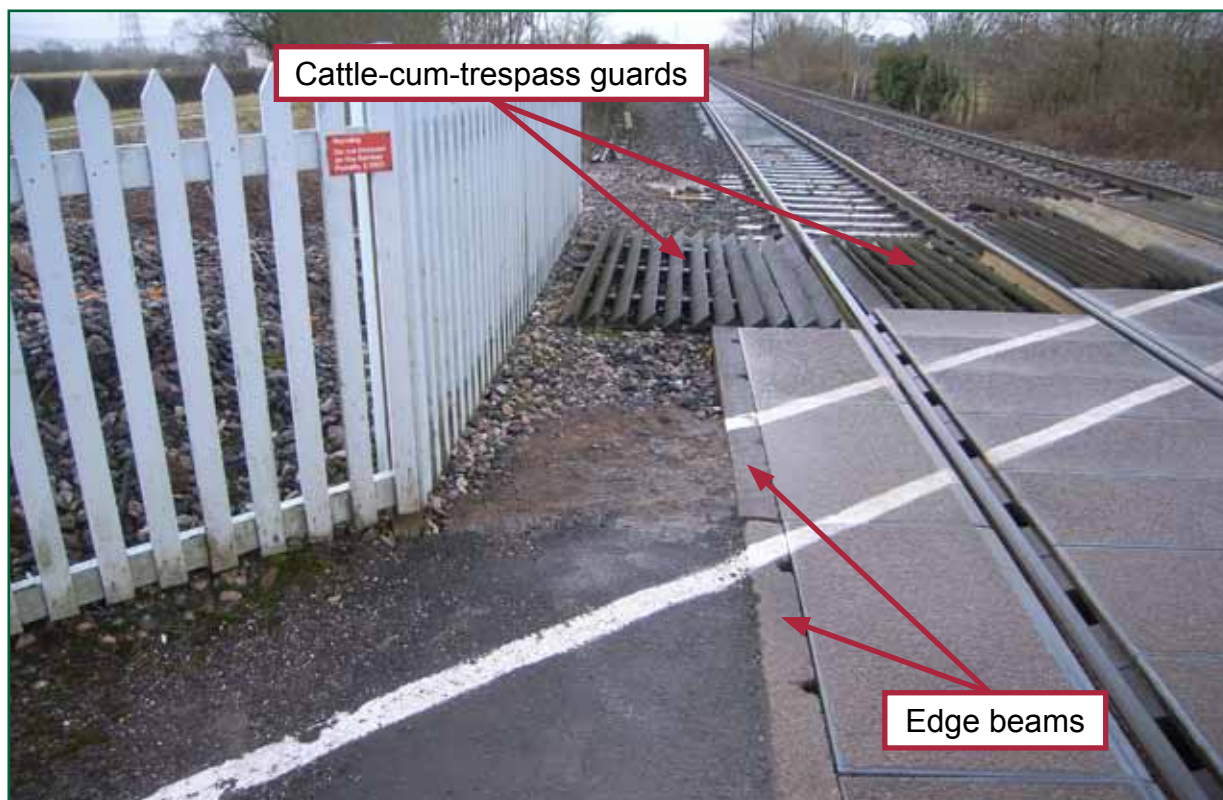
Figure 4: Position of edge beams and cattle-cum-trespass guards

- 21 At Victory level crossing the flangeway gaps were measured to vary between 55 and 62 mm.
- 22 Edge beams (figure 4) are installed on the north and south sides of the crossing to secure the outer crossing panels and to provide an edge for the asphalt section that is used to fill the gap between the crossing panels and the road approaches.

- 23 A footway for pedestrians is marked out over the level crossing surface to provide a walking area clear of the road carriageway. Cattle-cum-trespass guards (figure 4) are installed along the east and west sides of the crossing panels to deter animals and trespassers from gaining access to the railway lines.
