Rail Accident Investigation Branch

Rail Accident Report

**Near miss involving a freight train and two
passenger trains, Carstairs
22 December 2009**

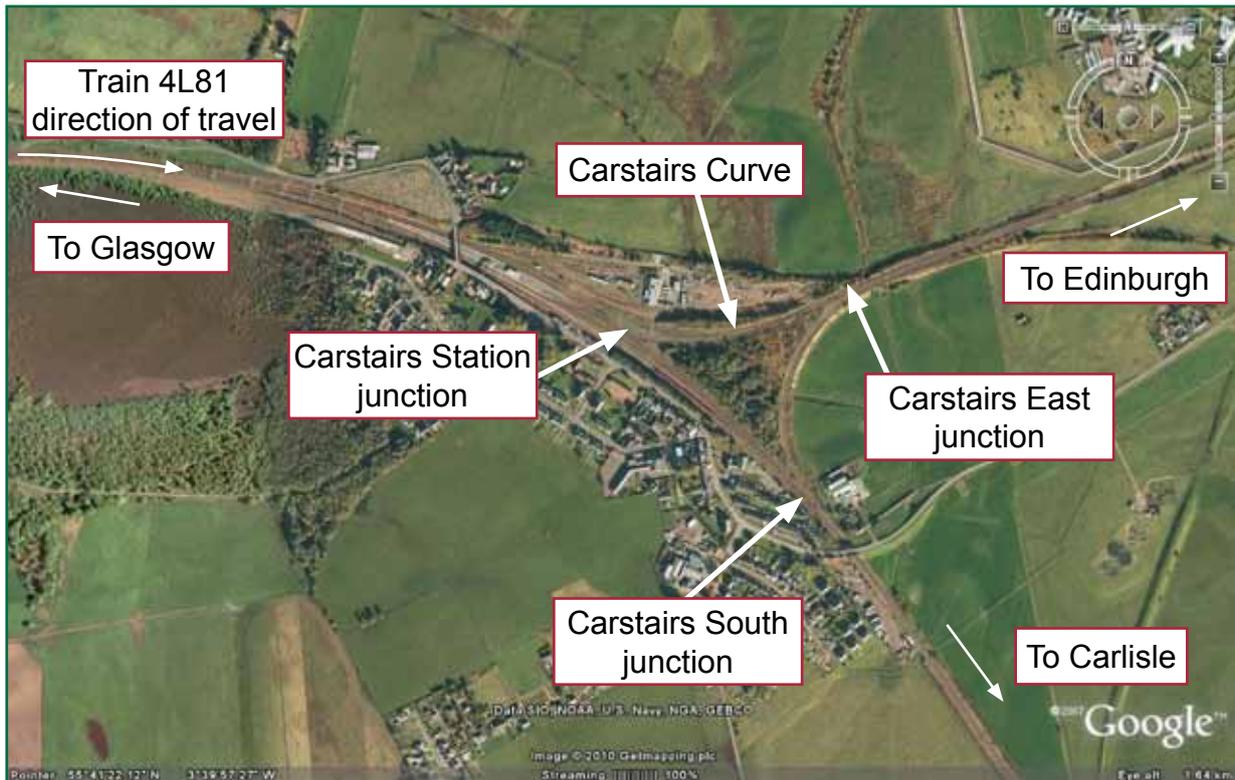
Figure 2: Overview of Carstairs showing railway junctions

- 5 At 20:26 hrs on 22 December 2009, a freight train travelling south on the West Coast Main Line (WCML) passed two red signals in succession at Carstairs (figure 1); one just to the north-west of the station and the other at its south-eastern end. In total the train took almost two and a half miles to stop after it had started braking and came to a stand over Carstairs Station junction (figure 2). This braking performance was below that expected of a train of its type.

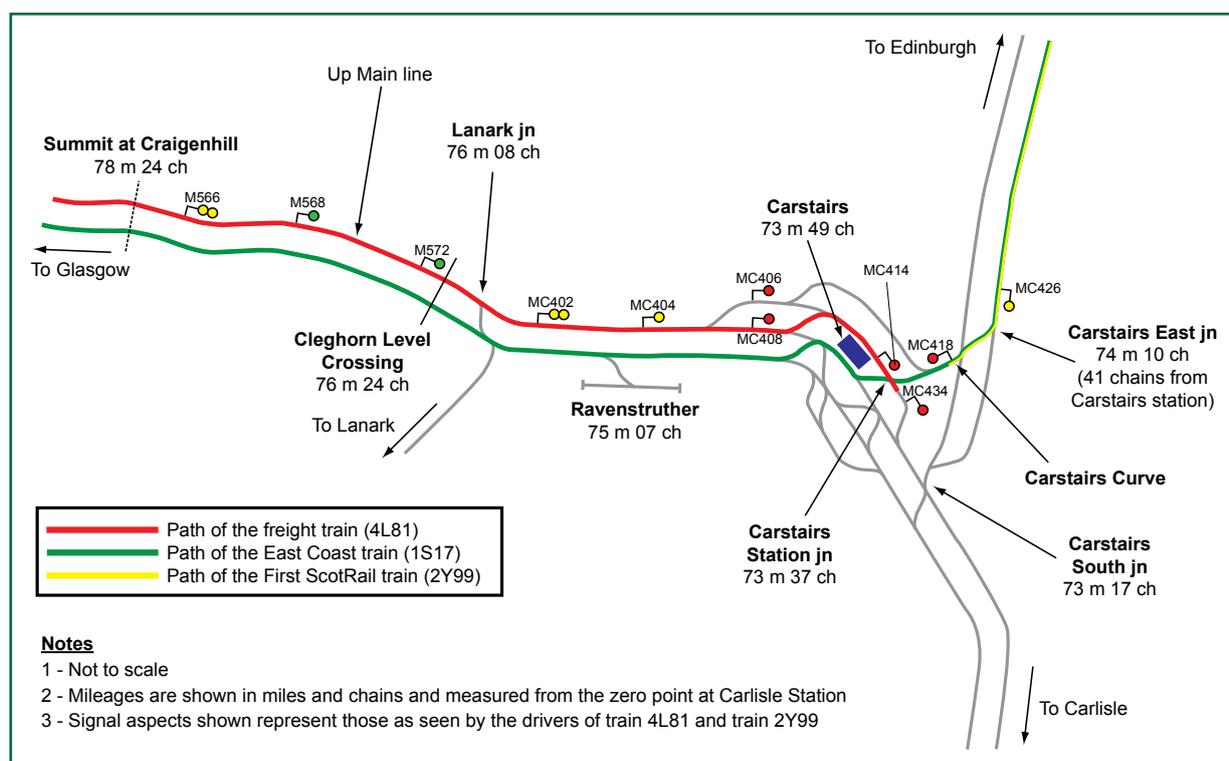
Figure 3: Track layout between Craighenhill and Carstairs showing movements of trains 4L81, 1S17 and 2Y99

- 13 The key locations are shown in figure 3. The incident began on the north-western approach to Carstairs, on the *Up Main line* of the WCML, at around *milepost* 76. It ended at Carstairs Station junction near to *milepost* 73½. This section of railway is on a falling gradient throughout. The freight train had joined this line at Law junction (near to *milepost* 84), with the summit between Law junction and Carstairs being Craighenhill at around *milepost* 78¼.

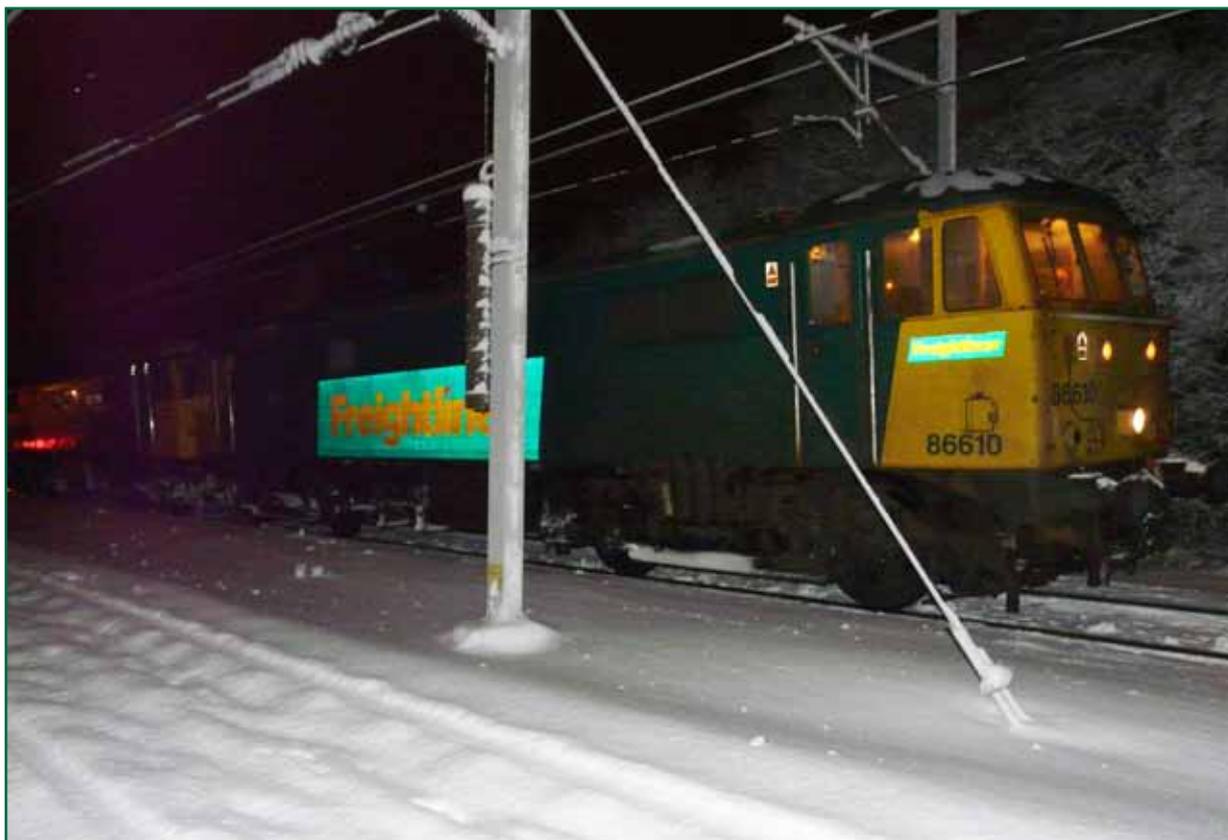
Figure 5: The leading class 86 locomotive of train 4L81 after the incident (courtesy of Network Rail)

- 16 The freight train was train 4L81, the 19:21 hrs service from Coatbridge to Tilbury, and was running about 30 minutes late. It consisted of two class 86/6 AC electric locomotives (figure 5) hauling 22 *bogie container flat wagons*, types FSA, FTA and FEA-B. The train was 488 metres long with a trailing weight of 1275 metric tonnes. All of the wagons except for one were loaded.

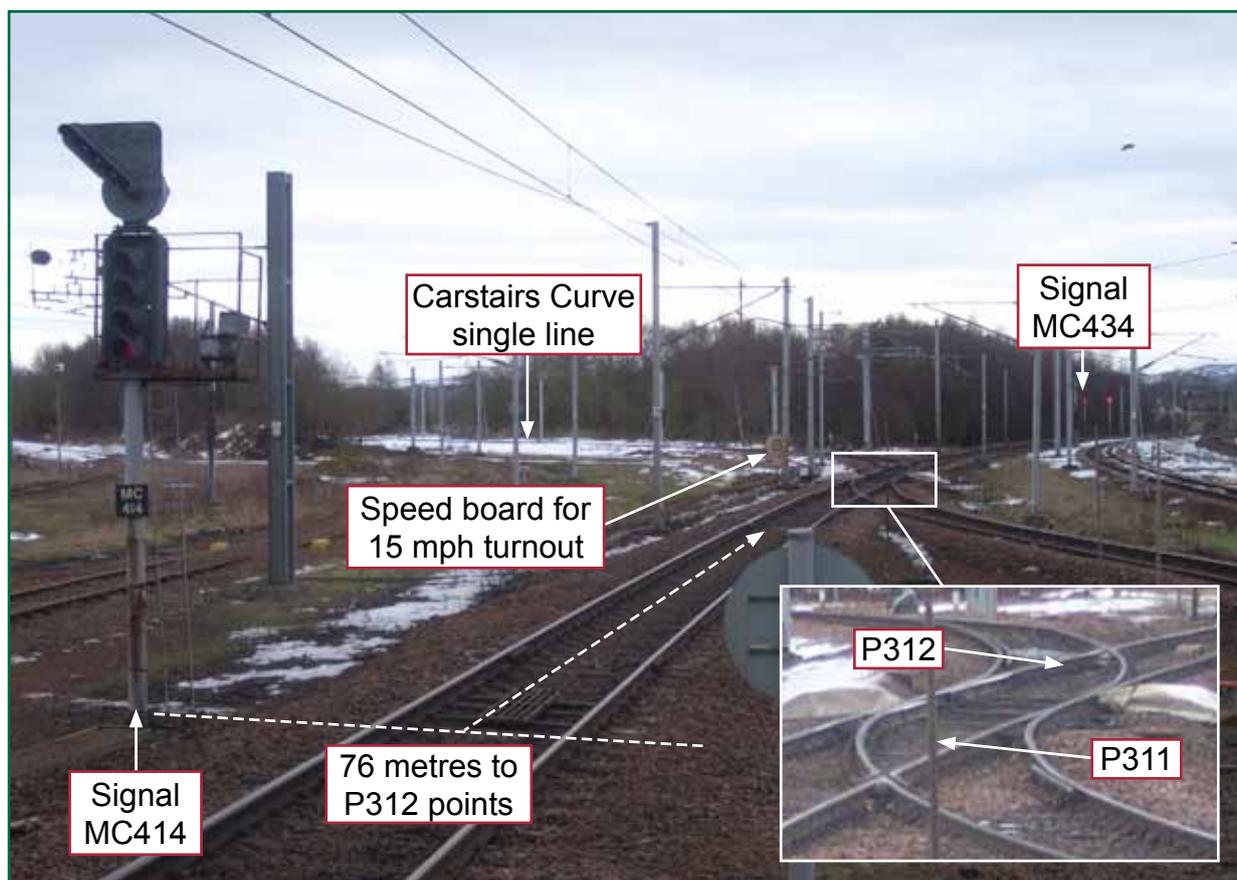
Figure 8: Signal MC414 and Carstairs Station junction

- 32 Five seconds later, train 4L81 passed signal MC414 at danger while still travelling at 25 mph (40 km/h). At 20:26:52 hrs train 4L81 passed over the points at Carstairs Station junction at 20 mph (32 km/h). Figure 8 shows signal MC414 at the southern end of the station and the junction beyond. This is the place where train 1S17 had been crossing over about 75 seconds before.

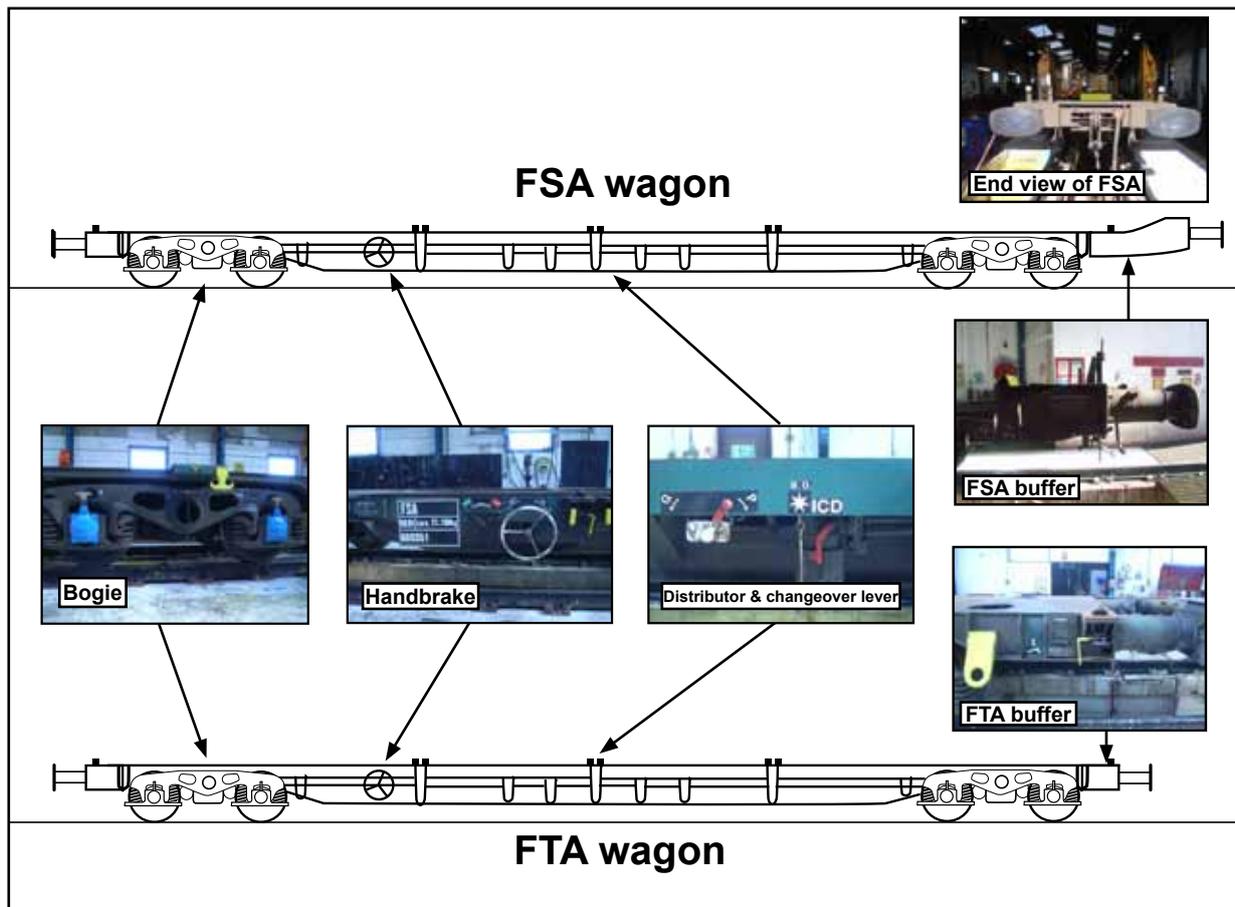
Figure 11: Side view of FSA and FTA wagons

- 48 The FSA and FTA wagons were built by Arbel Fauvet and commissioned into service between October 1991 and December 1993. Figure 11 shows that the mechanical difference between the FSA and FTA types of the wagon is that the buffer height differs at one end, but the rest of wagon design, including air and braking systems, is identical on both types.

- 49 Their braking equipment was specified to operate in a wide range of environmental conditions, including an ambient temperature range of -30°C to +40°C, a relative humidity range of 0 to 100%, and snow and ice. Their braking performance was specified to meet the requirements of two *International Union of Railways* (UIC) leaflets: UIC-543 (Brake Regulations) and UIC-544 (Brake, Braking Power).

- 50 Between April and June 1991, British Rail carried out braking performance acceptance tests on the wagons in their laden and tare conditions. From these test results, the RAIB calculated that the brakes gave an average deceleration of 6.1%g in its laden condition.

- 51 From the braking performance seen during the incident, the RAIB calculated that there must have been either a complete absence of braking on some wagons or a reduced braking force on some or all of the wagons, even after the effect of the falling gradient is taken into account. This was confirmed by calculations which showed that even if the braking effort provided by the two locomotives is removed, the remaining braking effort provided by the FSA and FTA wagons should still have been sufficient to stop the train before signal MC408.

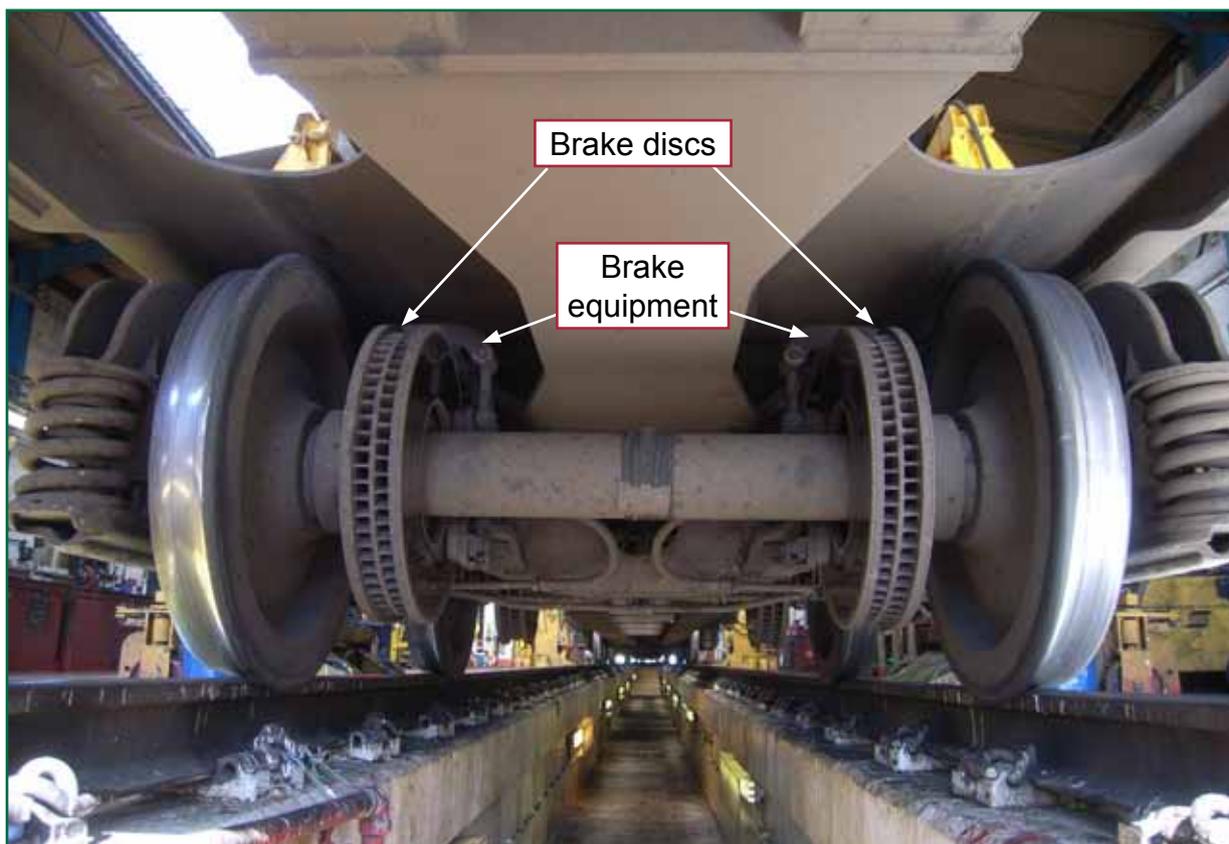
Figure 12: Brake discs mounted on one axle of an FSA/FTA wagon

54 Each FSA / FTA wagon has eight independent sets of brake actuators, pads, discs and rigging, with two sets per axle, giving four sets per bogie. The failure of one set of brake rigging will have no effect on the other seven. Figure 12 shows the axle mounted discs and figure 13 shows the arrangement for one set of brake equipment.

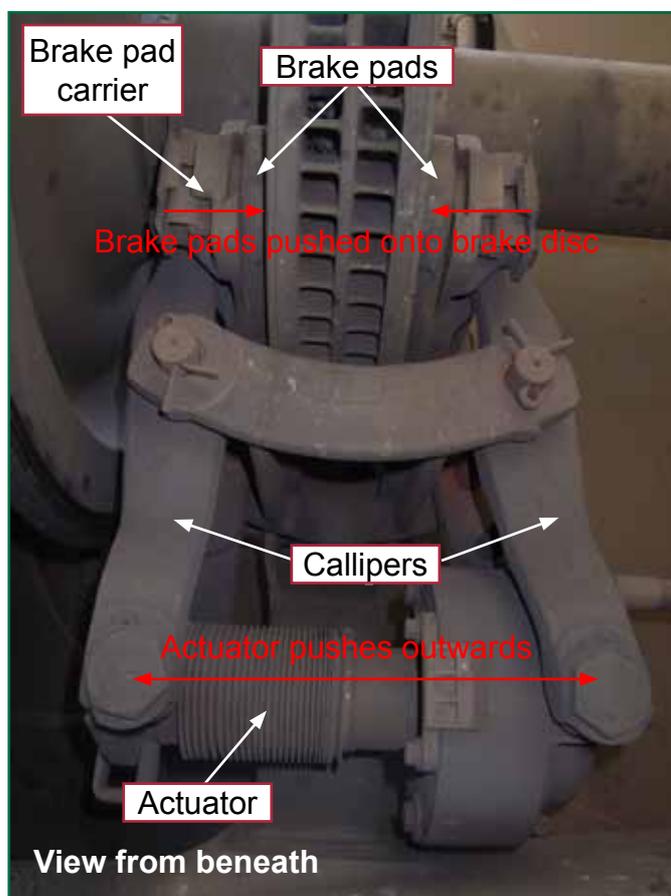
Figure 13: One set of brake equipment on an FSA/FTA wagon

55 When the brakes are to be applied, air is supplied to the brake actuator and it pushes a piston outwards. This outward force is transferred via a brake calliper assembly to push a pair of brake pads inwards and onto the axle mounted brake disc. Examination and measurements on two FSA and FTA wagons showed there was only a small amount of movement between the brake pads being in their released position, and in contact with the brake disc. The measured brake pad movement, ie the clearance between the brake pad and brake disc, was in accordance with Freightliner's maintenance standard MIE 07/FSA/01 (Vehicle Maintenance Instructions, FSA/FTA "Arbel" Container Wagons). A slack adjuster is also fitted to each brake actuator. This device automatically maintains the right amount of clearance by taking up any slack caused by the wearing of the brake pads. On the wagons that were examined, the outwards movement by the actuator piston was about 5 mm and this gave about 2 mm movement at the brake pads. If the movement of the brake callipers is restricted or limited, the amount of force that each brake pad then exerts on the brake disc is reduced, or in a worst case, the brake pad is held off completely.

- 58 The staff that arrived about 36 hours after the incident to de-ice the wagons found that all of the brake pad and brake calliper assemblies were covered in varying amounts of ice and snow. Staff visually checked the application and release of the brakes on each wagon before and after de-icing them. Before de-icing, the movement of each set of brake rigging was reported as restricted and slow. Once the rigging had been freed from ice and snow, the brakes released and applied quickly and there was an audible 'clunk' when the brake pads made contact with the brake disc. This indicates that the iced up brake rigging was preventing the wagons' brakes from working correctly.

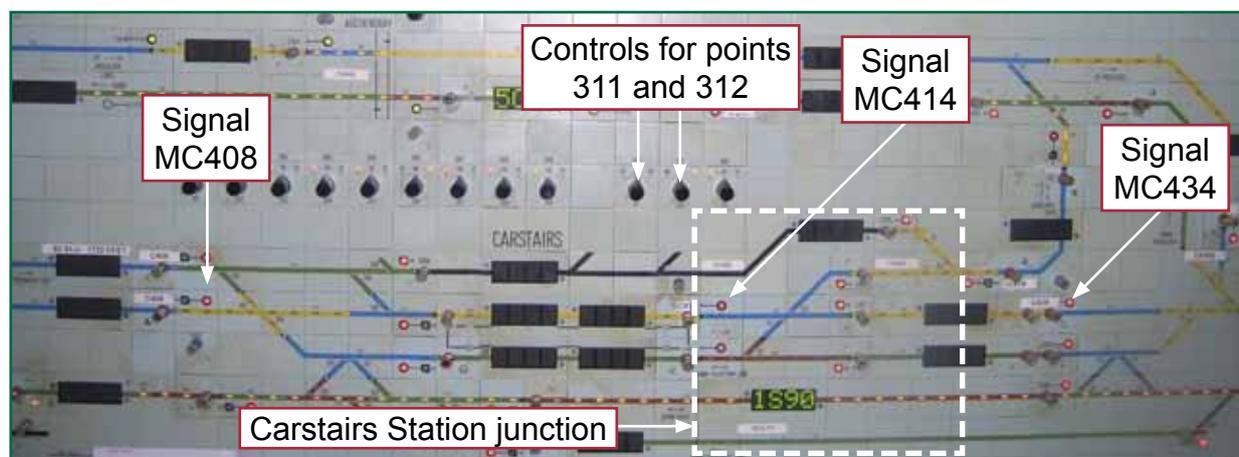
Figure 15: Carstairs area on the signaller's panel at Motherwell

139 The signaller took timely action and used the controls on his panel to change the position of two sets of points, P311 and P312, in front of train 4L81 (figure 15). His actions kept it on the WCML route, thereby preventing it from taking the low speed diverging route onto the Carstairs Curve. This had three effects on the consequences:

- Firstly, it stopped the train running through and damaging a set of trailing points, P311, which would have been in the wrong position.
- Secondly, it removed the risk of train 4L81 derailing on the *facing points*, P312. The divergence onto the Carstairs Curve has a maximum speed of 15 mph (24 km/h). The train's data recorder showed that it was travelling at 20 mph (32 km/h) when it reached this point. Therefore the risk of an actual derailment was very small but could have been much greater had the train reached the points at a higher speed.

- Thirdly, it removed the risk of train 4L81 running away towards train 2Y99 that was moving onto the Carstairs Curve from the opposite direction. Train 2Y99 had been signalled to travel as far as signal MC418 on the single line, which is located 444 metres from P312 points. Train 4L81 stopped about 135 metres after passing over the points. Therefore the risk of an actual collision was very small but could have been much greater under slightly different circumstances.
