RAIB Bulletin 01/2010

Passenger train collision at Darlington 3 October 2009

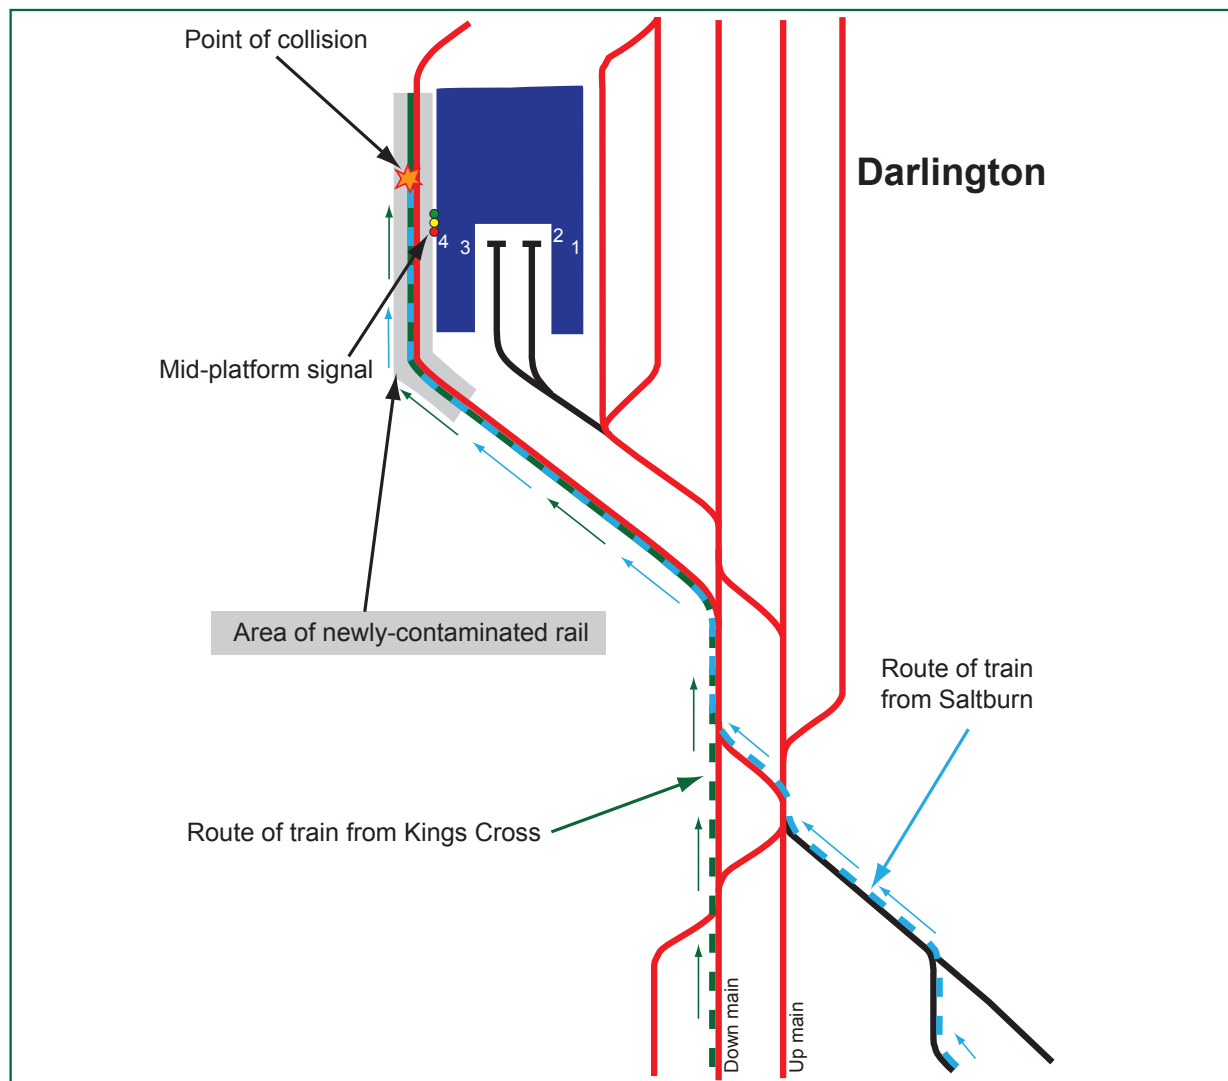
Figure 1: Layout of track and path of trains involved

1. At around 10:54 hrs on 3 October 2009, a passenger train arriving in platform 4 at Darlington station collided with the rear of another passenger train which had just started to depart from the same platform (see figure 1). The collision caused a small number of minor injuries and two passengers were taken to hospital for treatment. Both trains suffered minor damage.
