Rail Accident Investigation Branch

# Rail Accident Report

## Overhead line failure, St Pancras International 23 September 2009

Report 12/2010  
August 2010

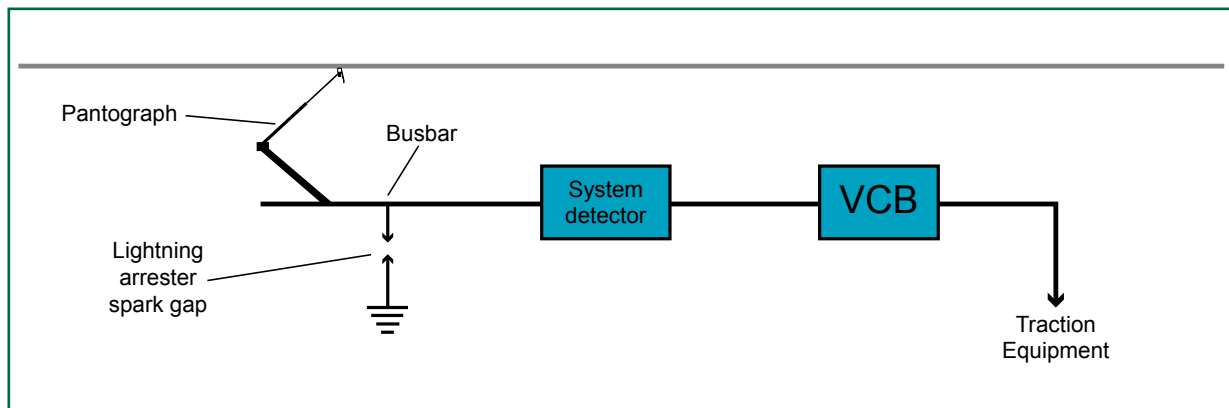
Figure 4: Diagram of roof equipment

- 31 The pantograph collects the current from the OHLE. The current then passes along a *busbar*, through the voltage detector and through the vacuum circuit breaker (VCB), before entering the equipment inside the power car. All these items are mounted on the roof of the power car (figure 4).

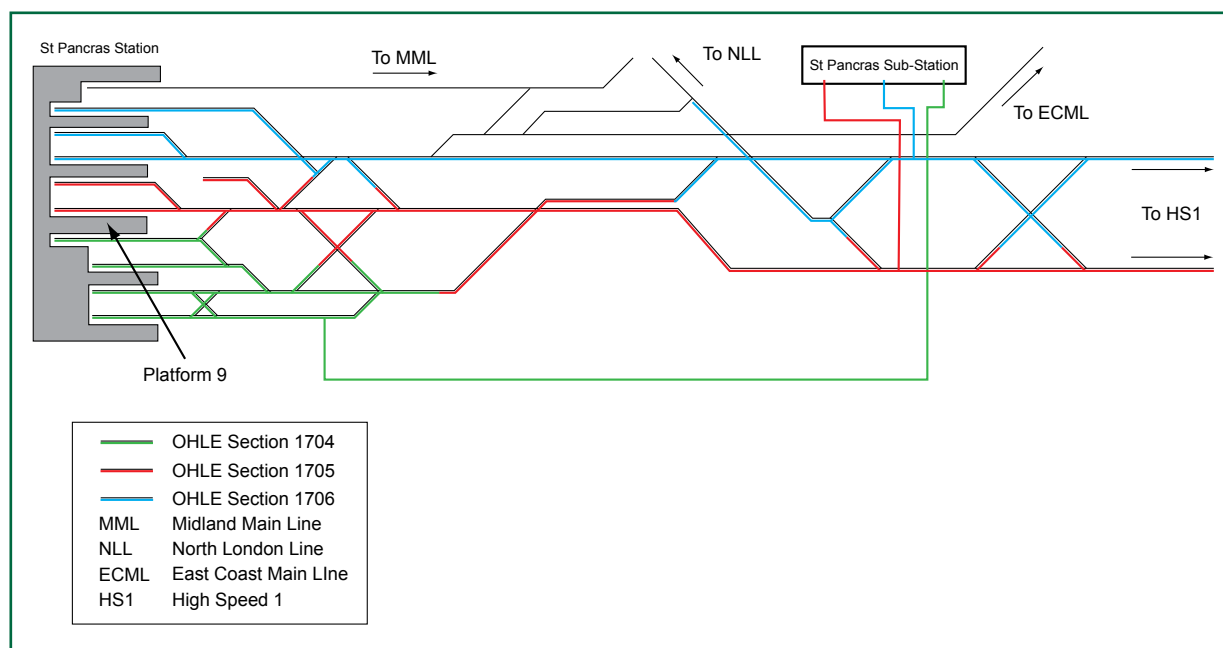
Figure 5: Diagram of the feeding arrangements

- 35 *Tramway OHLE* is installed at St Pancras and under the Barlow trainshed it is supported by transverse *headspans*. This system and the differences between it and the type of OHLE used on the rest of HS1 are described in paragraphs 116 – 118.
- 36 The power supply to the OHLE is fed with alternating current at 25kV 50Hz through *circuit breakers* located in a feeder station outside St Pancras International. These are controlled from the Control Room at Ashford and open automatically in the event of a fault in the overhead line (figure 5).
