# Rail Accident Report

## Collision on the Great Orme Tramway 15 September 2009

# Collision on the Great Orme Tramway

## 15 September 2009

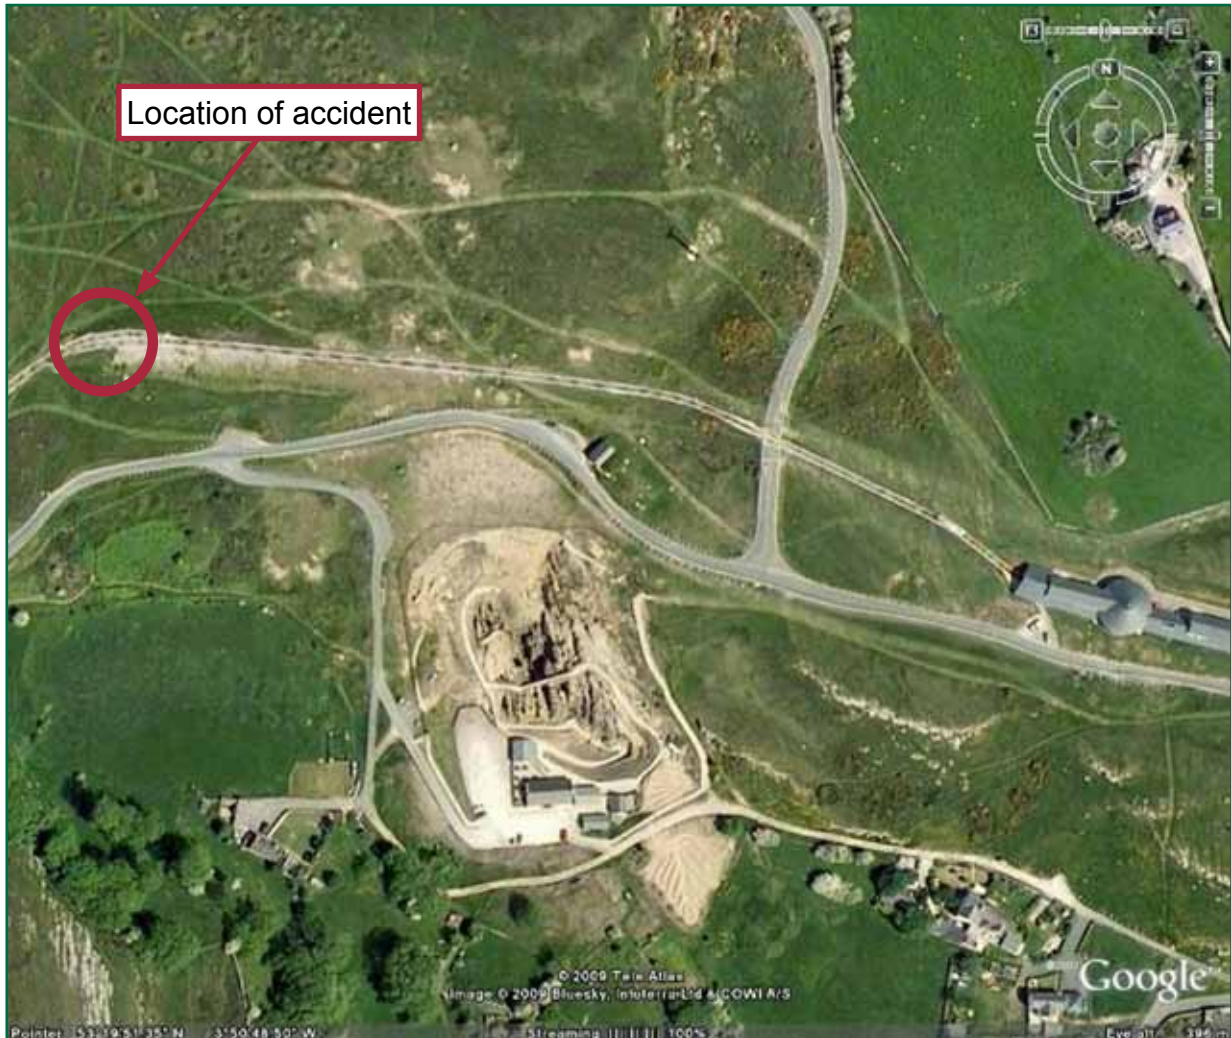
- 4 At 12:15 hrs on 15 September 2009 two trams travelling in opposite directions collided at the passing loop on the upper section of the Great Orme Tramway, Llandudno (figure 1). One person suffered minor injuries in the collision.

Figure 1: Aerial view of accident site showing location of accident (courtesy of Google Earth)

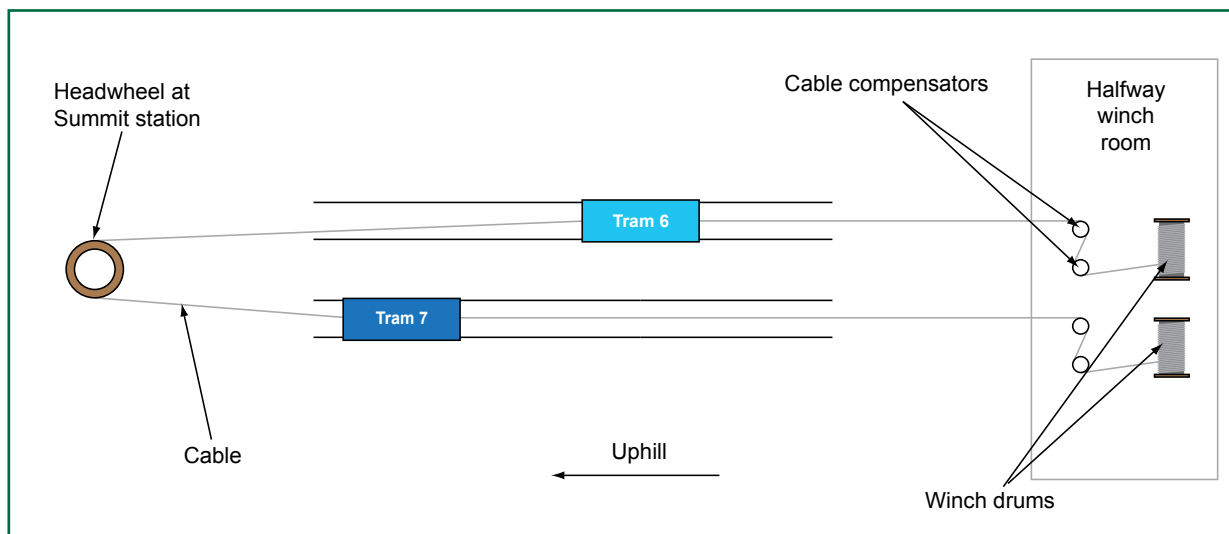
Figure 4: Schematic showing operation of the upper section

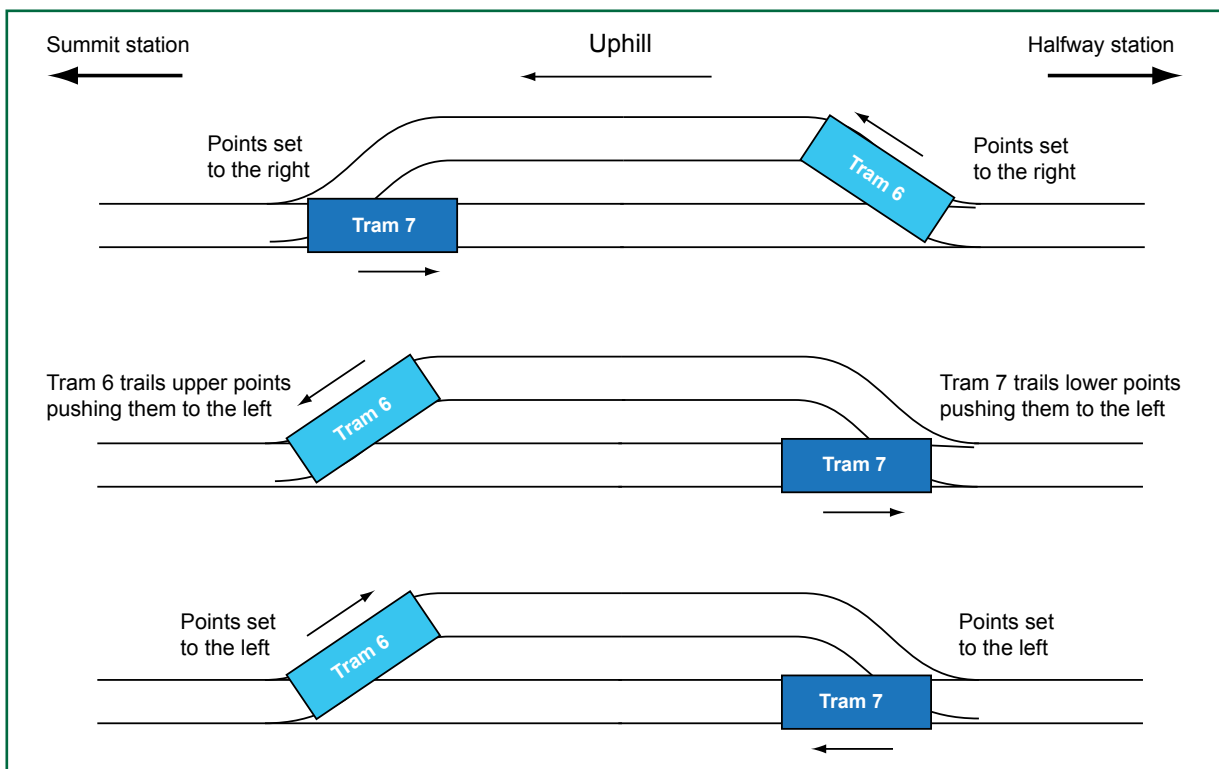
- 11 As the trams leave the loop the action of their wheels moves the points across. The points are then set in the correct positions for directing the trams to their correct tracks in the loop for their next return journeys (figure 5).

Figure 5: Operation of the upper section passing loop
