Rail Accident Report

Collision on the Great Orme Tramway 15 September 2009

15 September 2009

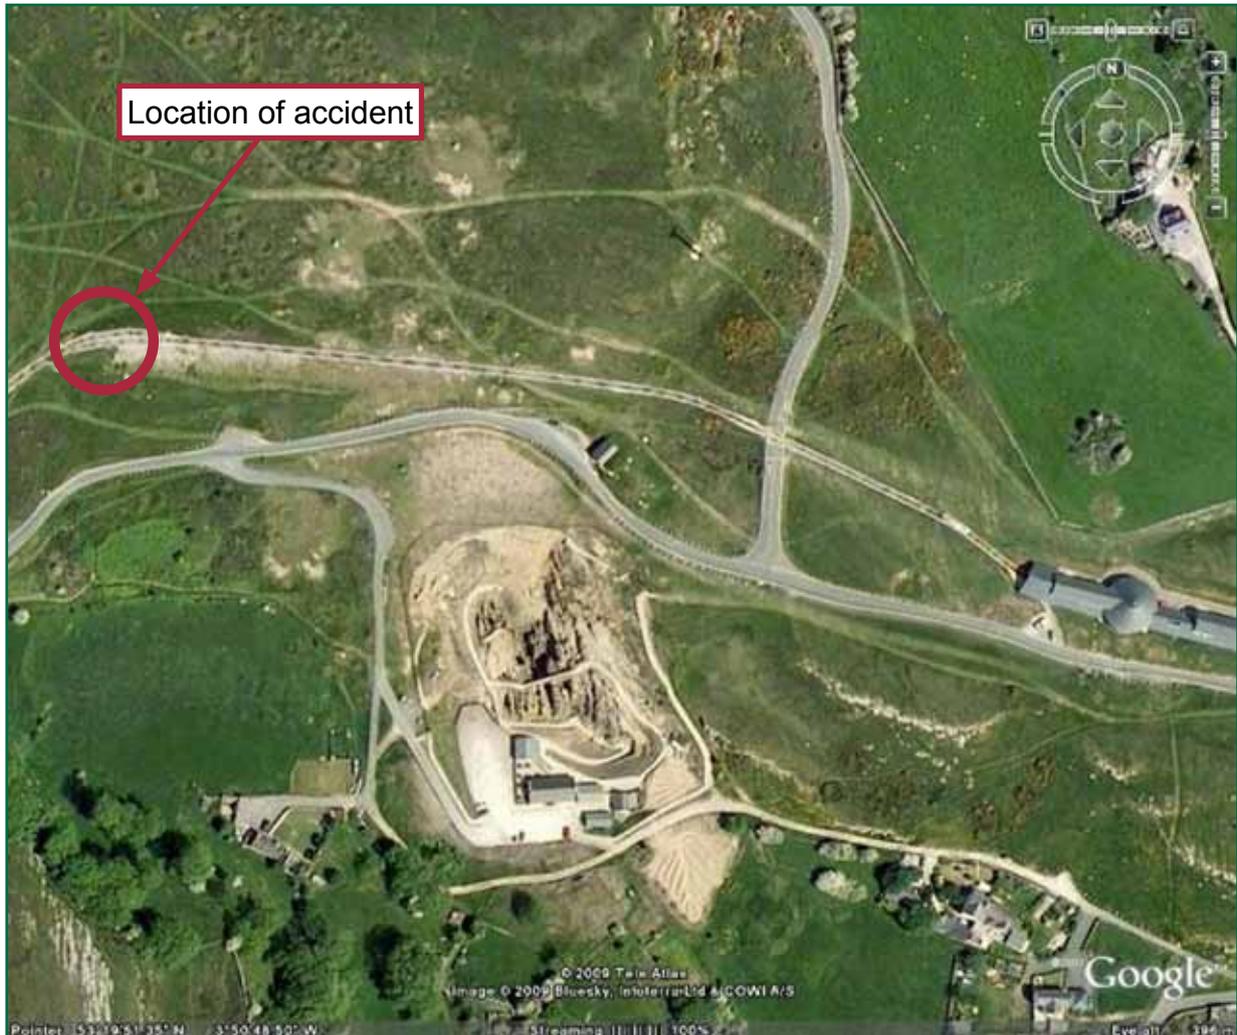
- 4 At 12:15 hrs on 15 September 2009 two trams travelling in opposite directions collided at the passing loop on the upper section of the Great Orme Tramway, Llandudno (figure 1). One person suffered minor injuries in the collision.

Figure 1: Aerial view of accident site showing location of accident (courtesy of Google Earth)

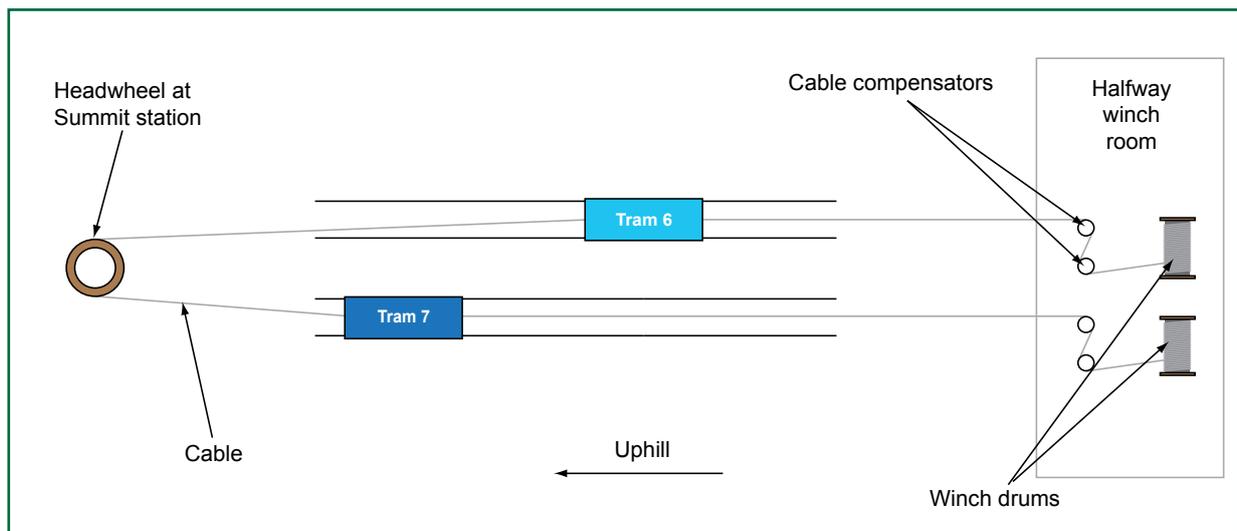
- 9 Each section has its own winch and the two sections are functionally independent. Trams 6 and 7 operate on the upper section of the tramway and are connected by a cable running uphill from the trams which passes via the headwheel at the Summit station. Each tram also has a cable between it and a winch drum at Halfway station (figure 4). The trams are operated by a combination of the winchman and an attendant in each tram. The winchman controls the cable winch drums at Halfway station and the tram attendants control the manually operated tram brakes. There are cable compensators close to the winch drums which ensure that any cable slack is managed and protect the cable against shock loads.

Figure 4: Schematic showing operation of the upper section

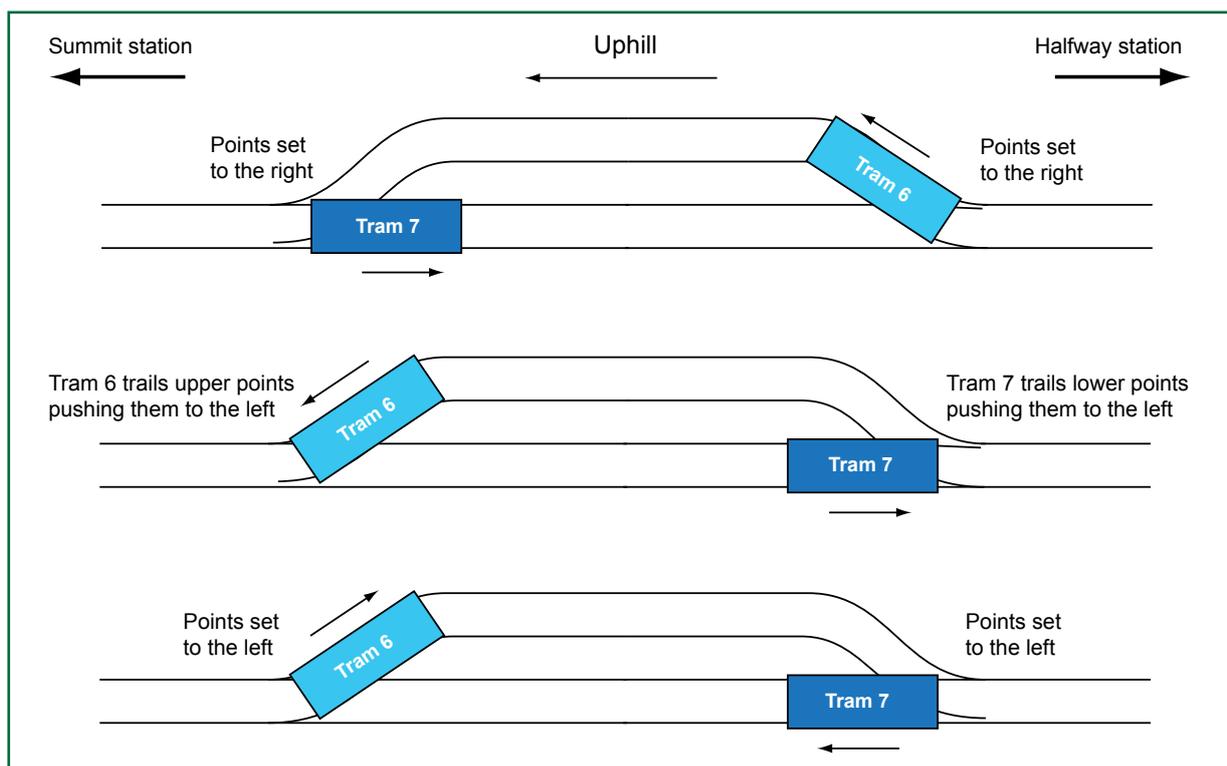
- 11 As the trams leave the loop the action of their wheels moves the points across. The points are then set in the correct positions for directing the trams to their correct tracks in the loop for their next return journeys (figure 5).

Figure 5: Operation of the upper section passing loop
