Rail Accident Investigation Branch

Rail Accident Report

Derailment of a Docklands Light Railway train near West India Quay station, London, 10 March 2009

Report 03/2010
March 2010

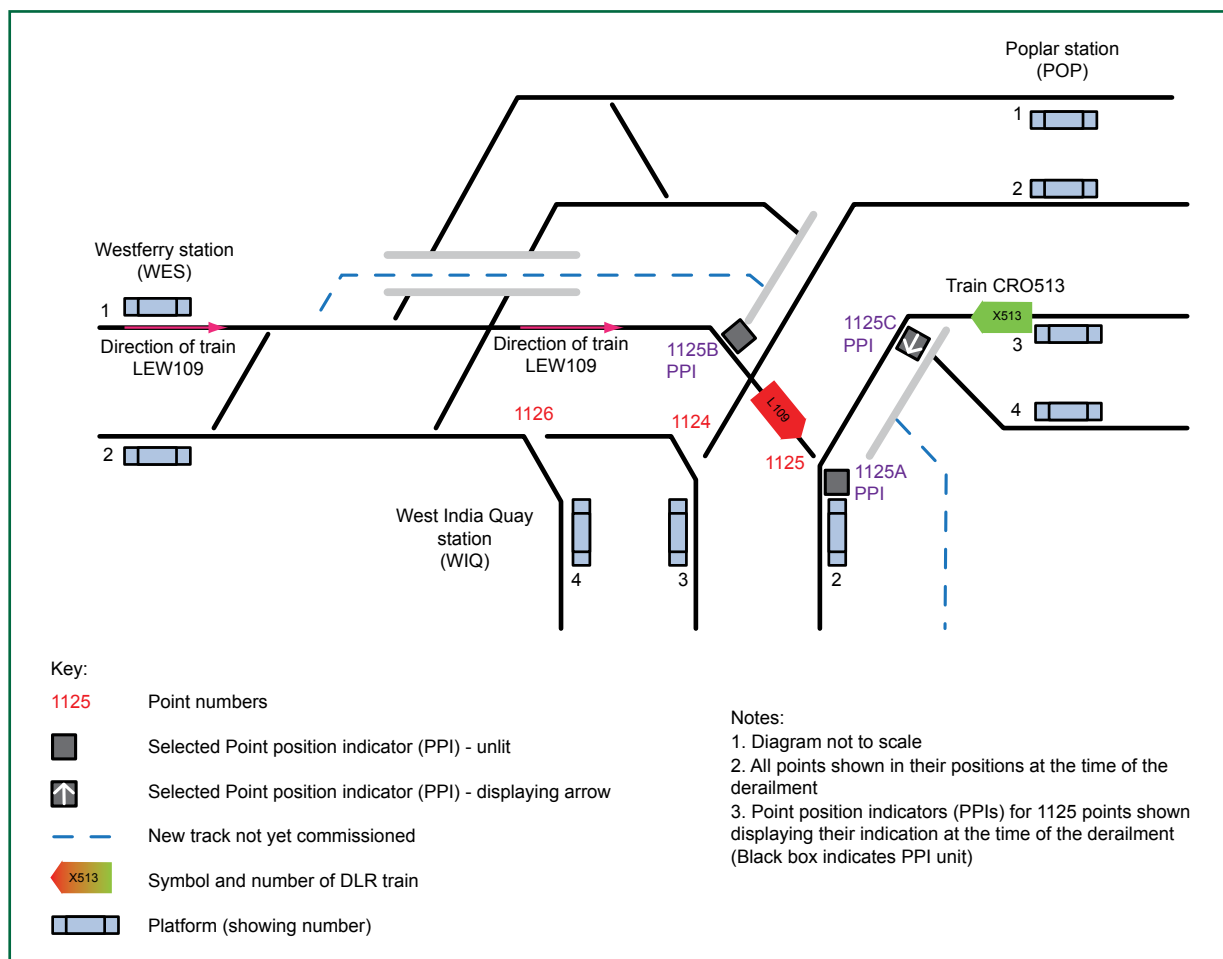
Figure 2: Diagram of the location of the derailment at North Quay Junction

- 12 At 10:02 hrs on 10 March 2009, the 09:50 hrs DLR service from Bank to Lewisham (train LEW109) became derailed by both axles of the leading *bogie* as it travelled through a set of trailing points that were not correctly set for the route of the train at North Quay junction, just north of West India Quay station.
- 13 The train had undergone an earlier automatic emergency brake application initiated by a failure of the signalling between Westferry and West India Quay stations, and was being driven by a passenger service agent in emergency shunt mode.
- 14 The train was travelling at approximately 10 km/h when it derailed on 1125 points at the junction. The front of the train came to rest 10.3 metres after derailing and approximately in line with the top of the end ramp of platform 2 at West India Quay station (figure 2).

- 26 The accident took place on 1125 points at North Quay junction, immediately north of West India Quay station (figure 2). At this location the track is level and constructed on a series of viaduct structures, approximately 9.5 metres above ground level.

- 53 At 10:00:15 hrs, 1125 points (figure 2) moved from the reverse⁵ to normal position as part of the normal route for train LEW109 to enter West India Quay station. 1125B point position indicator displayed a white arrow indication to indicate that 1125 points were set in the correct position.

120 The point position indicator applying to moves across the same points but in the opposite direction (1125A, see figure 2) was also unlit on 10 March 2009 when it should have been displaying a red bar. Further investigation of this indicator on site revealed that it too had corrosion on one of the pins of the lamp creating a high resistance in the electrical circuit.
