Rail Accident Investigation Branch

Rail Accident Report

Derailment of a freight train near Stewarton, Ayrshire 27 January 2009

Report 02/2010
February 2010

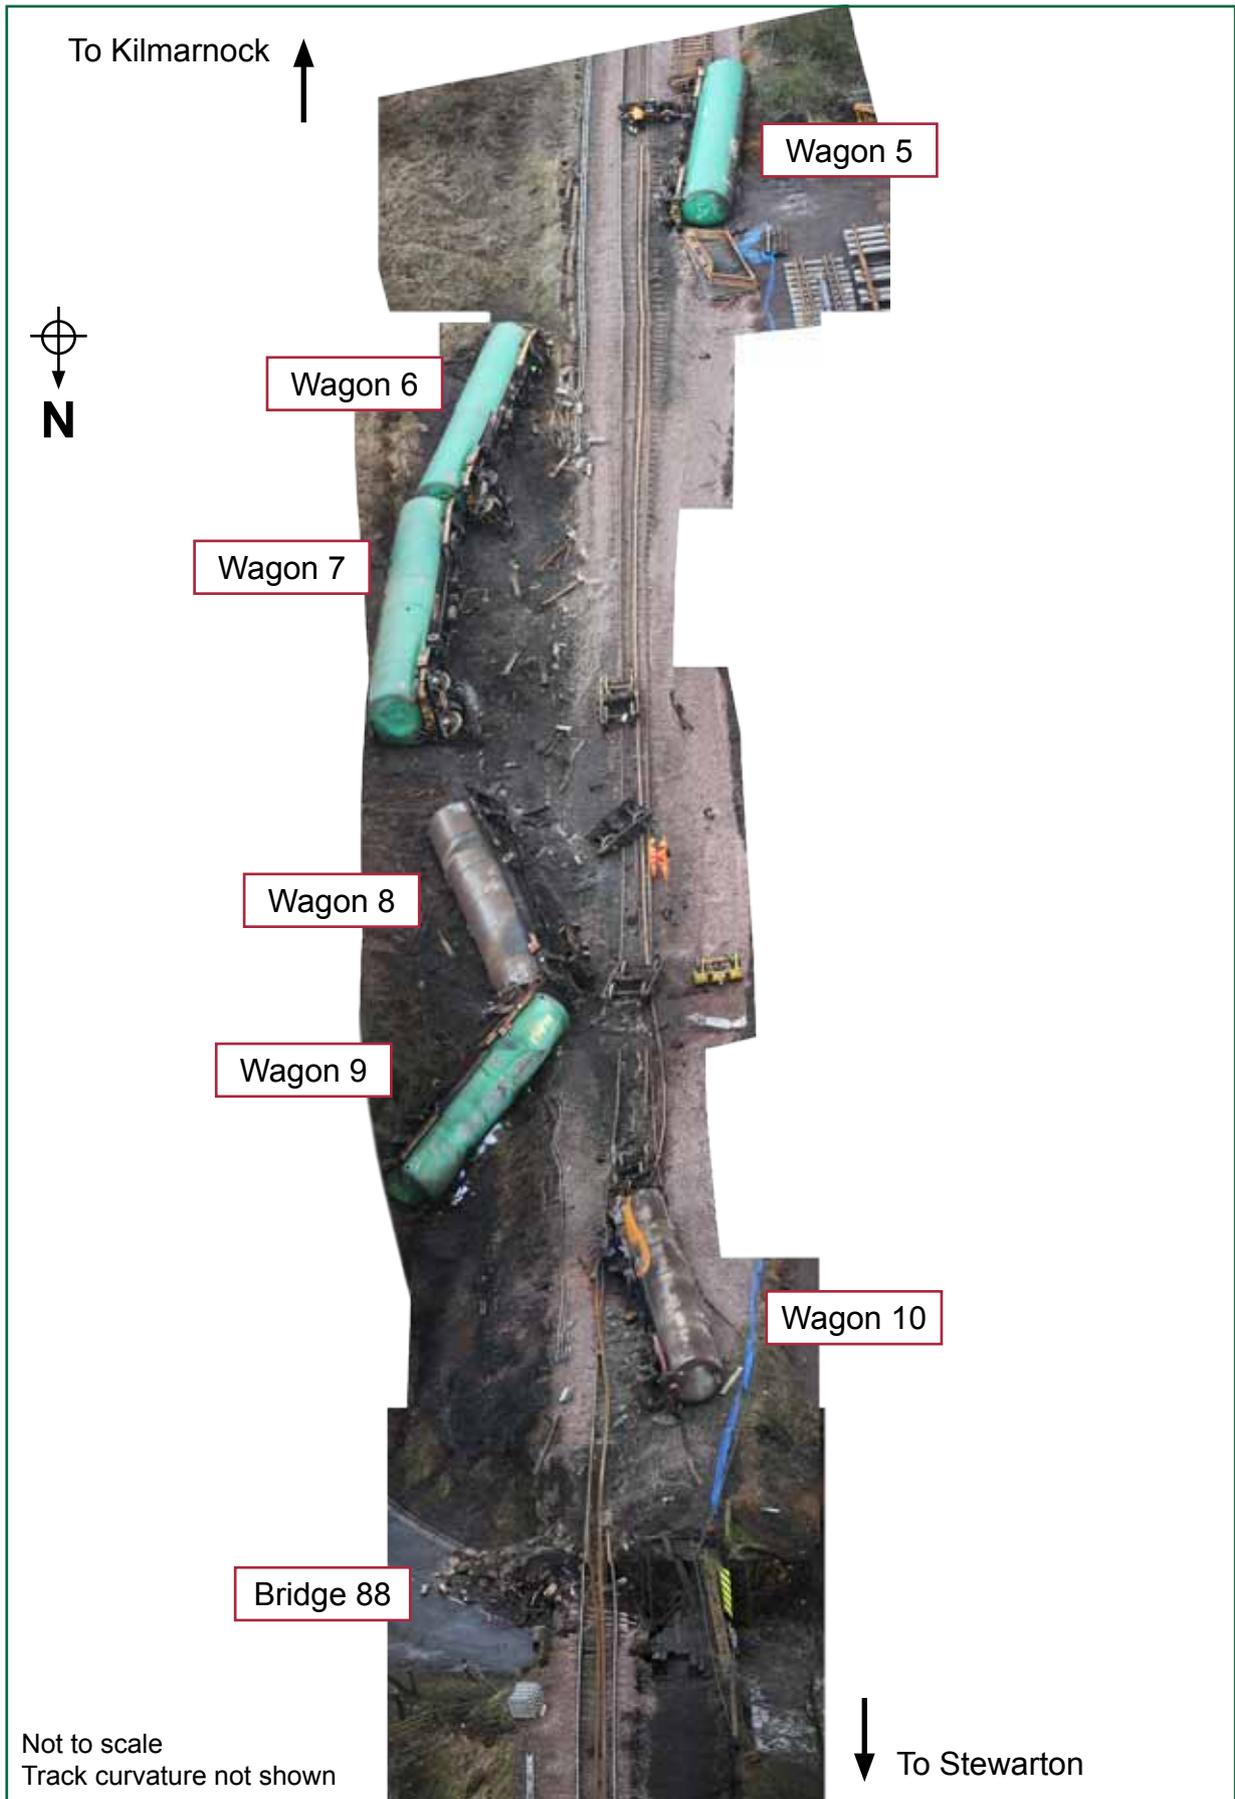
Figure 2: Composite aerial photograph showing the collapsed bridge and the location of the derailed wagons on the southern side (photographs courtesy of Network Rail)

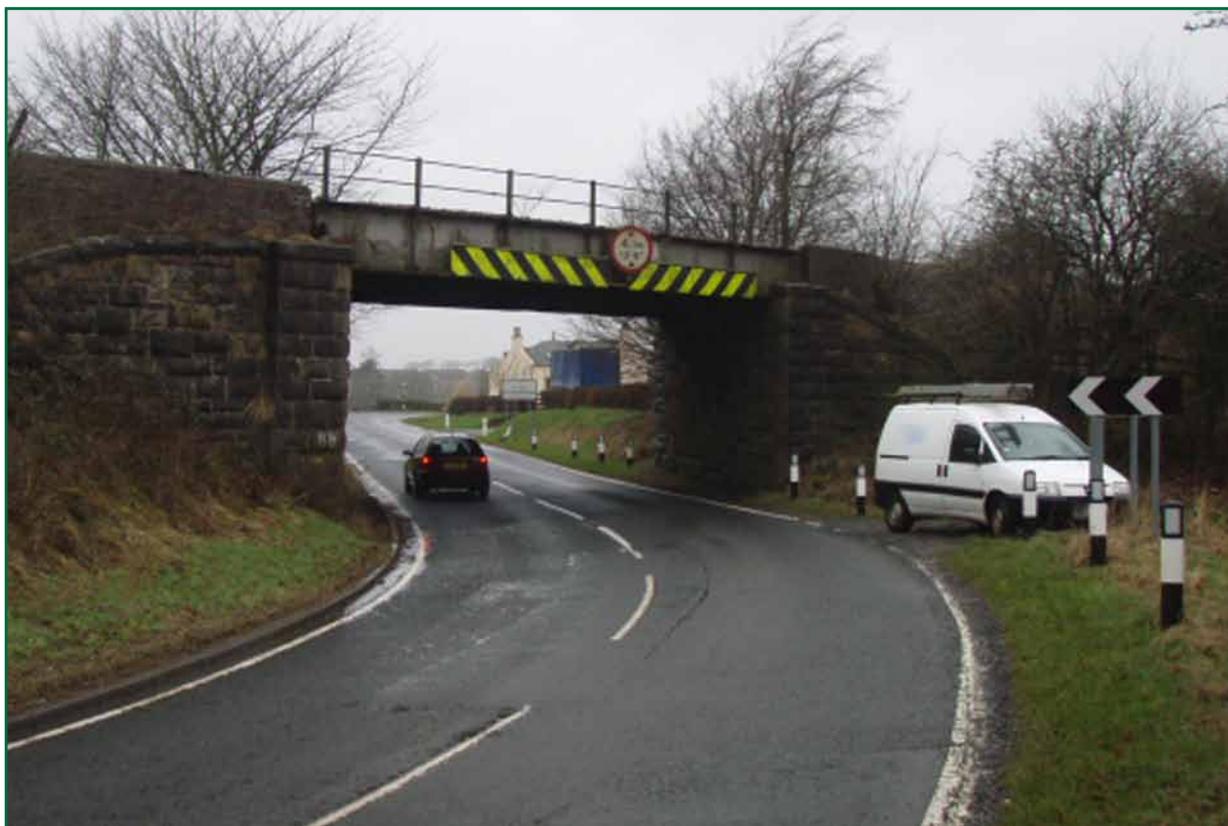
- 43 All the girders were fabricated from *wrought iron* plates, angles and T-sections, held together with wrought iron rivets. The supporting abutments were of stone masonry. The railway approached these, from both the north and south, on earth embankments. Figure 6 shows a photograph of the east elevation of the bridge at the time of the last routine examination in February 2008; train 6B01 was crossing from the right when it derailed.

Figure 6: East elevation of Bridge 88 in February 2008 (photograph courtesy of Network Rail)

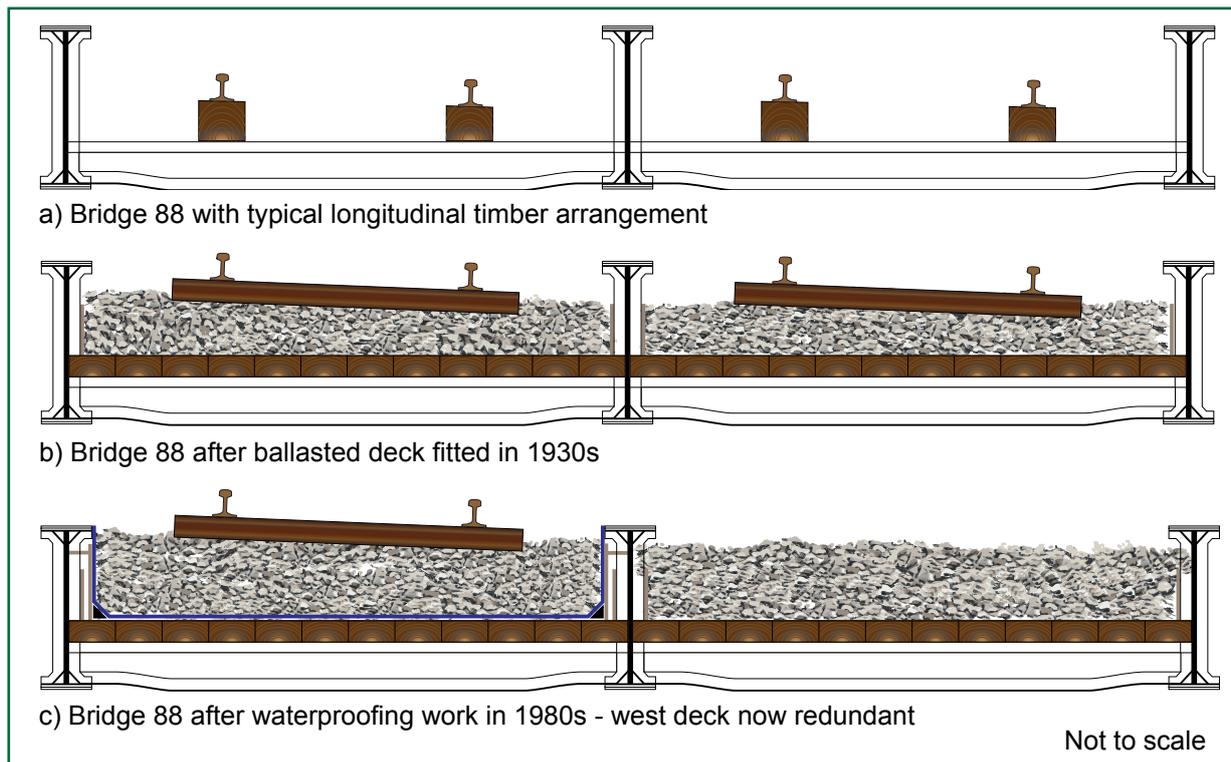
- 47 In 1984, British Rail decided to waterproof the east deck of the bridge because it was concerned about the condition of the timber deck; the line had been reduced to single track by this time and the west deck was redundant (paragraph 27). British Rail did this work in 1987. It involved removing the track and ballast, fitting a proprietary waterproofing system (the detailed application of which was designed by British Rail), and then replacing the ballast and track on top.

Figure 7: Cross-section of the deck of Bridge 88 showing the modifications made since it was constructed

48 The waterproofing system comprised a 6 mm thick layer of bituminous board on the timber deck, with a neoprene waterproof membrane laid on top. The membrane was protected by a further two layers of bituminous boarding, each 12 mm thick. At the sides of the deck, the waterproofing membrane was brought up to the top of the main girders. Figure 7c shows the arrangement fitted.

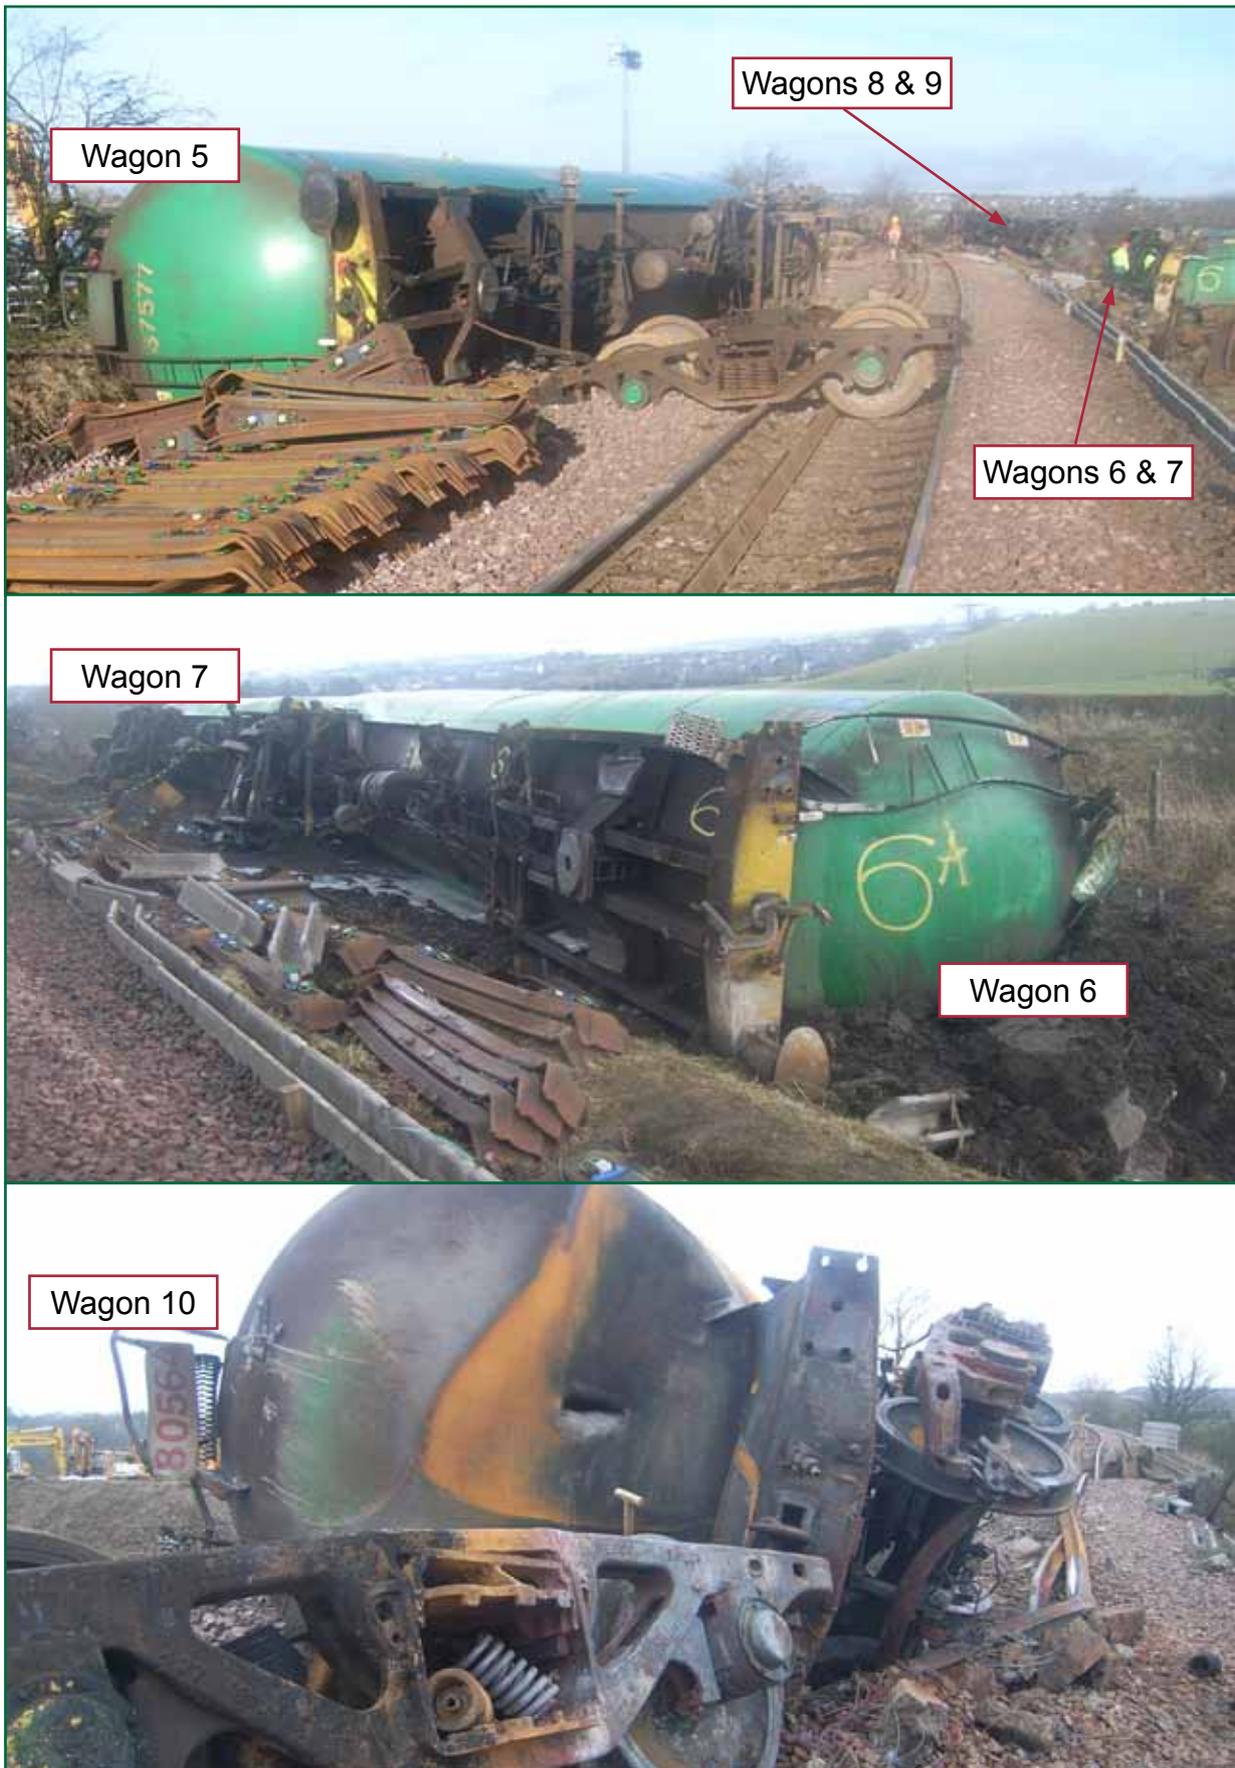
- 84 Figures 2 and 8 show the locations of the six rear wagons after derailment.
- 85 The tanks of wagons 6, 8 and 10 were all punctured by the drawhooks of adjacent wagons, and a *pressure and vacuum valve* was damaged on the top of the tank on wagon 7. Kerosene leaking from wagon 10 ignited.

Figure 8: Derailed wagons

242 The wagons made significant override movements as the train passed over the collapsing bridge, causing the tanks on wagons 6, 8 and 10 to be punctured by the drawhooks of adjacent wagons; the punctures on wagons 6 and 10 can be seen in figures 8 and 15. All of the fuel lost from these wagons leaked through these holes.

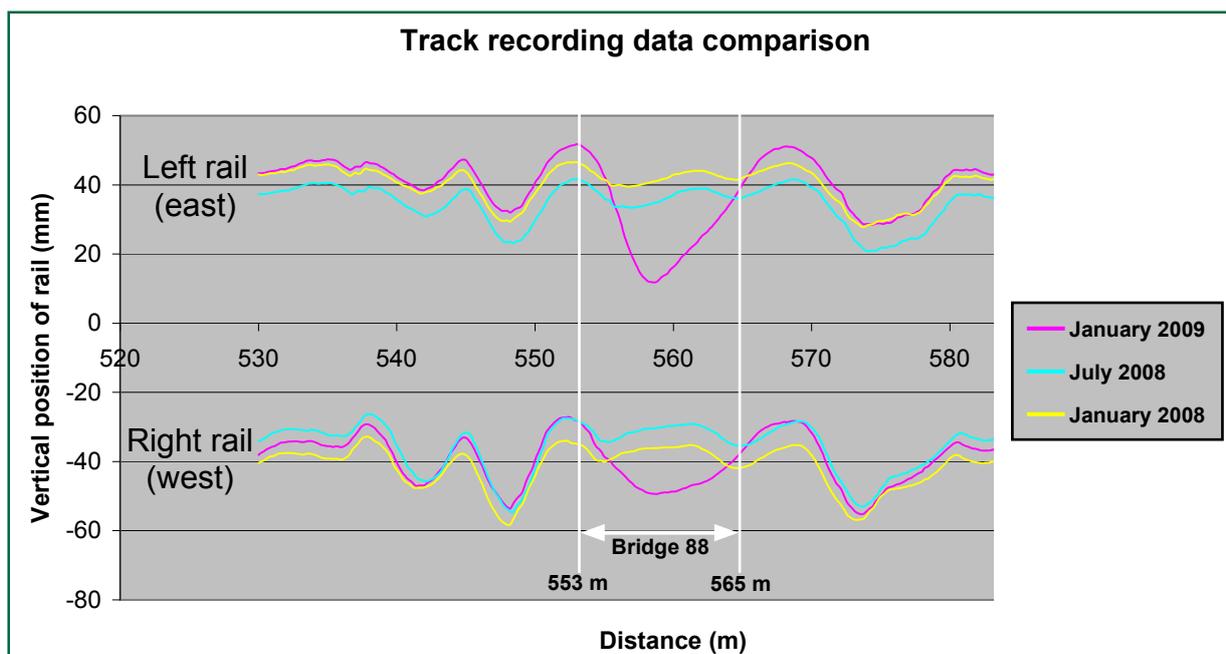
111 Network Rail has a fleet of special trains that regularly run over its network recording the geometry of the track for routine track inspection and maintenance purposes. One of these trains ran over Bridge 88 on 24 January 2009, three days before the accident. It recorded a dip on the bridge, which subsequent analysis showed was not present on runs in July 2008 and January 2008 (figure 13). The extent of the dip is coincident with the bridge span. The relatively rigid make-up of the elements supporting the rails on the bridge deck (concrete sleepers and granite ballast with no obvious source of *voiding*) means that this is likely to be an indication of increased deflection of the bridge superstructure. It suggests that, since the last run in June 2008, there had been a change in the structural performance of the bridge. A loss of web plate integrity would explain this. There is no record of recent track maintenance activity in the area to explain otherwise.

Figure 13: Vertical geometry of the track measured in the vicinity of Bridge 88

- 229 The first was if the geometry data recorded by the train had been analysed and compared with data recorded on previous runs. The RAIB did this to recreate the vertical track geometry plot in figure 13. However, this involved data analysis that cannot readily be done by those doing routine track inspection work - and there is currently no requirement for it. Bridge 88 collapsed three days after the track geometry was recorded. To have been of use, the analysis would have had to have been done and reported within this timeframe – in practice, an unreasonable expectation.

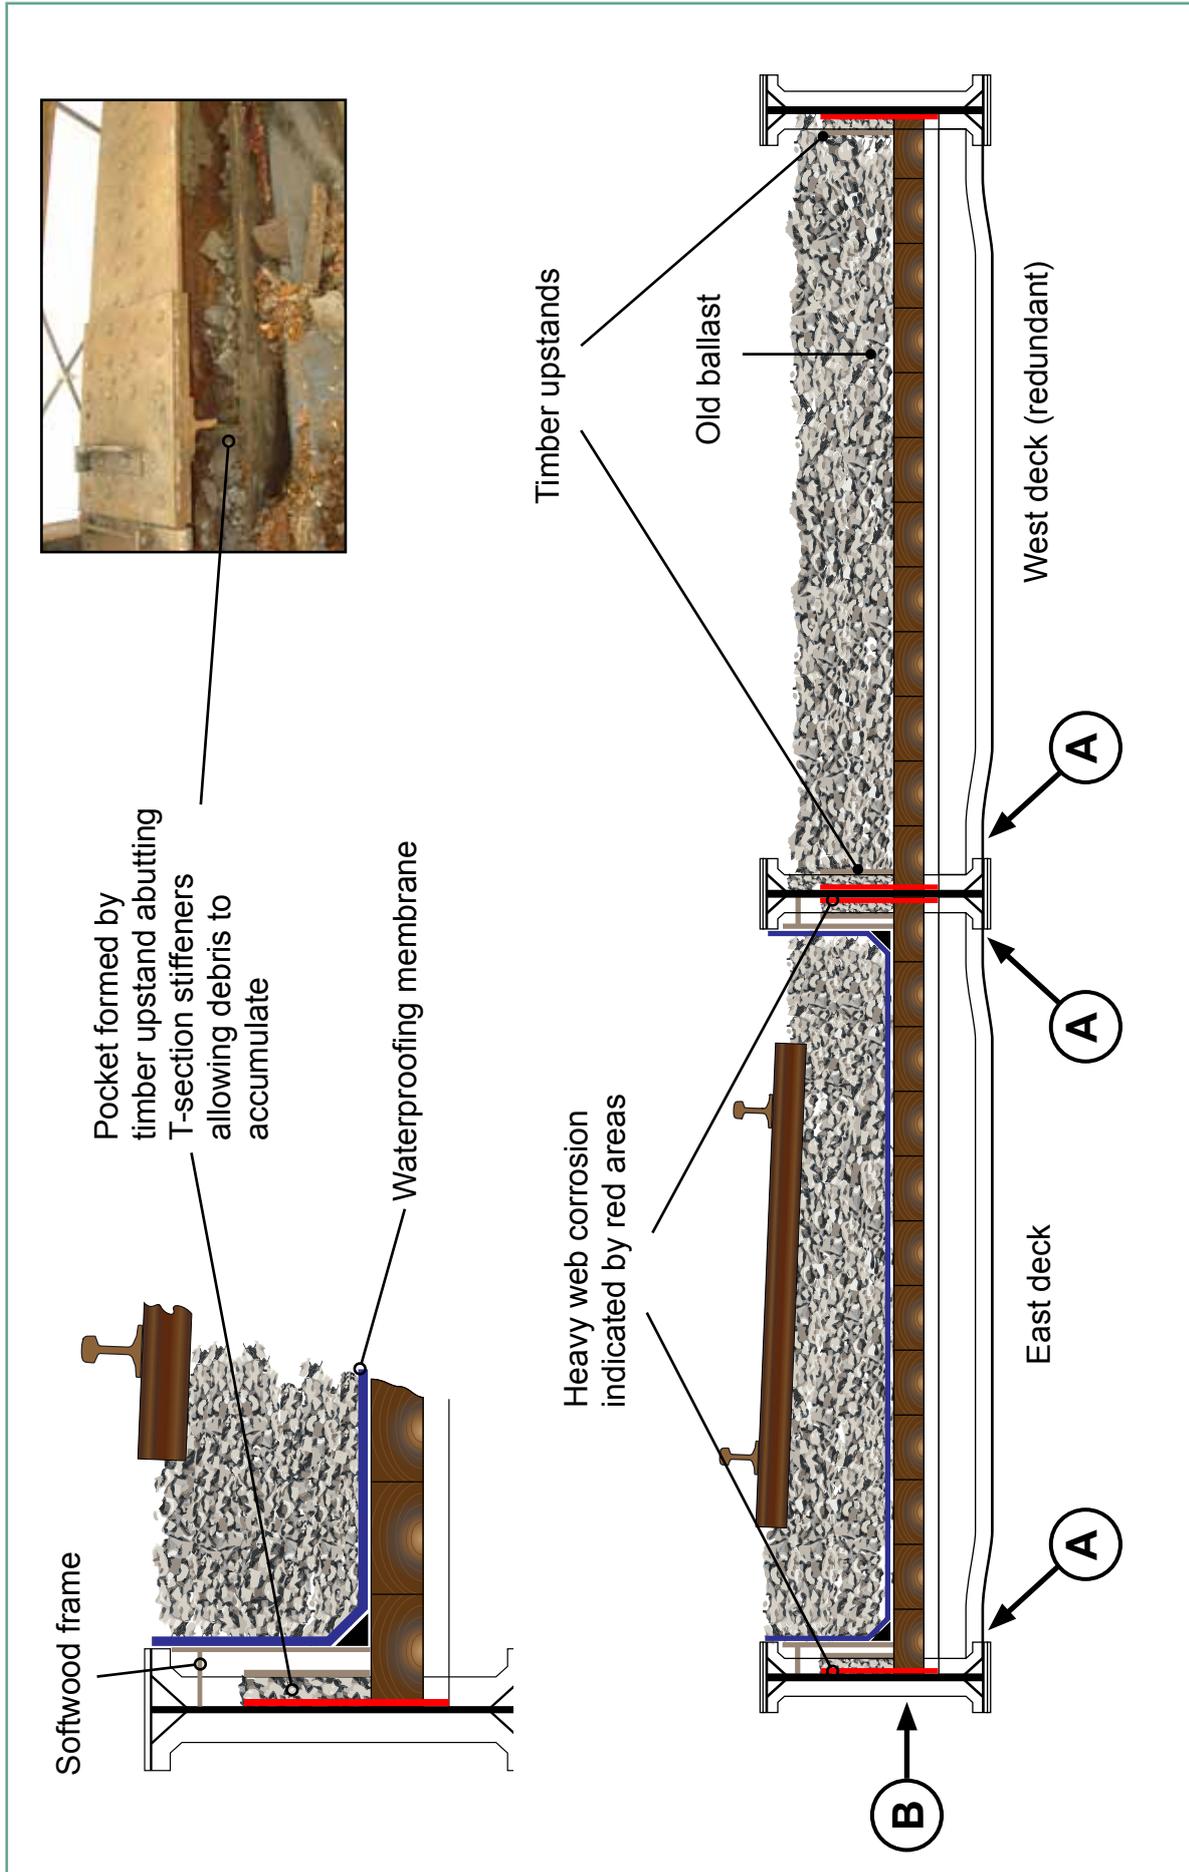
126 The timber upstands, which the LMSR fitted to keep the ballast in place on the timber deck (paragraph 46), formed pockets with the T-section stiffeners and the timber deck adjacent to the web plates. On dismantling the bridge, the RAIB found that debris, dirt and ballast had accumulated in these pockets. From observation and analysis of the condition of adjacent timbers (there was evidence of wet rot and damp), it was evident that this debris would have been wet. The location of the resulting moist environment corresponds with the horizontal band of corrosion found on the inner surfaces of the east and centre main girder web plates (paragraphs 103 and 104). It helps explain why the corrosion in this area was so severe. These features are shown in figure 16.

Figure 16: Cross-section of Bridge 88 showing areas of debris accumulation and heavy web corrosion

- the small area on the underside of the bridge, where, in places, the corrosion extended just below the timber deck (A on figure 16) – both main girders; and

- on the east elevation of the bridge, where, in some areas, corrosion was so severe that it had perforated the web plate (B on figure 16) – east main girder only.

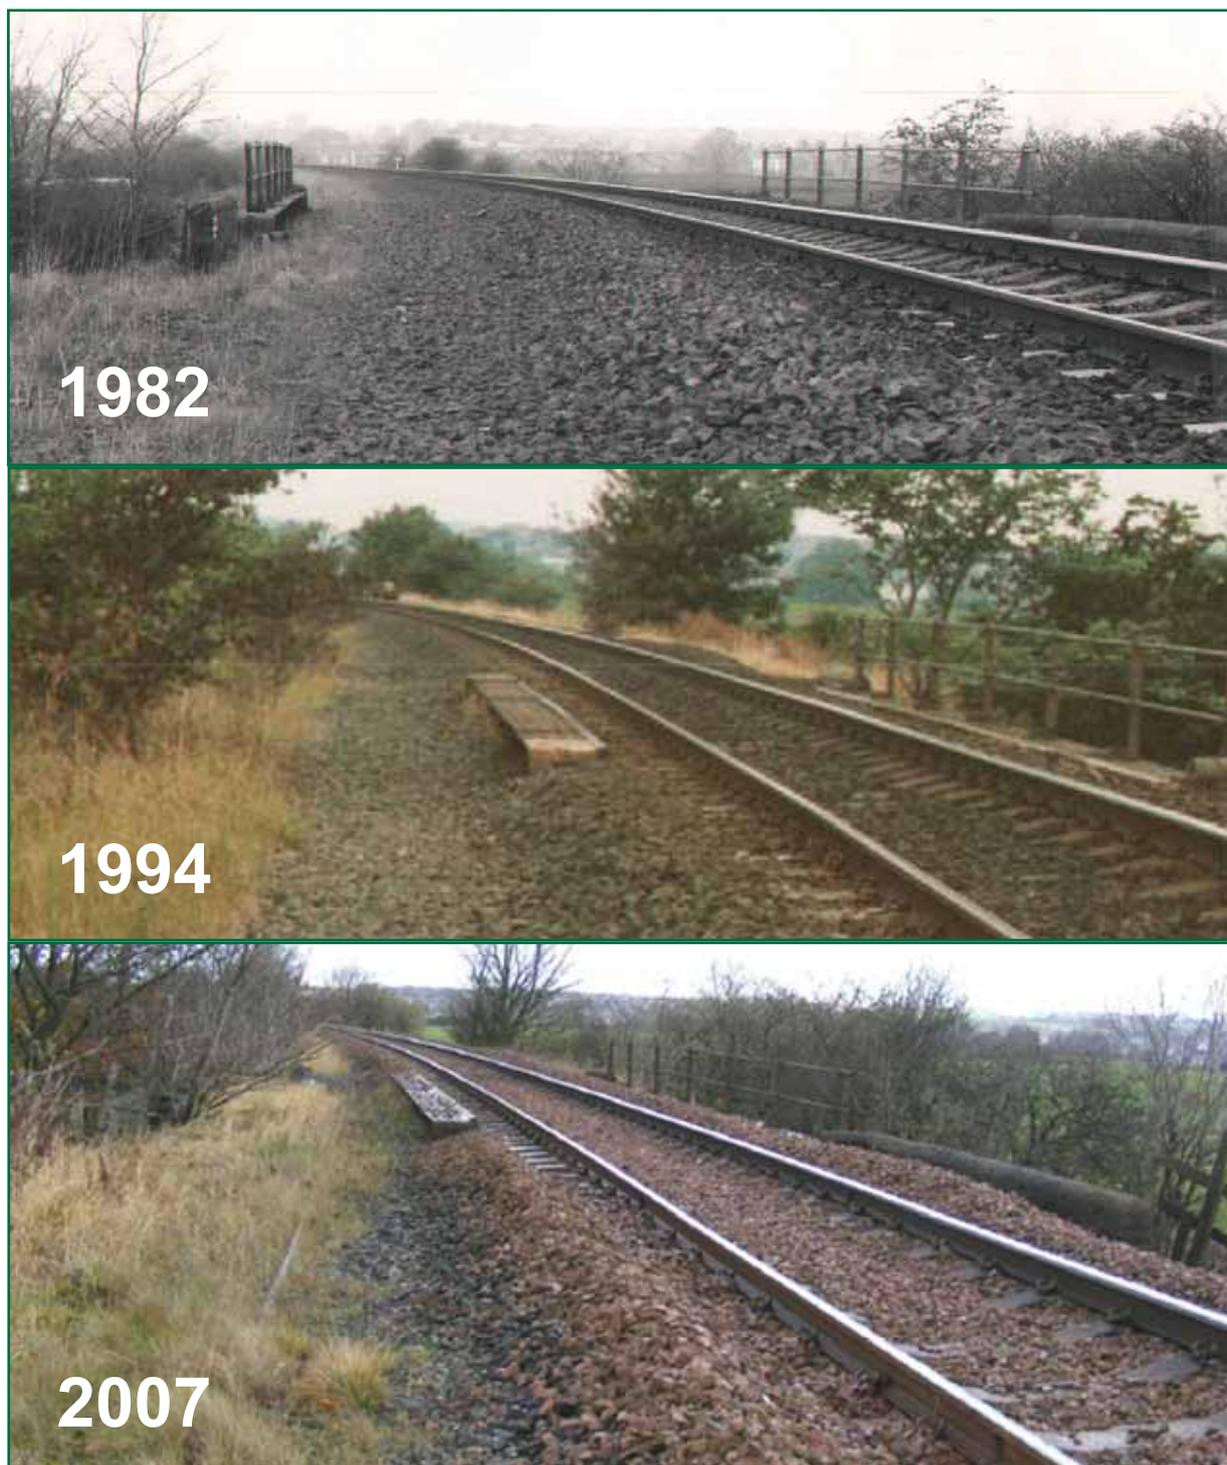
127 Photographs from the routine assessments done in 1982 and 1994, and the inspection done for the 2007 Assessment, show how high the ballast had been on the deck of Bridge 88 (figure 17). In 1982 it buried the centre main girder. The ballast on Bridge 88 would have made the corrosion band very difficult to see from above the deck; the proximity of the timber deck to the web plates would have made the corrosion difficult to see from below.

Figure 17: The level of ballast on Bridge 88 when photographed for assessments in 1982, 1994 and 2007 (photographs courtesy of Network Rail)

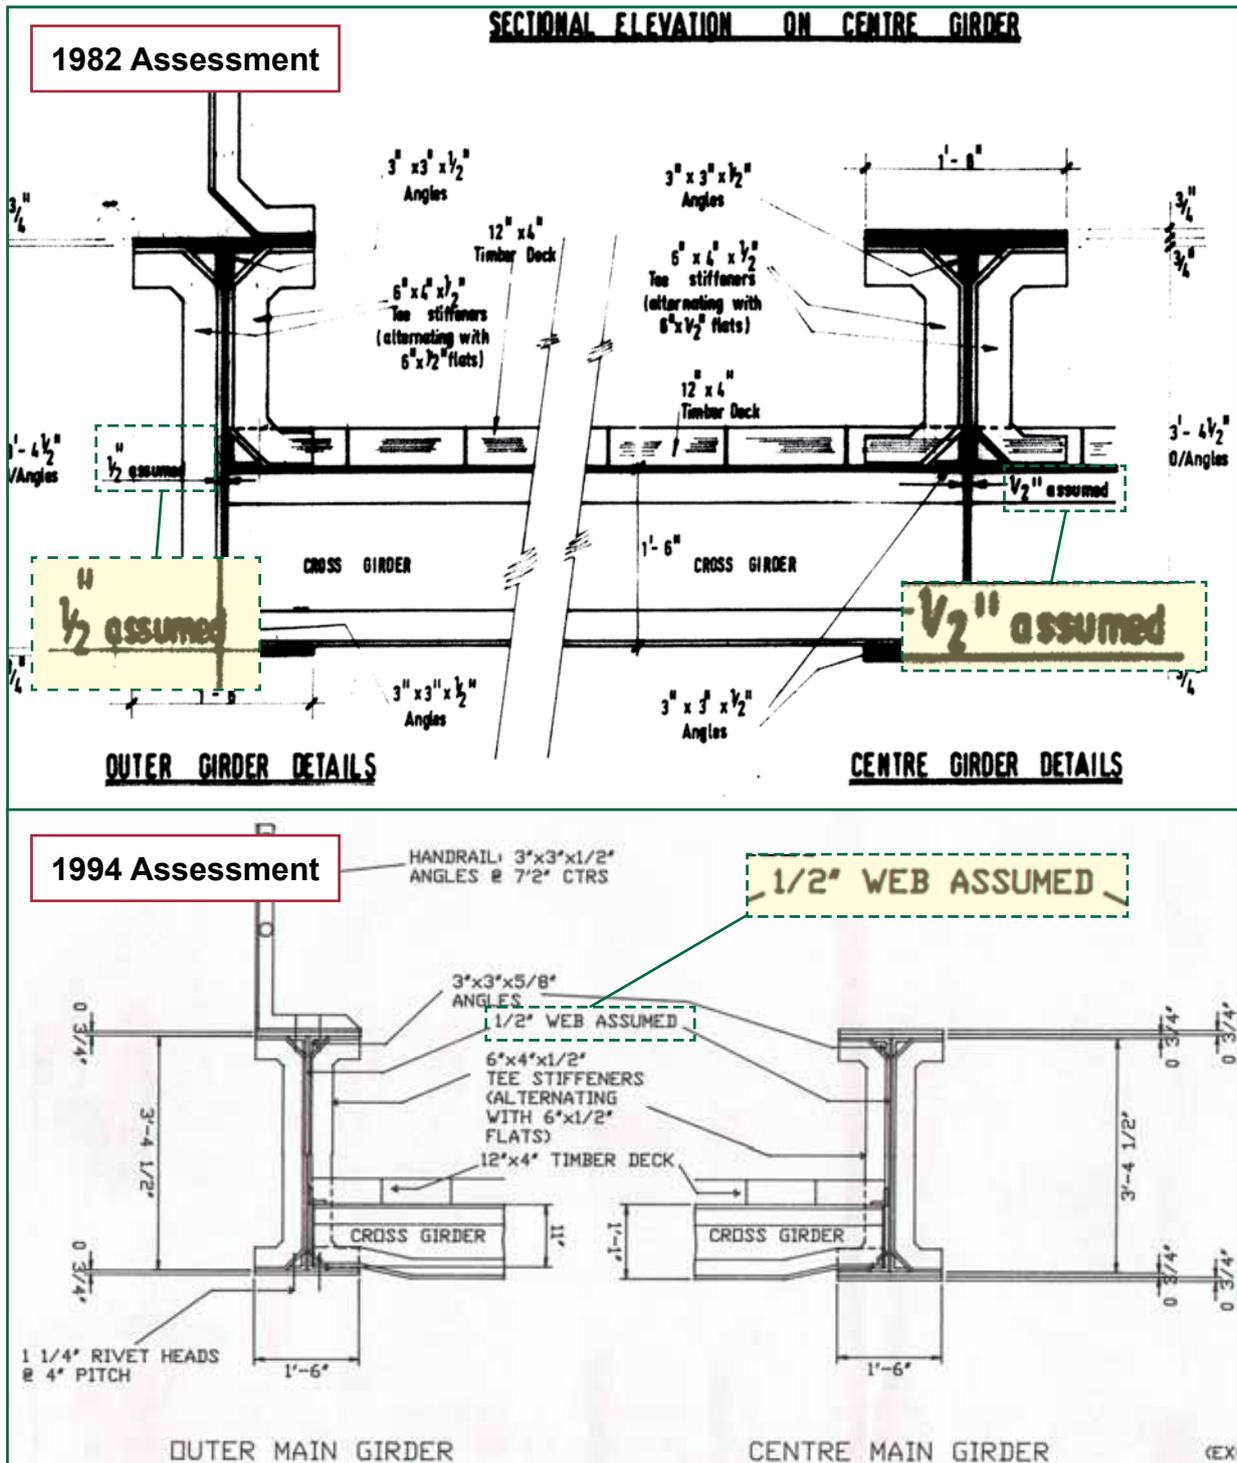
158 The consultants who undertook the assessment inspected the bridge and prepared a drawing of it. This drawing showed the sizes of the structural members that were used in the assessment calculations. The cross section showing the east and centre main girders had the note '1/2" assumed' against the web thickness dimension. Figure 20 includes an extract from the drawing showing the cross section.

Figure 20: Extracts from the drawings prepared for the 1982 and 1994 Assessments showing the cross-section of the main girders (images courtesy of Network Rail)

- 163 Railtrack inspected the bridge and prepared a new drawing of it for use in the assessment. This included a similar note regarding the web plate thickness, ‘1/2” web assumed’, showing that the same assumption had been made (figure 20). However, most of the other incorrect assumptions made in 1982 were amended. Consideration was also given to material lost through corrosion and strike damage from road vehicles, but this was only insofar as it related to the flanges of the cross girders and of the east main girder. All the webs, and all of the centre main girder, were treated as un-corroded.

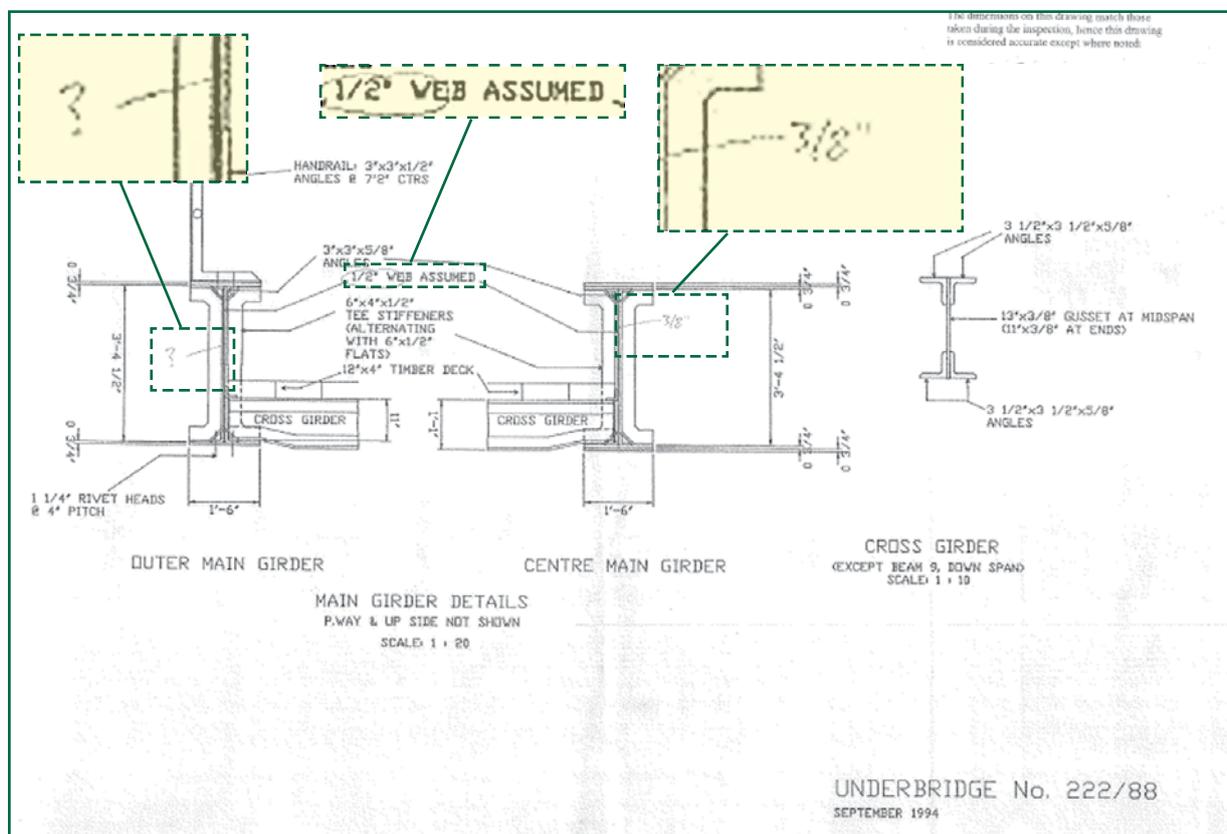
203 The marked-up drawing of the 1994 Assessment that detailed the main girder cross sections in the Inspection for Assessment report correctly recorded the centre main girder web thickness as '3/8" ' (9.5 mm)³⁰ (figure 22). This was an early indication of a significant inconsistency with the 1994 Assessment – which had assumed 1/2 inch (12.7 mm) (paragraph 163).

Figure 22: Extract from the bridge drawing used for the 2007 Assessment (image courtesy of Network Rail)

³⁰ Jacobs reported that it attempted to measure the east main girder web thickness at the Inspection for Assessment. However, the dimension was recorded as "?" on the marked-up drawing (figure 22). There is evidence that the overseas assessment engineer sought to verify this dimension with Jacobs' office in Glasgow; it confirmed that a thickness of 3/8 inch should be used. This is greater than the 1/4 inch measured by RAIB (paragraph 159).

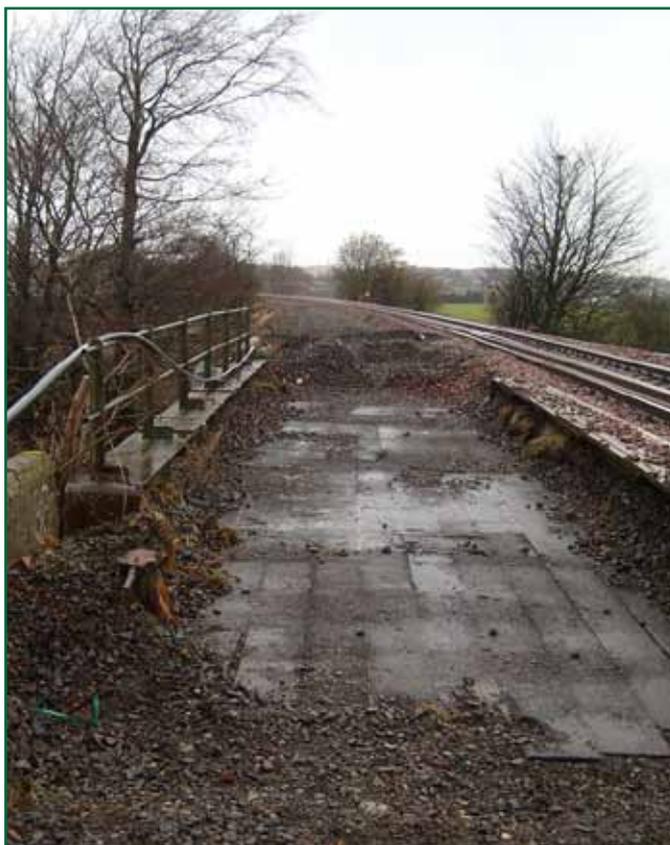
Figure F3: Site photograph of the west deck after the ballast was removed on 16-17 January 2009 (photograph courtesy of Network Rail)
