Rail Accident Investigation Branch

Rail Accident Report

**Fatal accident at Wraysholme crossing,
Flookburgh, Cumbria
3 November 2008**

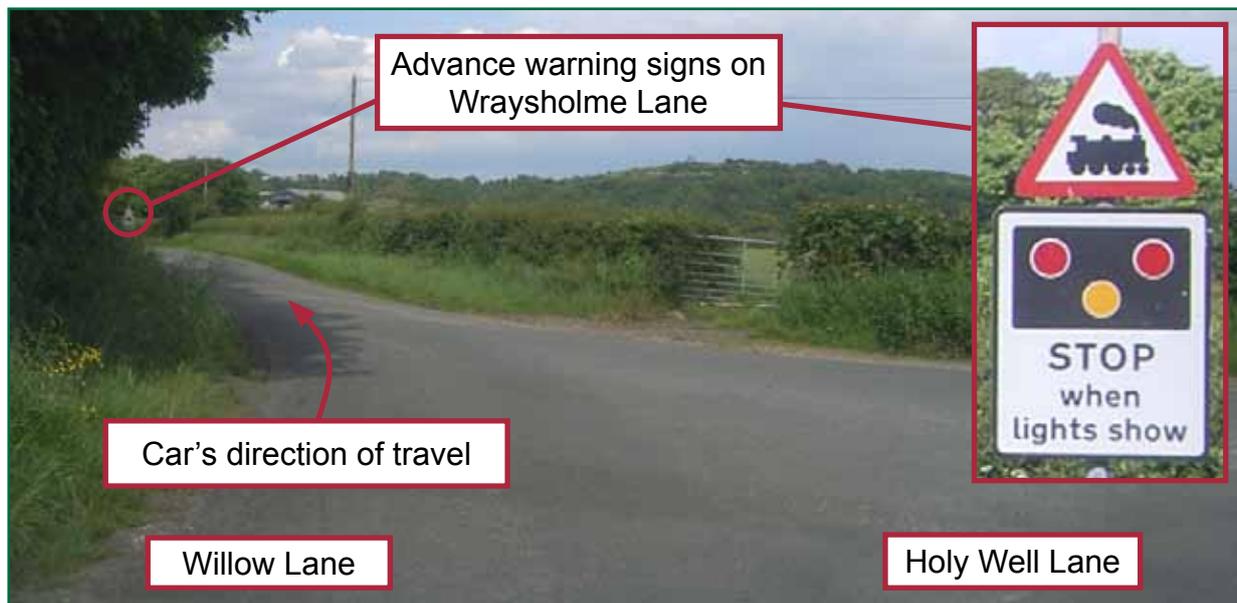
Figure 5: The advance warning sign

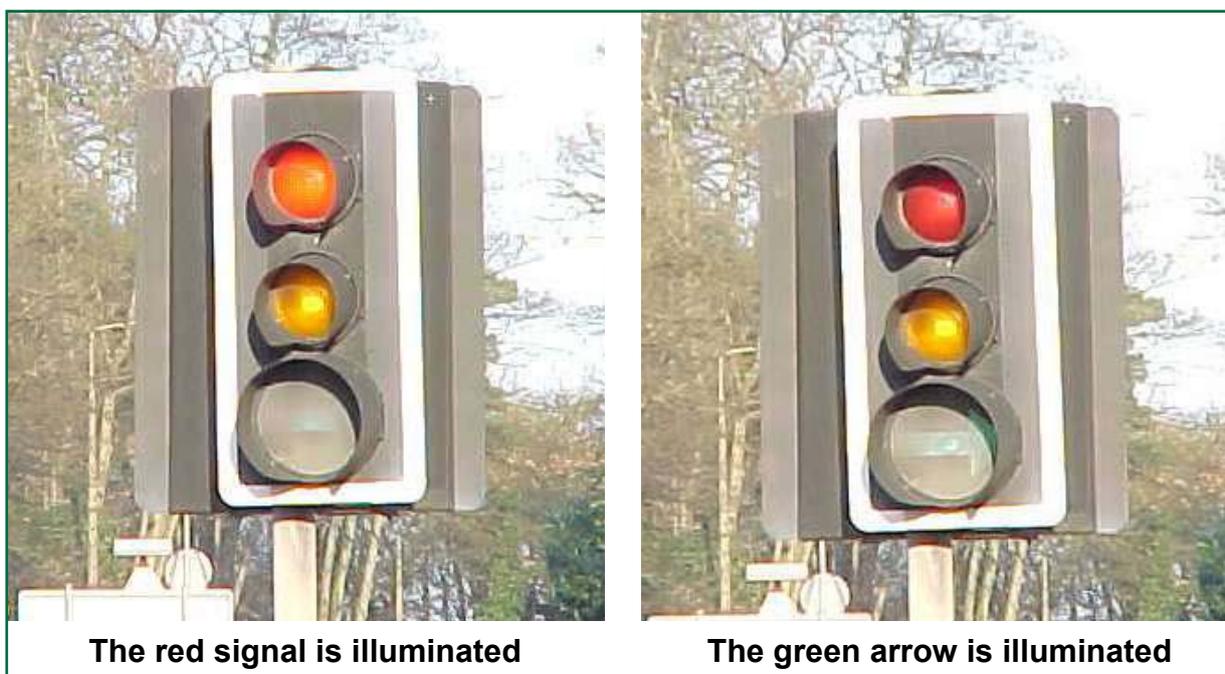
85 When the sun is bright, low in the sky and shining onto a signal, 'phantom' effects¹⁸, washout¹⁹, or reflection off the backboard may impair a person's ability to discern its aspect (Figures 9 and 10). All signals are fitted with hoods to reduce the sun's effects, and signals with an orientation that is susceptible to the sun's effects may be fitted with longer hoods. At the time of the accident, the Wraysholme signals were fitted with standard hoods.

Figure 10: The effect of sunlight on signals (taken from *Traffic Control System Design for All Purpose Roads*, Department for Transport publication MCH 1969 published December 2003)

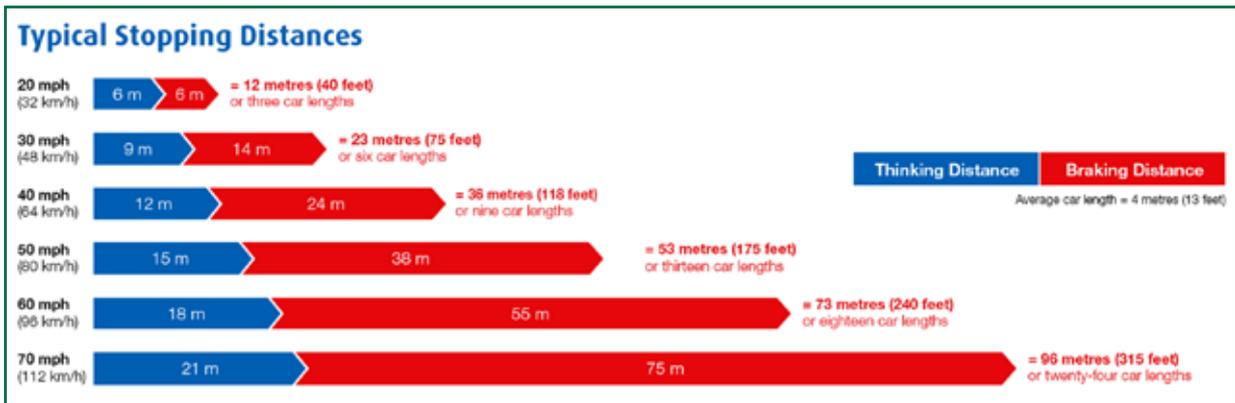
- 100 As speed increases, a road user has less time to observe, understand and react to an environment and its signals. As part of this investigation, a road traffic specialist assessed the accident site and concluded that the maximum safe speed limits over Wraysholme Lane were 15 mph (24 km/h) at its junction with Willow Lane, 37 mph (60 km/h) at a distance 50 metres from the crossing and 50 mph (80 km/h) over it. Wraysholme crossing was laid out for a road on which British Rail expected 85% of traffic to travel at 30 mph (48 km/h) or slower. For this speed, the construction and operation requirements recommend a minimum distance of 70 metres for signal visibility; the left and right-hand signals at Wraysholme are visible at 55 metres and 71 metres respectively (Figure 3). Stopping distances in the Highway Code show that a driver can stop in 53 metres from speeds up to and including 50 mph (80 km/h) (Figure 12).

Figure 12: Stopping distances extracted from the Highway Code

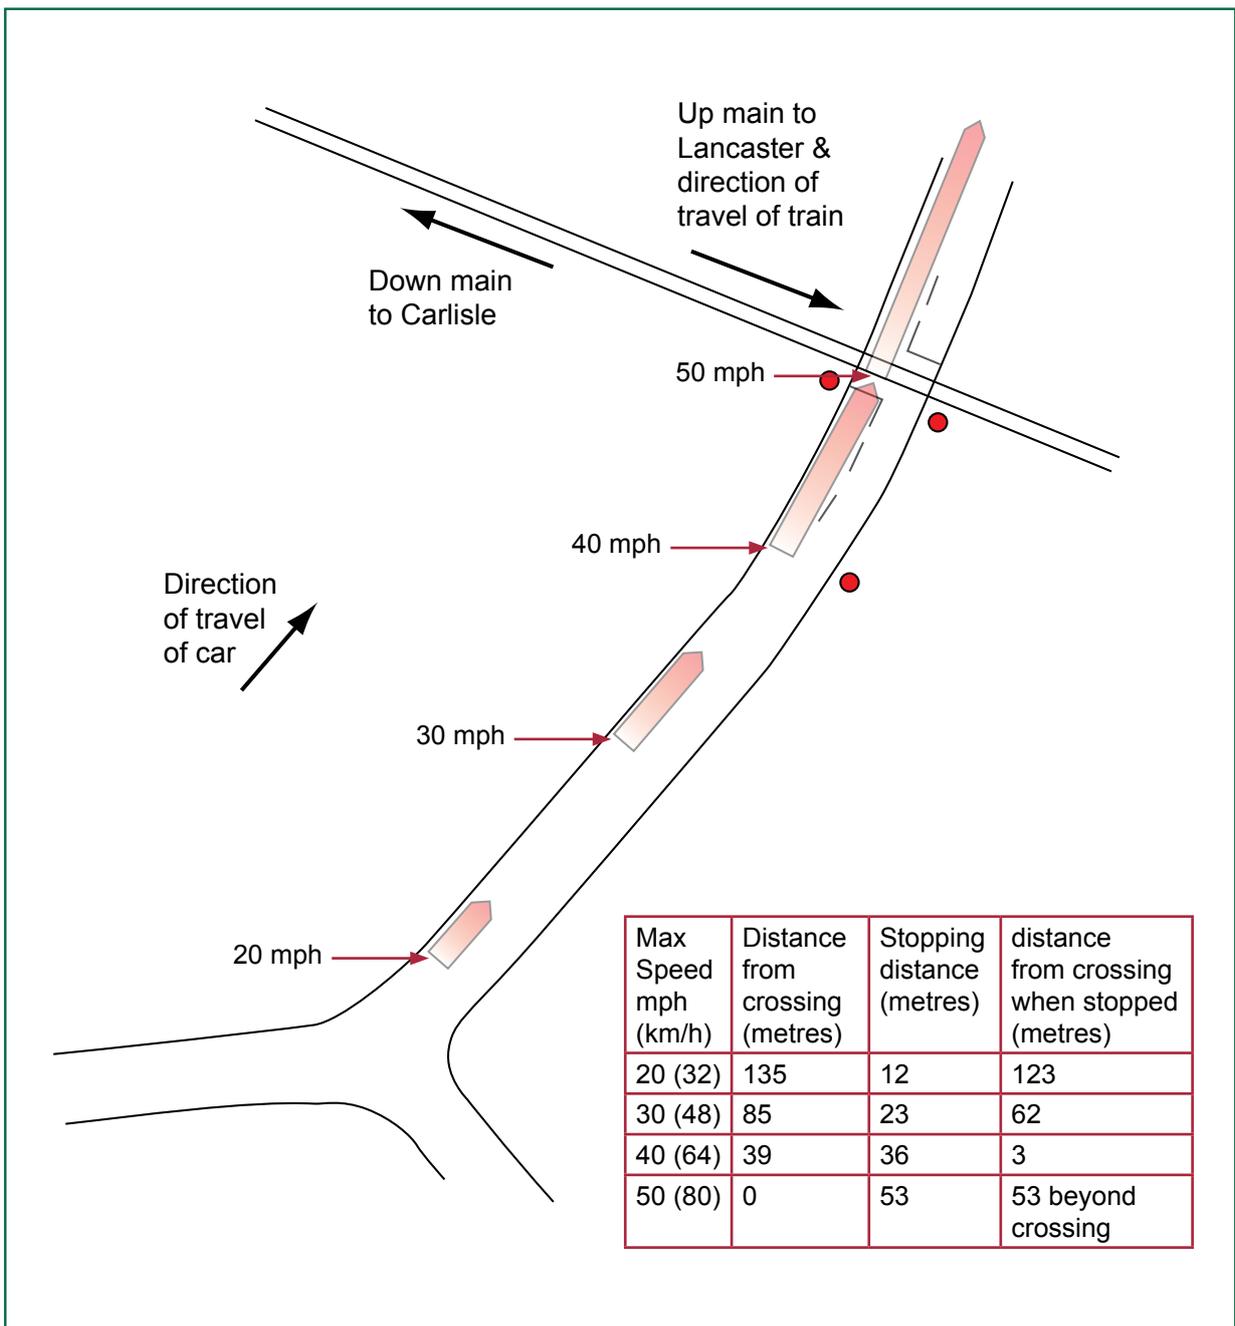
- 101 These stopping distances are achievable in good conditions; if conditions deteriorate, then drivers should adjust their driving accordingly. Figure 13 summarises the maximum safe speed limits along Wraysholme Lane and the Highway Code stopping distances. For these reasons, the crossing's layout is satisfactory if a road user can discern its signals' aspects at distance.

Figure 13: Stopping distances from maximum safe speed on the approach to Wraysholme crossing

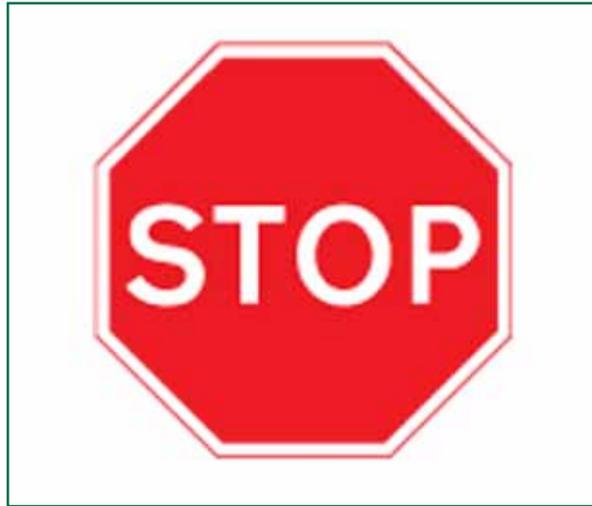
- 128 In accordance with the Traffic Signs Regulations³³, road users must stop at the solid white line and give way each time they approach a 'STOP' road marking and octagonal 'STOP' sign (Figure 14). There is no octagonal 'STOP' sign at Wraysholme crossing and the 'STOP' road marking is there in error. It contradicts the normal instruction to proceed over the crossing, stopping only when the red lights show, and confuses road users.
- 129 The RAIB and the Office of Rail Regulation assessed the use of the crossing on several occasions; each time they observed road users who slowed or stopped at the crossing and then crept over it looking out for trains when they were required to proceed. Network Rail observed and recorded the same behaviour at the crossing while conducting site visits.

Figure 14: Extract from Highway Code
