Technical Investigation Report concerning the Fire on Eurotunnel Freight Shuttle 7412 on 11 september 2008

November 2010

Affaire n° BEATT-2008-015

**Technical Investigation Report
concerning the Fire on
Eurotunnel Freight Shuttle 7412
on 11 September 2008**

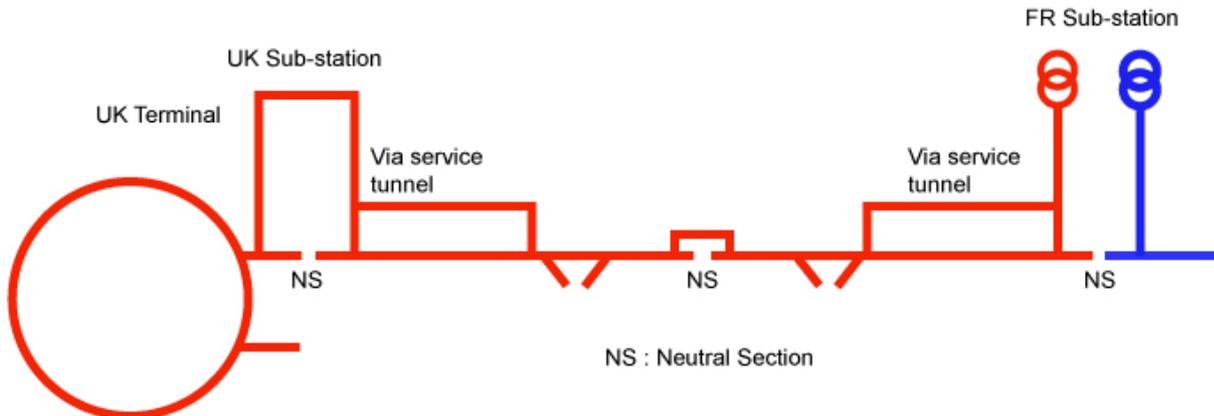
Figure 29: North Tunnel electric supply before the fire

On 11 September there was no breach of the catenary in Running Tunnel North, but there was a failure of the traction current 30 seconds after the train stopped.

The supply arrangement for the North Tunnel before the disconnection is as follows:

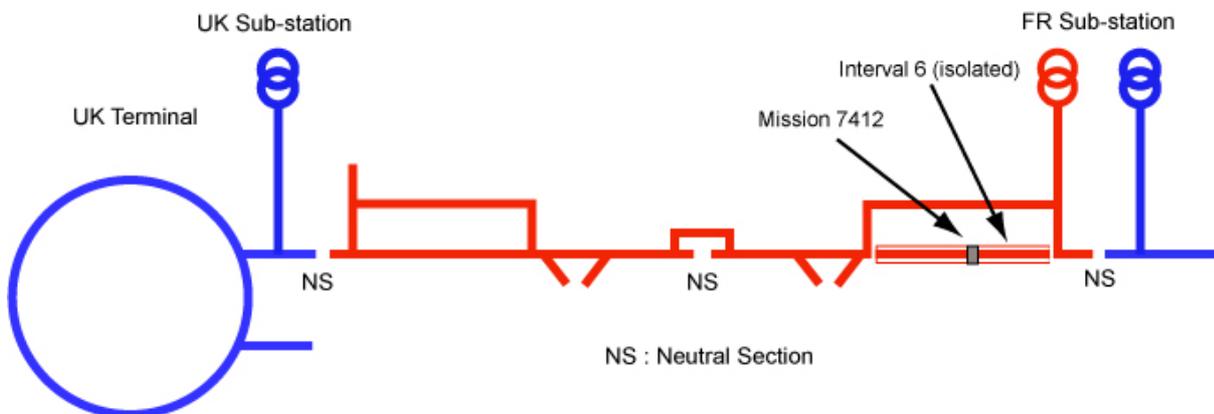
Figure 30: North Tunnel electric supply during evacuation of the two missions inside the tunnel

After the disconnection, no electricity is supplied to the whole of the North Tunnel. But there are trains inside the tunnel behind mission 7412. It is therefore necessary to restore the supply to the catenary so that the trains can be sent back to the UK.

To achieve this it is necessary to:

- isolate the interval where mission 7412 is located (or at least a portion either side of the fire) and where the catenary has failed,
- re-supply the North Tunnel upstream of that interval and the UK terminal.

A little before 16:16 hrs, the catenary in the North Tunnel is reconfigured, i.e. supply is restored to the catenary on the UK side of interval 6.

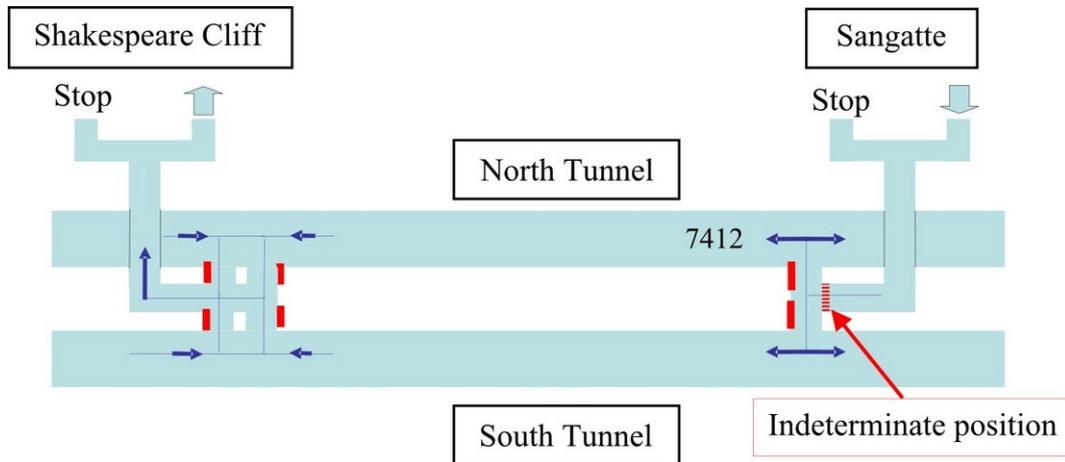
At 16:09'17'' a fan on the French side breaks down following the failure of the 21 kV cable. As the damper supplying the South Tunnel at Sangatte is still open, there is reduced air flow in the North tunnel.

The situation is then as follows:

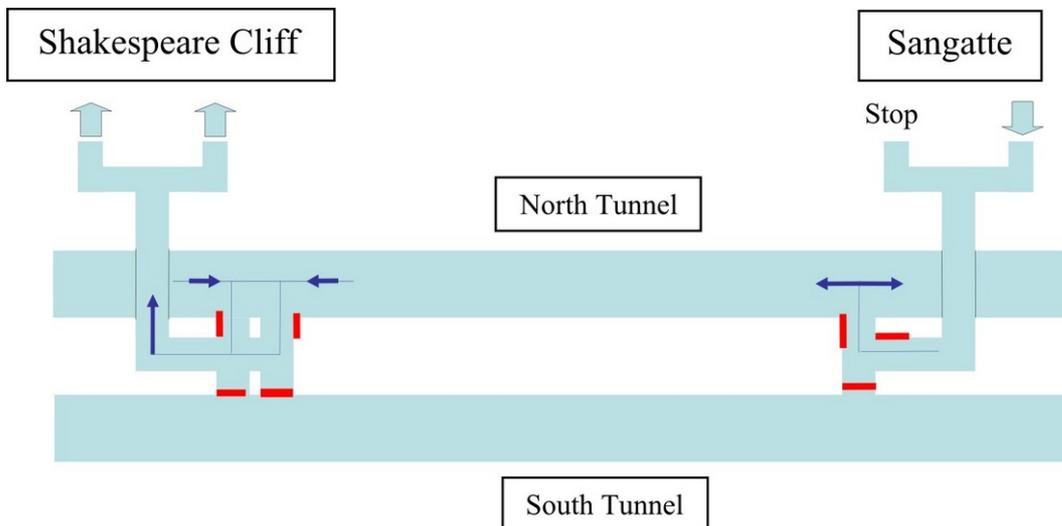
At about 16:26 hrs, the EMS controller realises that the French main damper malfunction message has disappeared. He then closes the damper for the Running Tunnel South, thus directing all of the air towards the North Tunnel. Although the SVS configuration on the French side is operating as it should, he keeps the UK SVS in Duplex mode, thus increasing the airflow in the North Tunnel. The configuration of the SVS is therefore still not compliant with Eurotunnel's rules for this scenario.

The situation is as follows:

The above configuration is maintained for almost two hours. At 18:39 hrs, the EMS controller stops one of the UK fans. The SVS is now running according to the regulations. The situation is therefore as follows:

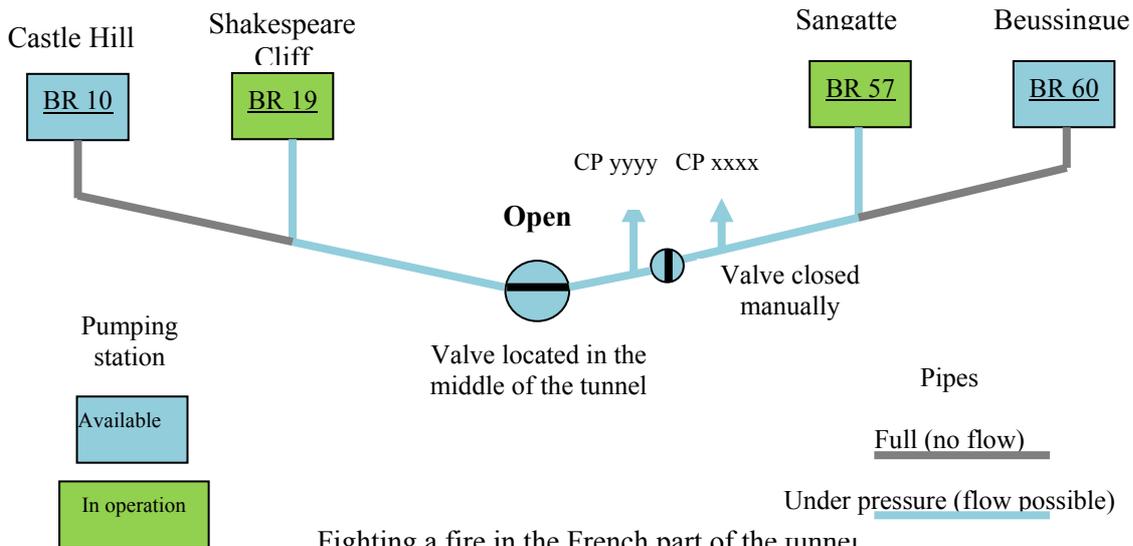
Fighting a fire in the French part of the tunnel
 Attacking through two passages with additional supply from UK pumps

At 18:39 hrs, a fire hydrant located in cross-passage 4864 begins to leak under the effect of the heat, causing a sudden loss of pressure.

At 19:01 hrs, the EMS controller closes the mid-point valve so that the fire can be attacked from both ends and opens the valve for the pipe in passage 4822 to be supplied for the UK fire-fighters. However, there is no water getting to this location. After investigating in situ¹⁸, it is found that one valve, at PK 36.21, is closed. At 19:35 hrs, the Eurotunnel technicians open it locally.

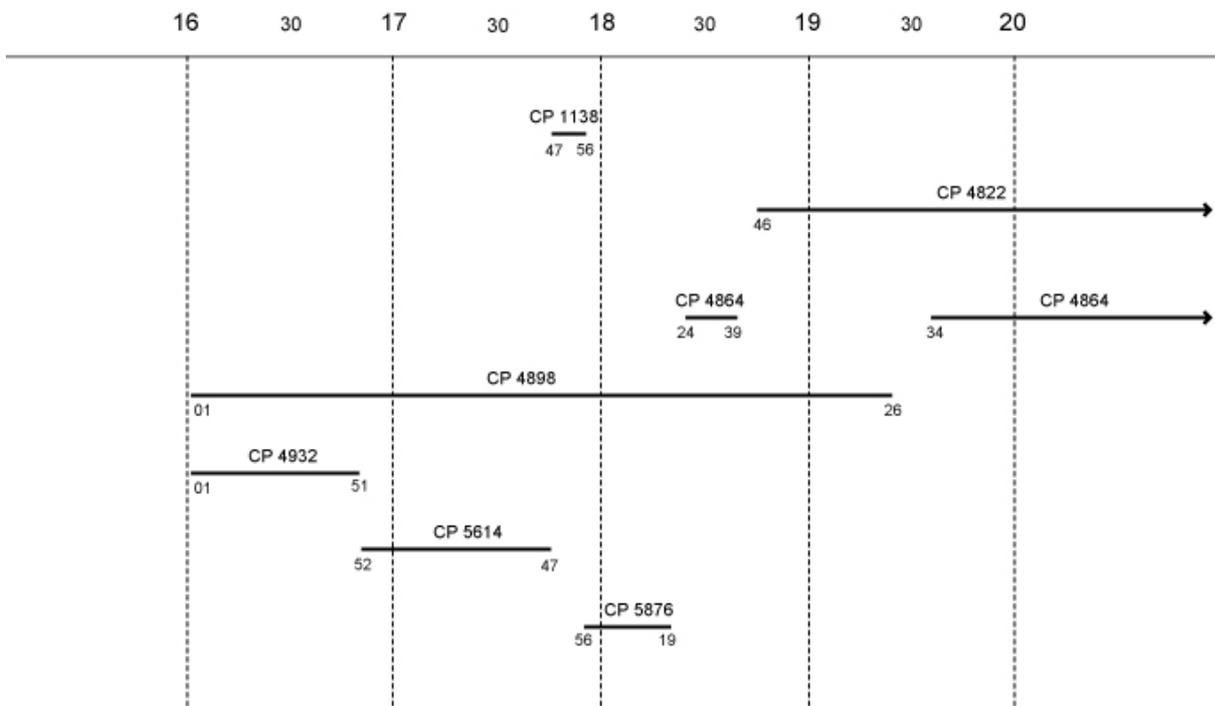
Figure 32: Opening of the cross-passage doors

The door of CP 4822 also had to be opened manually; with the exception of this control difficulty, the cross passage doors played their part.

The diagram below shows which doors were open between the start of the fire and 20:00 hrs and it can be seen that the rule of only having 2 doors open at the same time was observed.

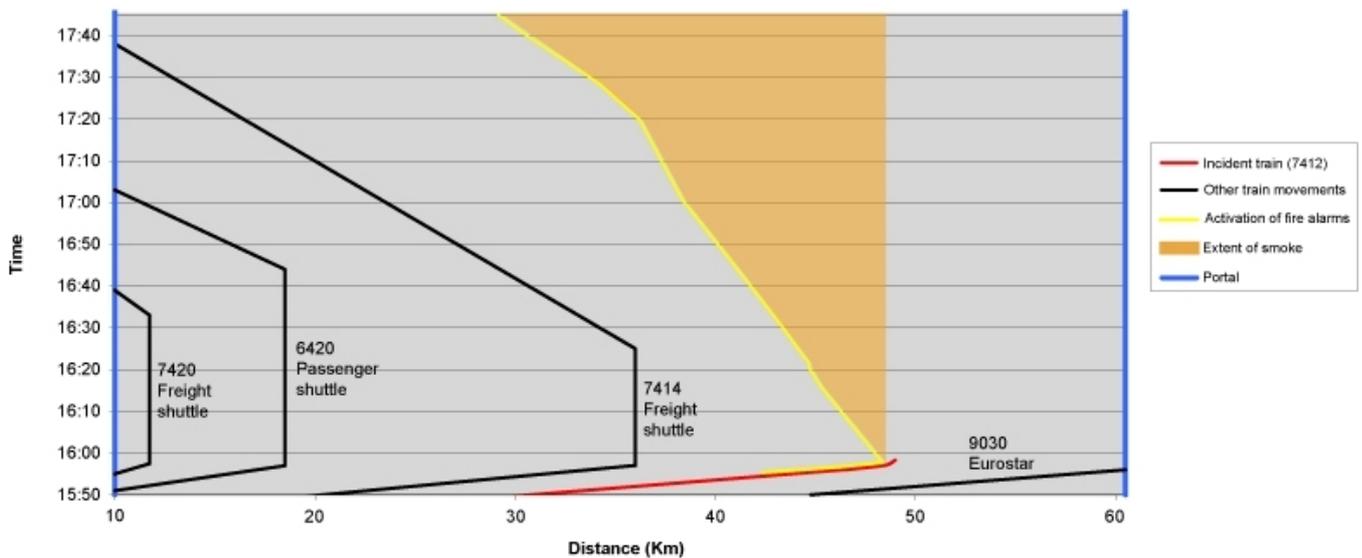
Figure 33: Spread of smoke in the Running Tunnel North

Between 15:51 hrs and 16:03 hrs, when the supplementary ventilation system (SVS) was started, the smoke is moving in the direction in which mission 7412 is travelling, and accompanying it. The amenity coach and the locomotive are therefore in a smoke-filled atmosphere when mission 7412 stops.

After 16:03 hrs, the smoke is pushed back towards the UK portal. It moves at a speed in the order of 2.7 metres per second. It reaches the point at which mission 7414 stopped approximately forty-five minutes after that mission started to return towards the UK. The differences are even greater with the two other missions in the same tunnel that have had to return.

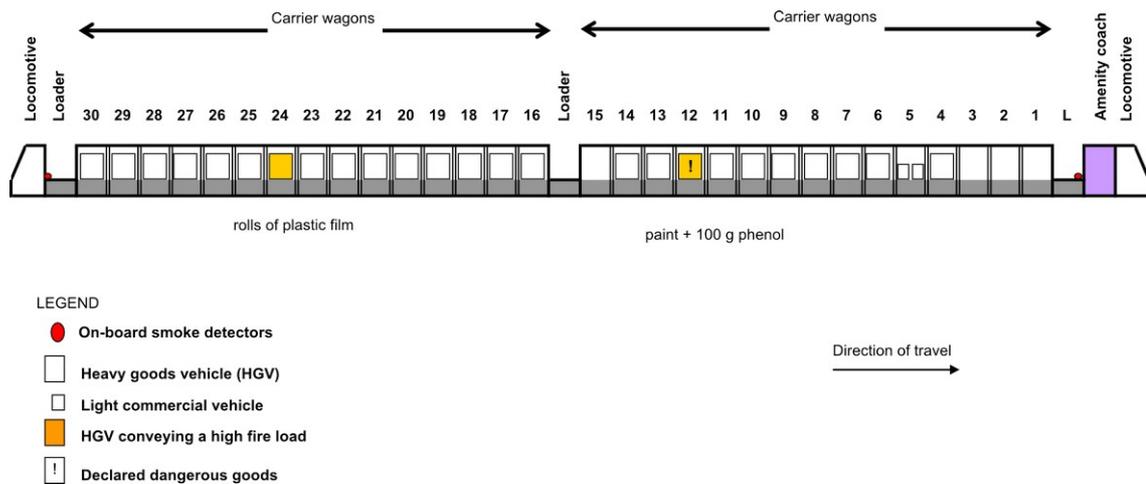
Figure 37: Composition and loading of mission 7412

Mission 7412 starts loading at about 15:20 hrs. A total of 27 freight vehicles are loaded (see Figure 37). One of the vehicles, carrying dangerous goods that had to be declared on arrival at the terminal (see Section 4.2.1), is now on wagon no. 12 instead of wagon no. 13. The loading information is not amended in the ISIS database.

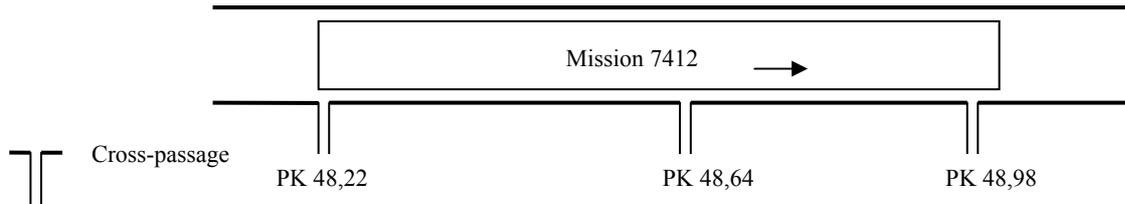
Figure 38: Position of the shuttle

At about 15:58'30'', the driver stops the shuttle in the position stipulated, with the driver's cab window beside the controlled stop marker. At this stopping point, he can see the marker indicating PK 49 but has not spotted the number of the cross-passage.

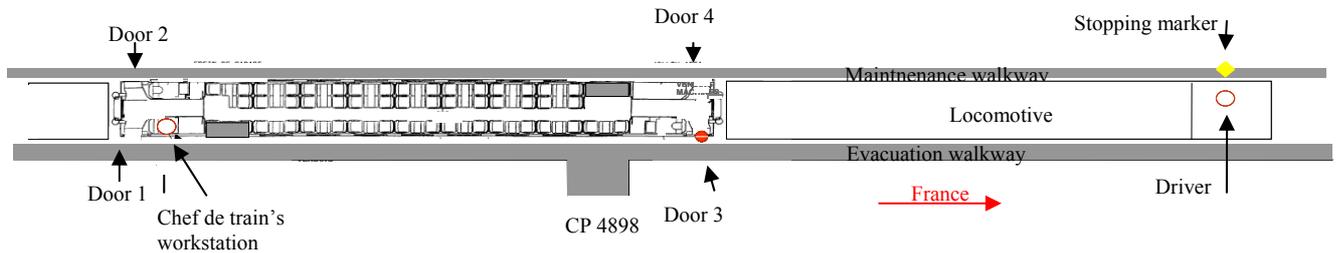
figure 39: Position of the amenity coach after shuttle 7412 has stopped

Although the chef de train has called to the passengers to follow him and leave the amenity coach through the rear right-hand door, they instead break the glass of the first window using a hammer provided for that purpose. The holes made by the hammer are not big enough for a person to pass through. One of the passengers kicks most of the remaining glass out of the window. It is approximately 16:03'30'', twenty-five passengers and the catering agent evacuate the amenity coach through this window in approximately two-and-a-half minutes. Some of them cut themselves on bits of glass still in the window frame and others suffer bruises when they fall onto the walkway.

The chef de train leaves the amenity coach through the rear right-hand door and heads for the cross-passage by walking along the evacuation walkway. None of the passengers follow him. After having covered 20 metres in the smoke he enters the area of fresh air around cross-passage 4898, at about 16:06 hrs. All the passengers who left through the window are already in the cross-passage or the service tunnel.

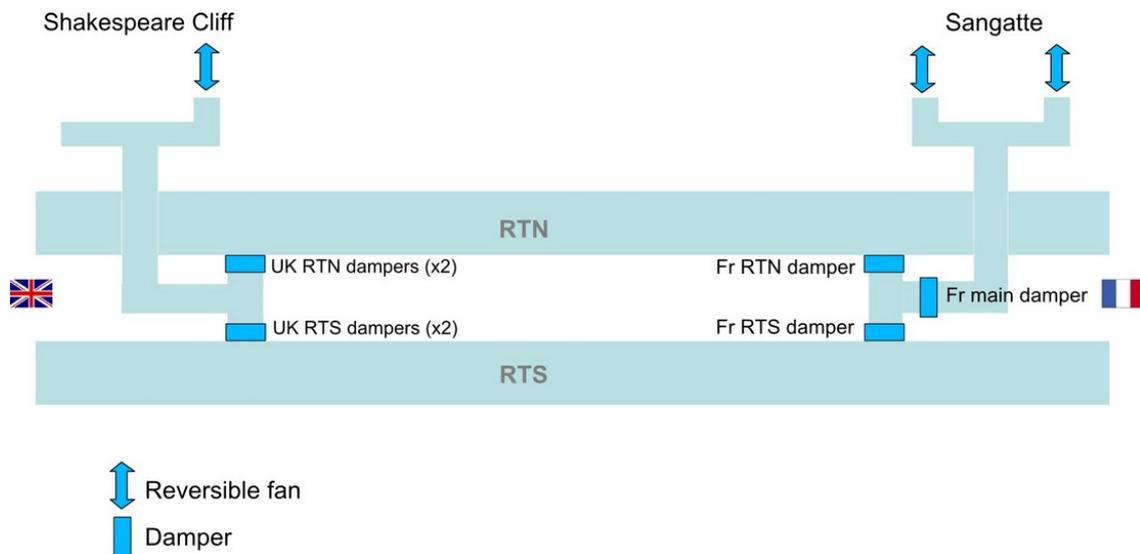
Figure 13 from paragraph 3.2.6.2)

At about 16:09 hrs, the loss of the 21 kV electricity supply causes one of the two fans in the SVS at Sangatte to stop. Furthermore, the main damper and the South damper at Sangatte are displaying malfunction messages.

As with the fault that occurred at 16:03'15'', the EMS controller has no information telling him whether the dampers have failed in the open or closed position. The controller does not have any procedure for situations of uncertainty regarding the condition of the fans or dampers.

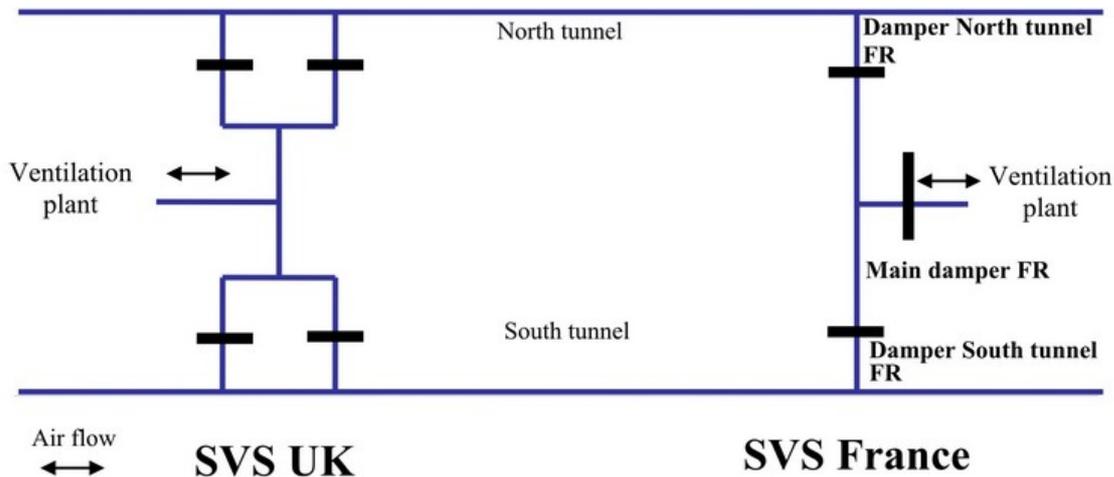
Figure 41: Ventilation dampers on the French and UK sides

The configuration of the supplementary ventilation system in the running tunnels is shown in the diagram above. This diagram shows that the malfunction of just one damper on the French side could mean that the operation of the French supplementary ventilation system
