Rail Accident Investigation Branch

Rail Accident Report

Near miss at Poplar Farm level crossing, Attleborough, Norfolk 1 July 2008

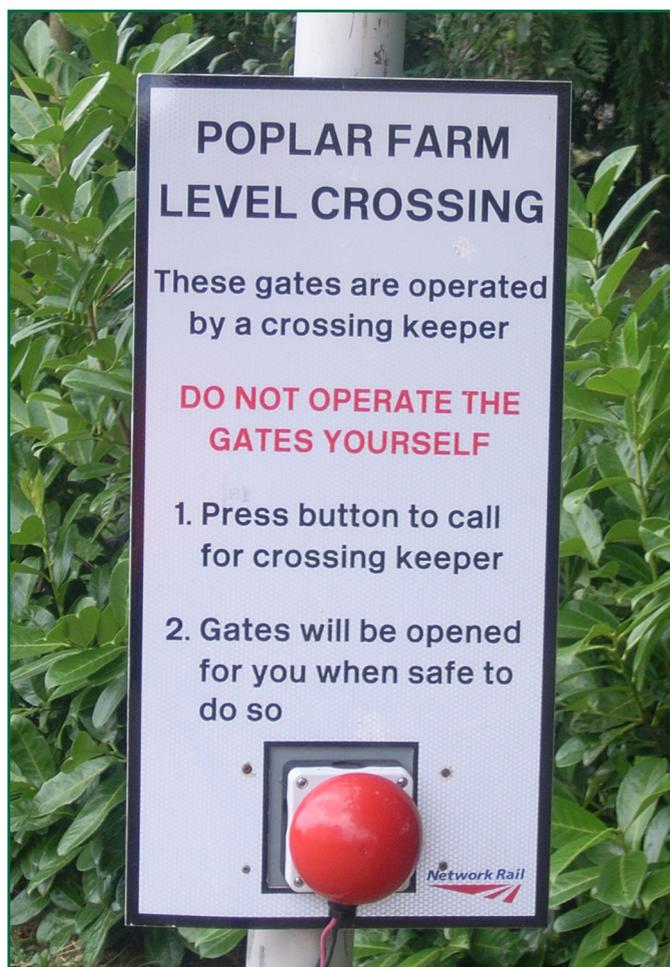
Figure 4: User instructions, Poplar Farm level crossing

- 11 A crossing keeper employed by Network Rail is provided at the crossing to open the vehicular occupation crossing gates when requested to do so, providing there is no train approaching the crossing. A person requiring vehicular access over the crossing is required to depress a button located on the approach to the crossing (see Figure 4). This rings a bell in the crossing keeper's cabin located on the down side of the railway on the Attleborough side of the crossing (Figure 3).
