Rail Accident Investigation Branch

Rail Accident Report

Collision between a passenger train and two rail-mounted grinding machines at Acton West 24 June 2008

24 June 2008

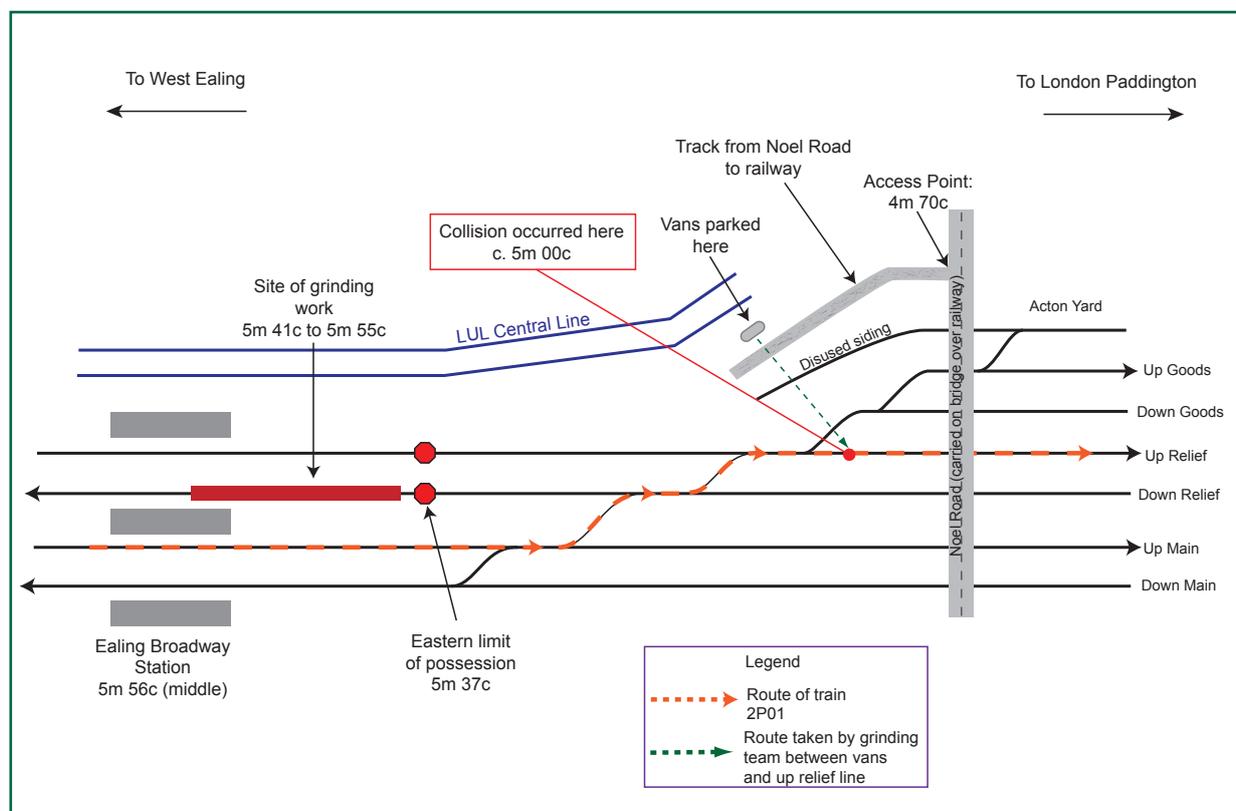
Figure 2: Track diagram of the area in which the accident occurred

- 13 This accident occurred near Acton West Junction, which is situated on the Great Western Main Line from Paddington to Bristol. Paddington station is five miles to the east and Ealing Broadway station less than a mile to the west.
- 14 The layout of the lines at this location is shown in Figure 2. There are four lines used by main line passenger trains at this location, designated down main, up main, down relief and up relief. The main lines are generally used by faster trains and the relief lines are generally used by slower trains calling at Ealing Broadway station. A series of crossovers at Acton West allows trains to cross from the up main line to the up relief line and from the down relief line to the down main line.

- 20 At around 01:00 hrs on the morning of 24 June 2008, three members of a grinding team had placed two rail-mounted grinding machines on the up relief line east of the crossovers at Acton West Junction (see Figure 2), and were waiting for permission from the COSS to push the machines towards Ealing Broadway station.
