Rail Accident Report

**Fatal accident at Tackley station level crossing,
Oxfordshire
31 March 2008**

Report 09/2009
March 2009

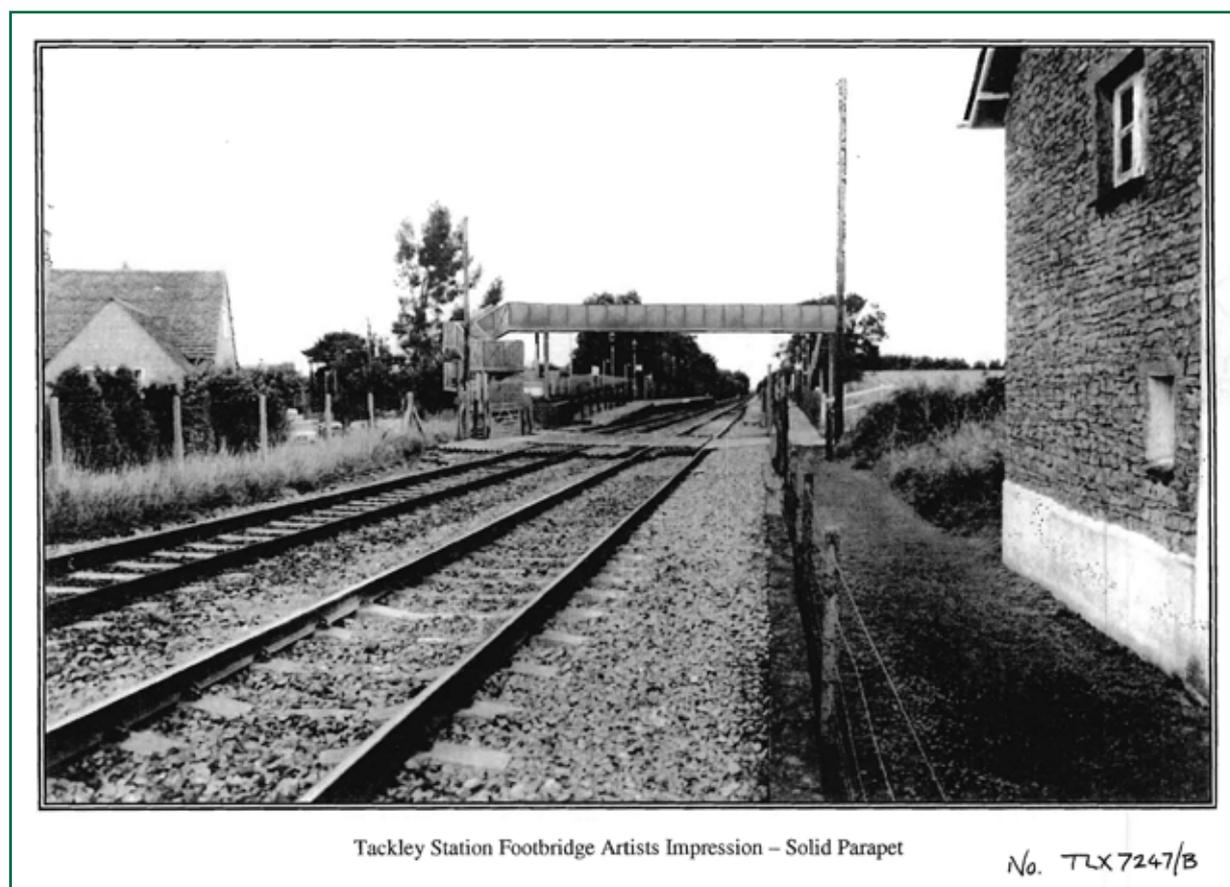
Figure 7: Artist's impression of proposed footbridge (Network Rail)

- 93 On 19 December 2000, Railtrack made a planning application for a footbridge to the local planning authority, West Oxfordshire District Council. The footbridge was to be sited immediately north of the existing level crossing, and was intended for pedestrians only, supplementing rather than replacing the crossing (Figure 7).

- 94 On 6 March 2001, this planning application was refused by the local planning authority, citing 'that the proposed footbridge will, by reason of its size, design and use of materials represent an alien, incongruous and overtly urban feature in this rural location'.

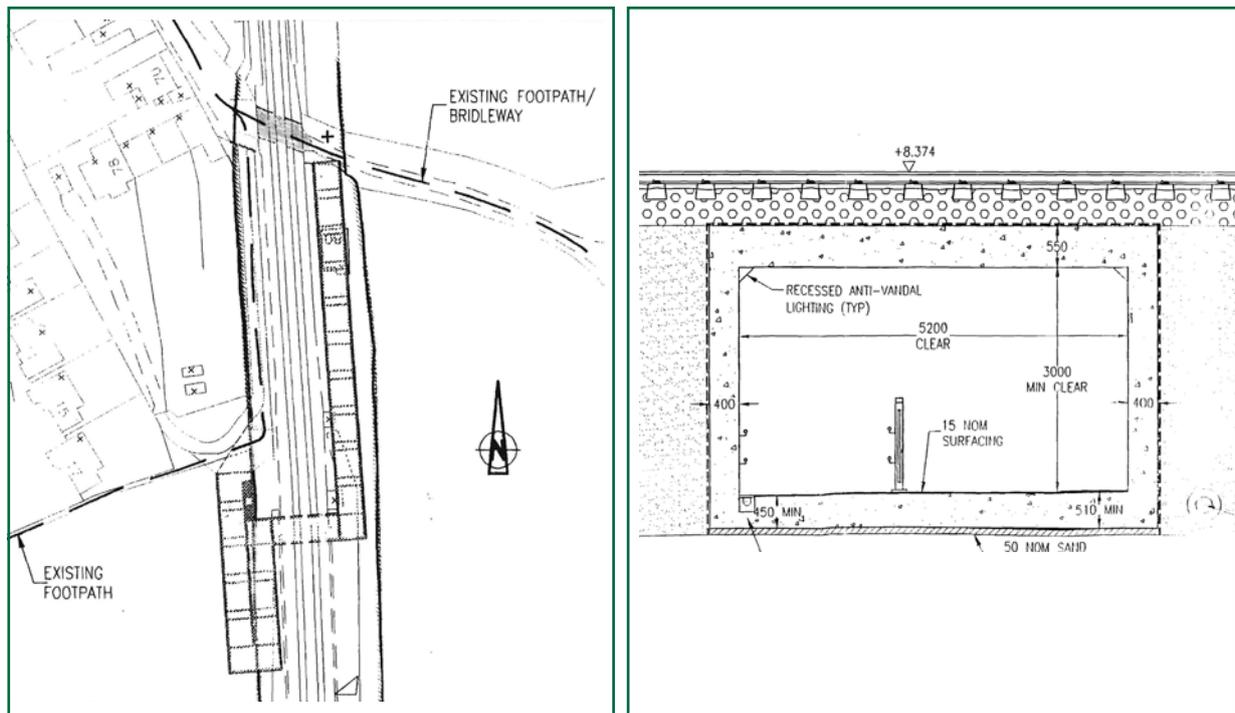
Figures 8 & 9: Proposed subway showing location and cross-section (Network Rail)

- 96 Due to the existing access road at the south-west corner of the crossing, the subway was to be sited approximately 90 metres to the south on agricultural land. Drainage concerns dictated that the structure be kept as shallow as possible; the design drawings showing a structure passing beneath the railway at the minimum depth, and with insufficient headroom for horse riders to remain mounted. To minimise the amount of land required, the approach ramps were to be situated close to the railway fence, with steps and a ramp provided on the west approach and a shared ramp on the east side. A dividing barrier was proposed between bridleway and pedestrian sections (Figures 8 and 9).

- 97 On 10 October 2002, the planning application was refused by West Oxfordshire District Council, on the basis of “the design’s failure to make safe and convenient provision for horses, their riders, pedestrians, cyclists, the elderly and disabled people; and that the subway would appear as an unduly prominent and intrusive feature in the rural scene”. This decision was supported by Oxfordshire County Council.
