Rail Accident Report

**Track worker struck by a train on Grosvenor
Bridge, London Victoria
13 November 2007**

Report 19/2009
July 2009

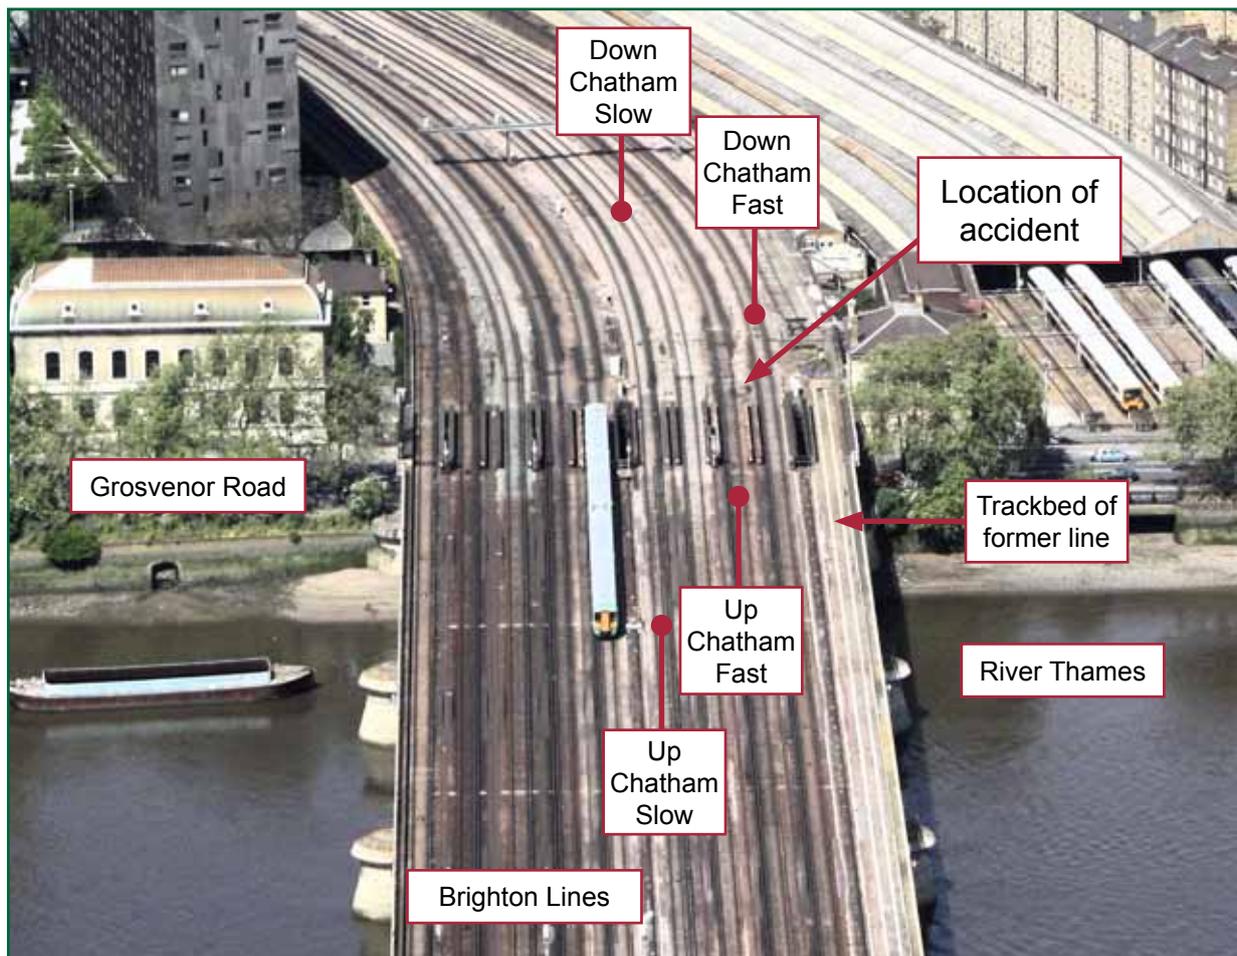
28 There are nine railway tracks on Grosvenor Road Bridge (Figure 2). From east to west the first four - referred to collectively as the Chatham lines - are known as:

Figure 2: Aerial view, looking north towards Victoria station, of the railway lines crossing Grosvenor Road Bridge, showing the normal direction of rail traffic. © Metropolitan Police

- 30 Between the Down Chatham Fast line and the eastern bridge parapet there is an area that formerly had a track laid on it, this now forms a cess wide enough to stand in, which is well clear of trains.
- 31 On the river bridge the four Chatham tracks are separated by *six-foot* areas which are *ballasted*.
- 32 On the Grosvenor Road Bridge there are raised parapets to a height of 1100 mm between the four tracks. There are two of these parapets between each track separated by a narrow gap of 450 mm. The parapets are 23.850 m in length (Figure 3).

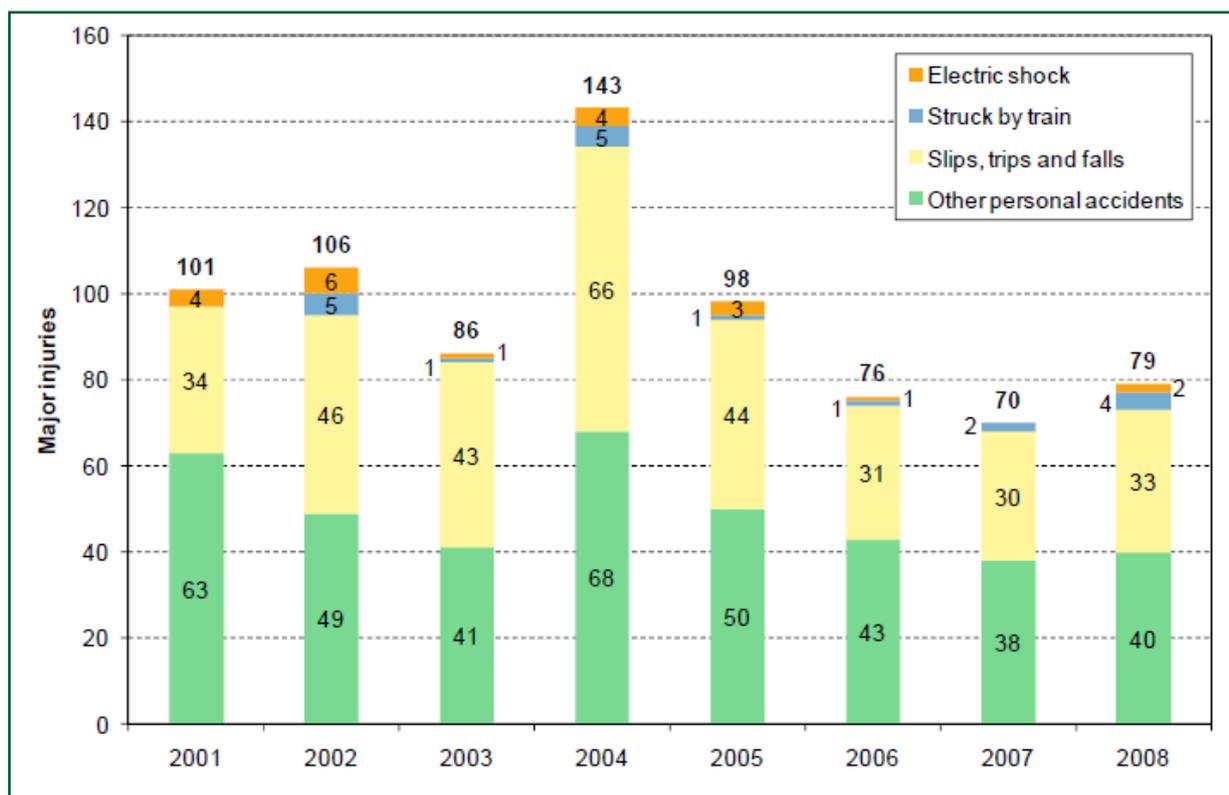
- 72 The number of major injuries caused by track workers being hit by trains has not reduced, running at one or two per year, with a particularly poor year in 2004.

Table 4: Track worker major injury rates for the last five years (extract from RSSB Annual Safety Performance Report 2008)
