Rail Accident Investigation Branch

Rail Accident Report

Runaway of two wagons from Camden Road Tunnel 19 July 2007

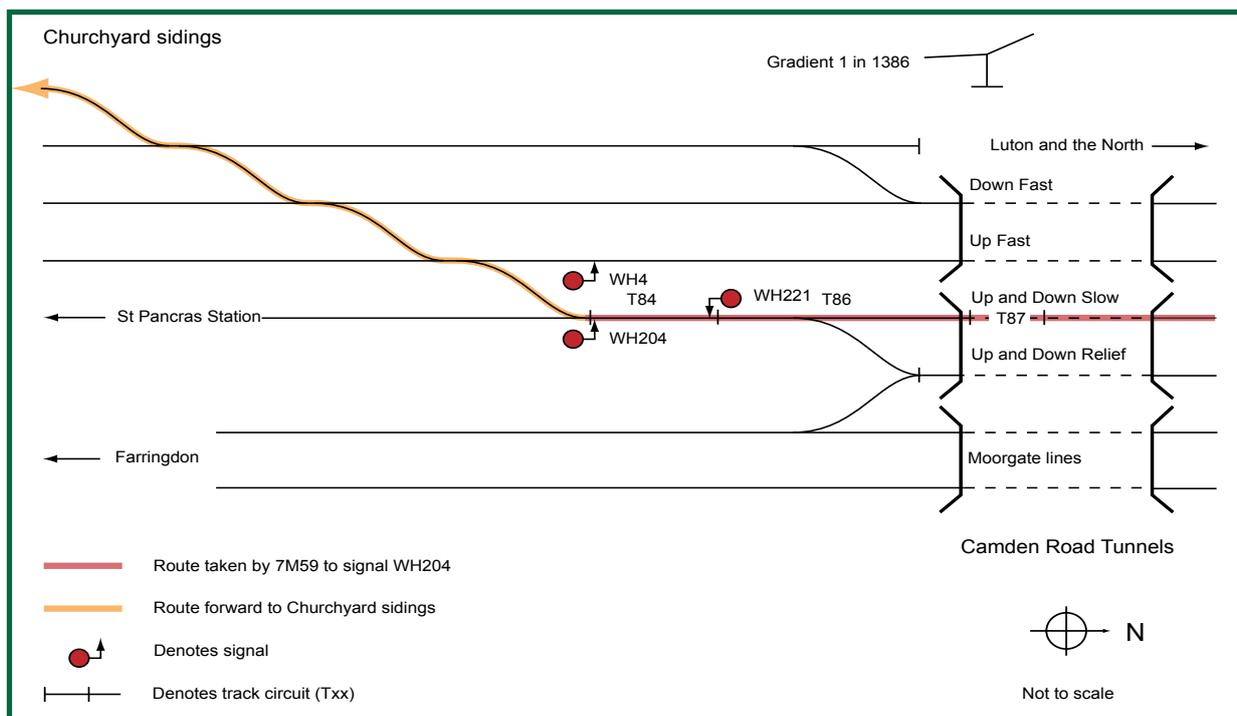
Figure 2: Key features of the incident location

- 18 At around 23:50 hrs, due to a combination of air leaking out of the brake cylinders of one wagon and incorrectly set slack adjusters on the other, the two detached wagons, loaded with stone, ran away southwards down the gradient out of Camden Road Tunnel. After travelling for 200 to 300 metres, the wagons changed direction due to a local reversal of the gradient, eventually coming to rest about 140 metres from where the runaway started. The key features of the incident location are shown in Figure 2.

- 33 At 23:41 hrs, the signaller noticed that track circuit 87 (see Figure 2), covering the southern end of Camden Road Tunnel, was still showing occupied. He contacted the driver and asked him to check his train was complete. The driver checked the train with the assistance of the shunter in Churchyard Sidings and found that the rear two wagons were missing.

- 34 Between 23:50 hrs and 00:05 hrs, the signaller saw track circuit 86 show occupied closely followed by track circuit 84 (Figure 2). This was followed by the *SPAD alarm* associated with signal WH221 sounding. These events indicated that railway vehicles were moving out of control and after having run towards St Pancras International station, stopped and reversed direction at a local change in gradient. From calculations, the RAIB believes that the speed of the runaway vehicles did not exceed walking pace.

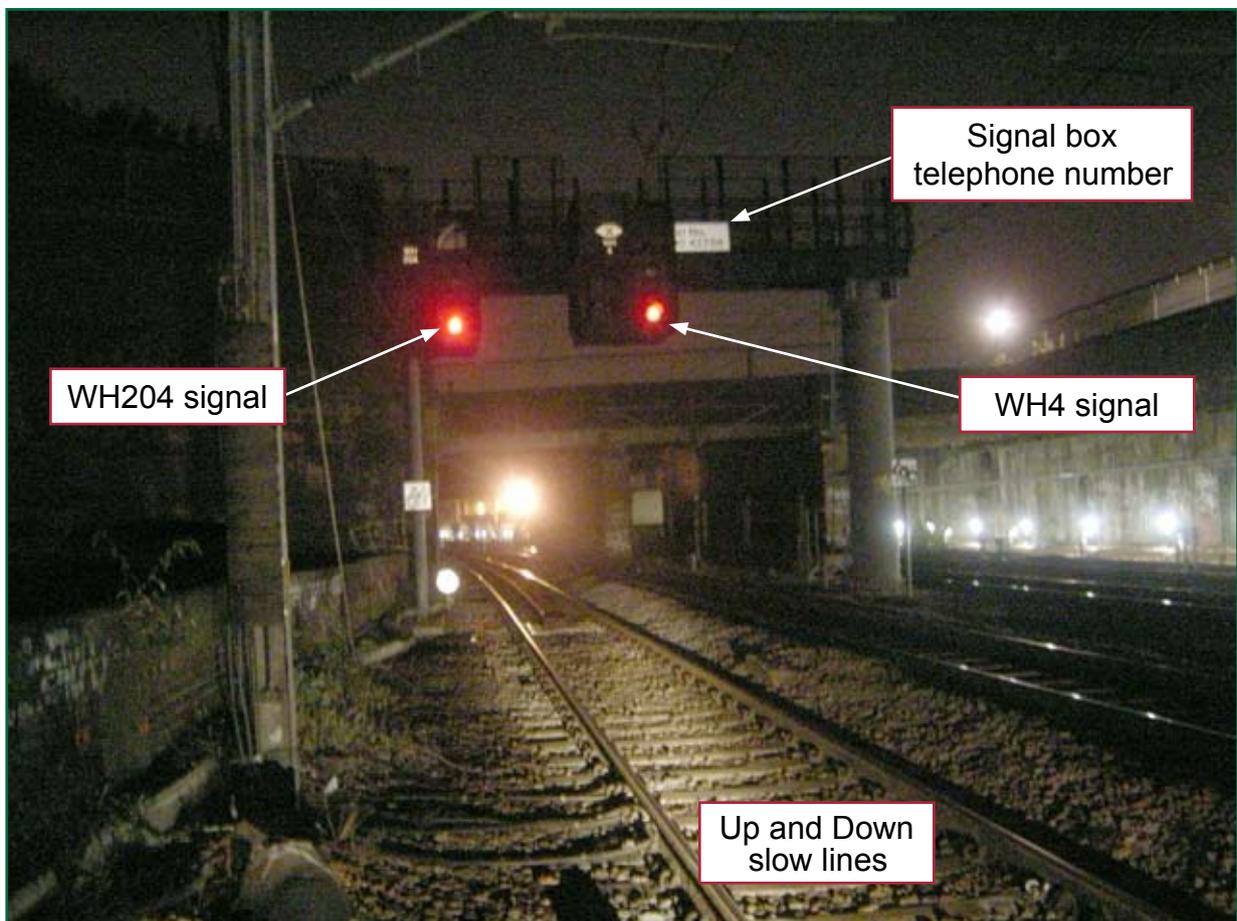
Figure 10: Signal WH204 and signal WH4

- 80 When initially stopped at signal WH204, the driver's evidence is that he contacted the signaller using the telephone number displayed on a plate attached to the side of signal WH4 (Figure 10). This number had been recorded into his mobile phone the first time he used it to contact the signaller when initially stopped at signal WH204 (paragraph 44). The plate displaying the telephone number becomes progressively more difficult to read the closer a train draws up to the signal and provides evidence that he stopped at the correct stopping point, adjacent to the SPT, some 20 metres before the signal.

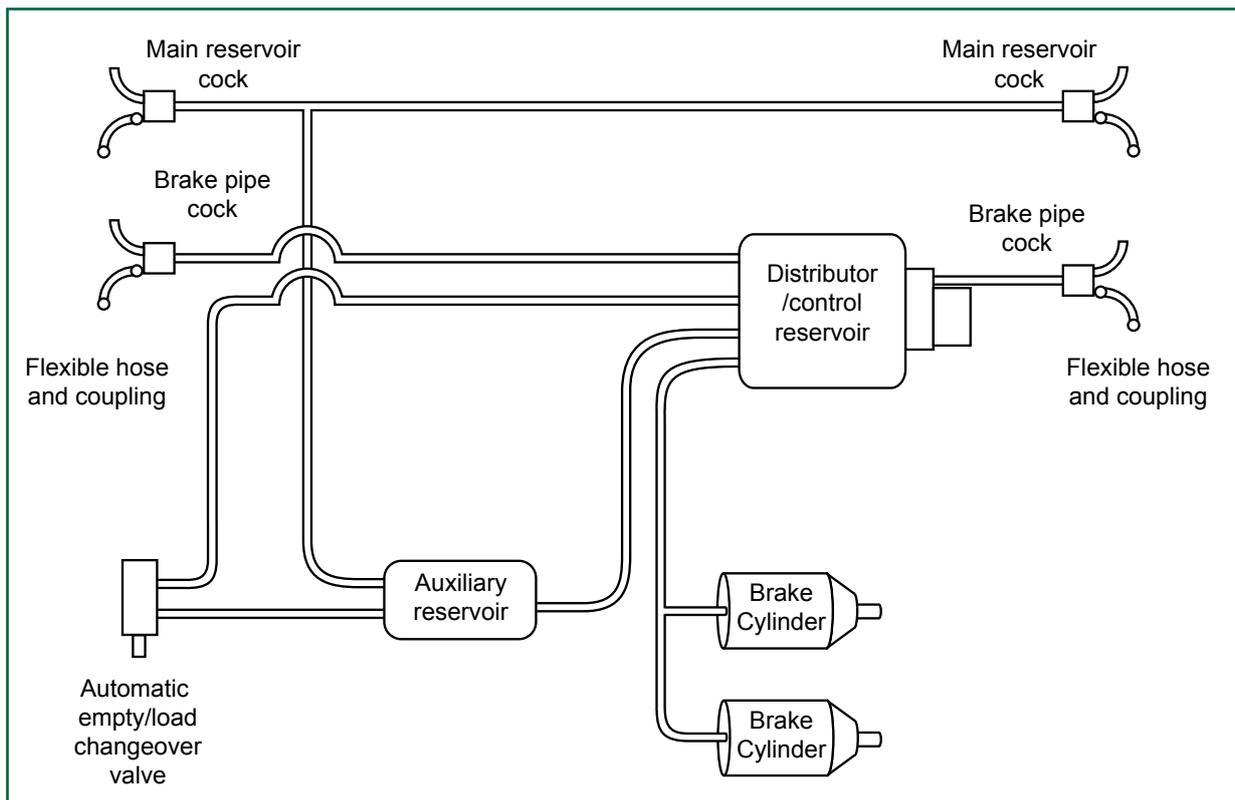
Figure 14: Schematic diagram of the brake system fitted to wagons MAR17712 and MAR17725

- 56 A schematic of the brake system is shown in Figure 14. The normal *running pressure* of 5 bar in the brake pipe is reduced when the driver operates the service brake in the driving cab. This is sensed by the *distributor* which operates to allow air pressure stored in the *auxiliary reservoir* to pass to the brake cylinders in proportion to the degree of reduction in brake pipe pressure. The runaway wagons were also fitted with automatic *empty/loaded changeover valves* which sense whether the wagon is loaded or empty. When the wagons are loaded, the brake cylinder pressure is increased in order to provide more brake force.

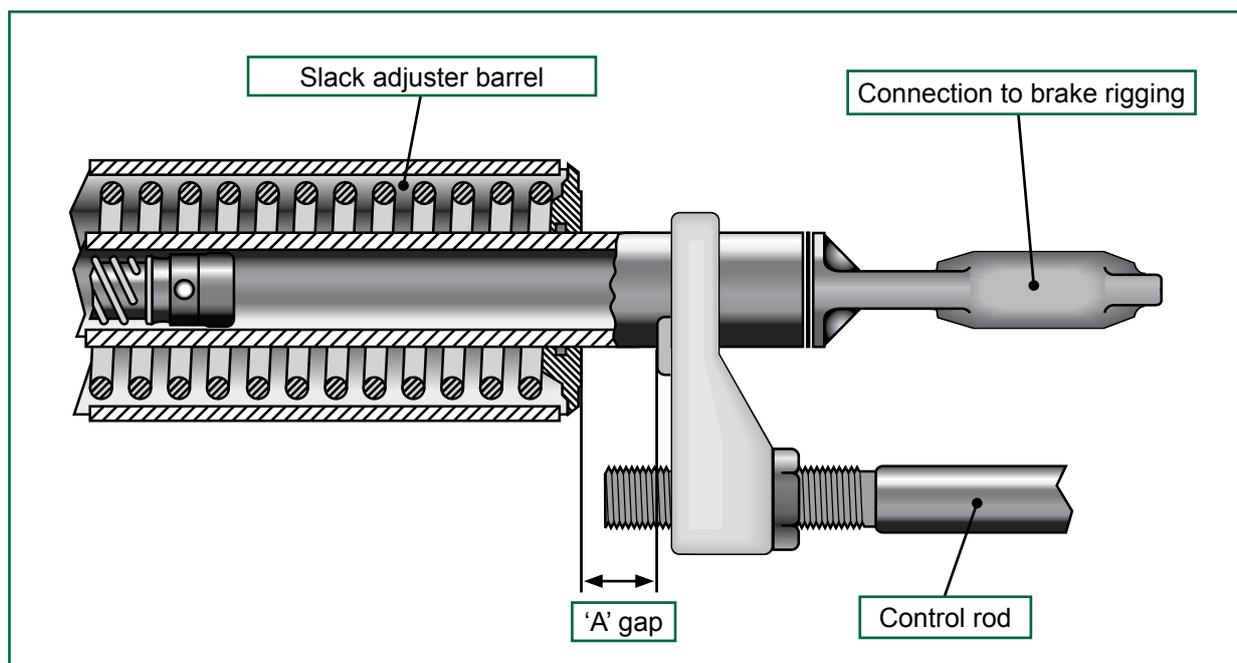
Figure 15: Slack adjuster 'A' gap

57 The brake system includes slack adjusters whose purpose is to ensure that slack in the brake rigging is taken up as the brake blocks wear. A dimension known as the 'A' gap in the slack adjuster assembly must be set to the value laid down in maintenance specification EWS/ES/0085 so that the brake blocks are set the correct distance from the wheels (Figure 15).
