Rail Accident Investigation Branch

Rail Accident Report

Track worker fatality at Ruscombe Junction 29 April 2007

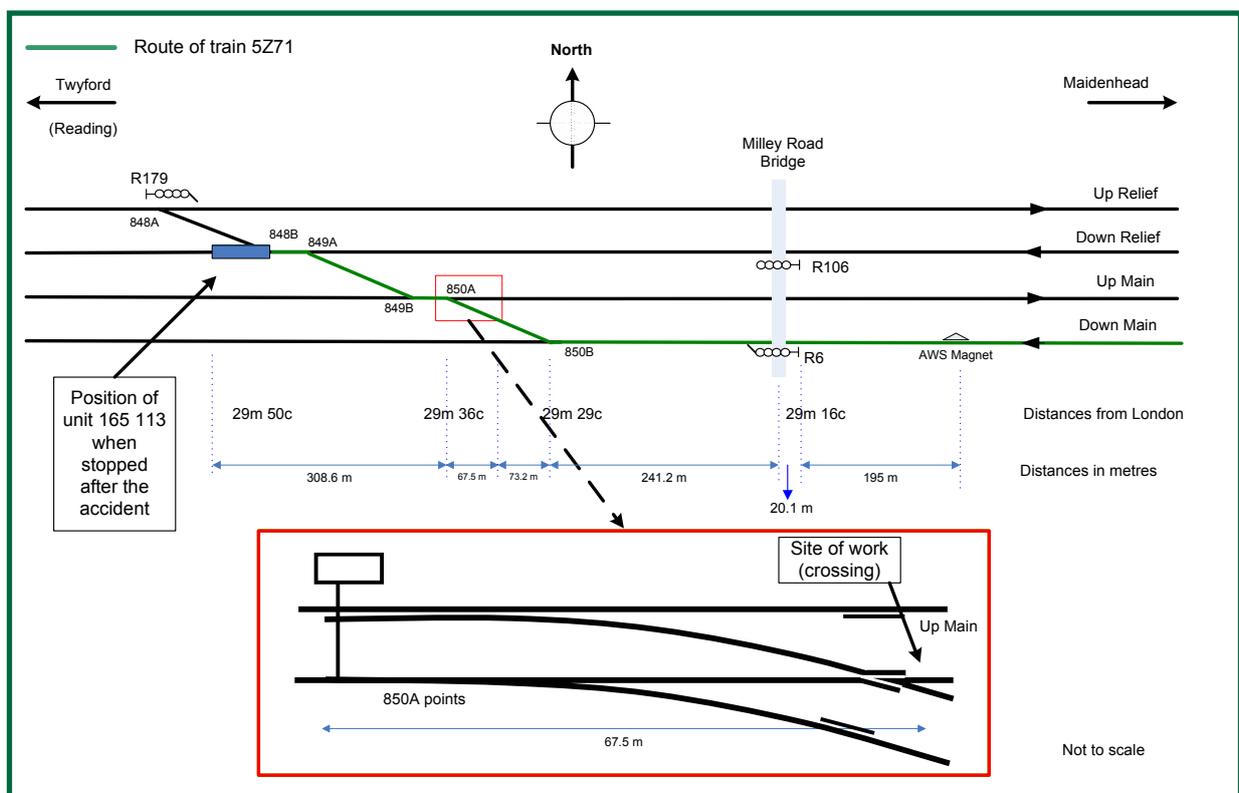
Figure 2: General layout of Ruscombe Junction, showing route of train 5Z71 in green

- 16 At 11:26 hrs on Sunday 29 April 2007, train 5Z71, the 10:45 hrs empty coaching stock train from Old Oak Common depot to Reading depot, struck and fatally injured a track welder at Ruscombe Junction, five miles (8 km) west of Maidenhead station. The accident occurred as train 5Z71 was being routed from the down main line towards the down relief line (Figure 2) via two high speed crossovers. The team involved were the welder, a controller of site safety (COSS) and a *lookout*. The welder was undertaking arc welding repairs to the crossing nose of 850A points in one of the crossovers.
- 17 The COSS and the lookout were not physically injured. The train was undamaged.

- 25 The highest permitted speed on the relief lines is 75 mph (120 km/h).
- 26 The four lines are connected at Ruscombe Junction by three high speed crossovers. Each crossover is formed by a pair of points and a short interconnecting section of track such that trains are able to transfer from one track to another (Figures 2 and 3).

- 131 As the driver passed over the *Automatic Warning System* (AWS) magnet at signal R6, (195 metres on the approach to signal R6 - Figure 2), he applied the brake in order to slow his train to the authorised speed for the junction of 70 mph (112 km/h). While the train was braking he noticed some track maintenance staff working on the track ahead. The train had decelerated to a speed of 68 mph (109 km/h). He noticed that one of the group was welding.

- 170 The Air Ambulance helicopter was deployed by the South Central Ambulance Service, NHS Berkshire Division, as part of the emergency response to the accident. The helicopter arrived at Ruscombe Junction at approximately 11:35 hrs and landed approximately 100 m from the site of the accident, (between Milley Bridge and 850B points) across the down and up main railway lines (Figure 2).

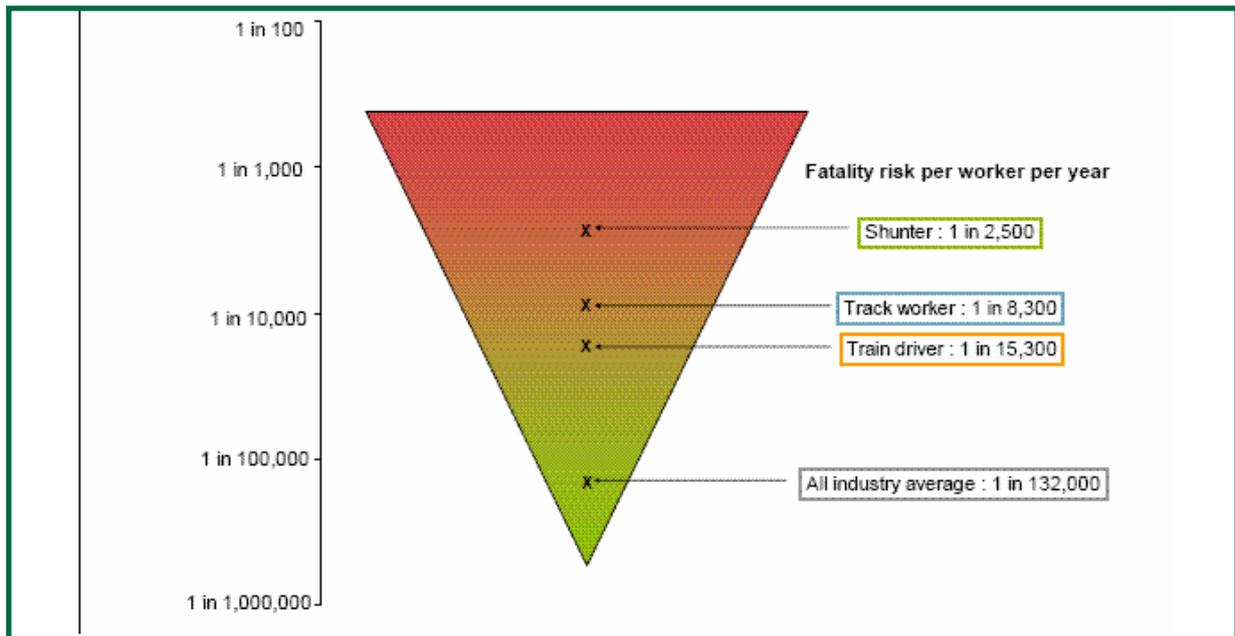
Figure 4: Levels of individual risk (extract from the RSSB Annual Safety Performance report)

- 68 Track workers are subject to levels of risk well in excess of the average for all workers in the railway industry. The RSSB Annual Safety Performance Report (provisional) for 2006 concludes that the risk of fatality per track worker per year is 1 in 8,300 (Figure 4). This compares to 1 in 15,300 for train drivers and 1 in 132,000 average for all workers in the industry.

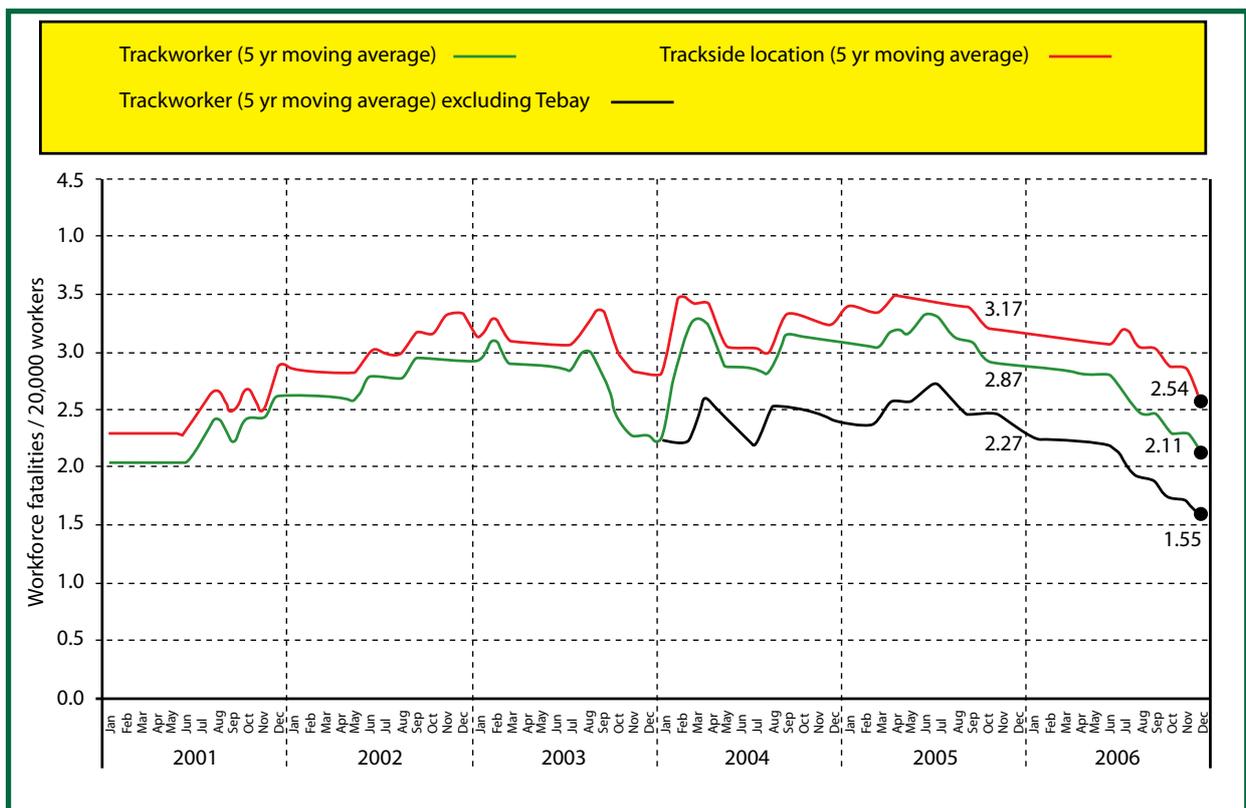
Figure 5: Track worker fatality rates normalised by staff numbers (data provided by RSSB)

- 69 Statistics provided by the RSSB show that the 5-year moving average track worker fatality rate (normalised by staff numbers) for 2006 was roughly similar to that in 2001 (Figure 5). However, this average was influenced by the four fatalities that occurred in 2004 as a direct consequence of a criminal act at Tebay. If the impact of this single event is excluded from the data, the track worker fatality rate is calculated to have fallen by 25 per cent between 2001 and 2006.
