Rail Accident Investigation Branch

Rail Accident Report

**Fatal collision between a Super Voyager train
and a car on the line at Copmanthorpe
25 September 2006**

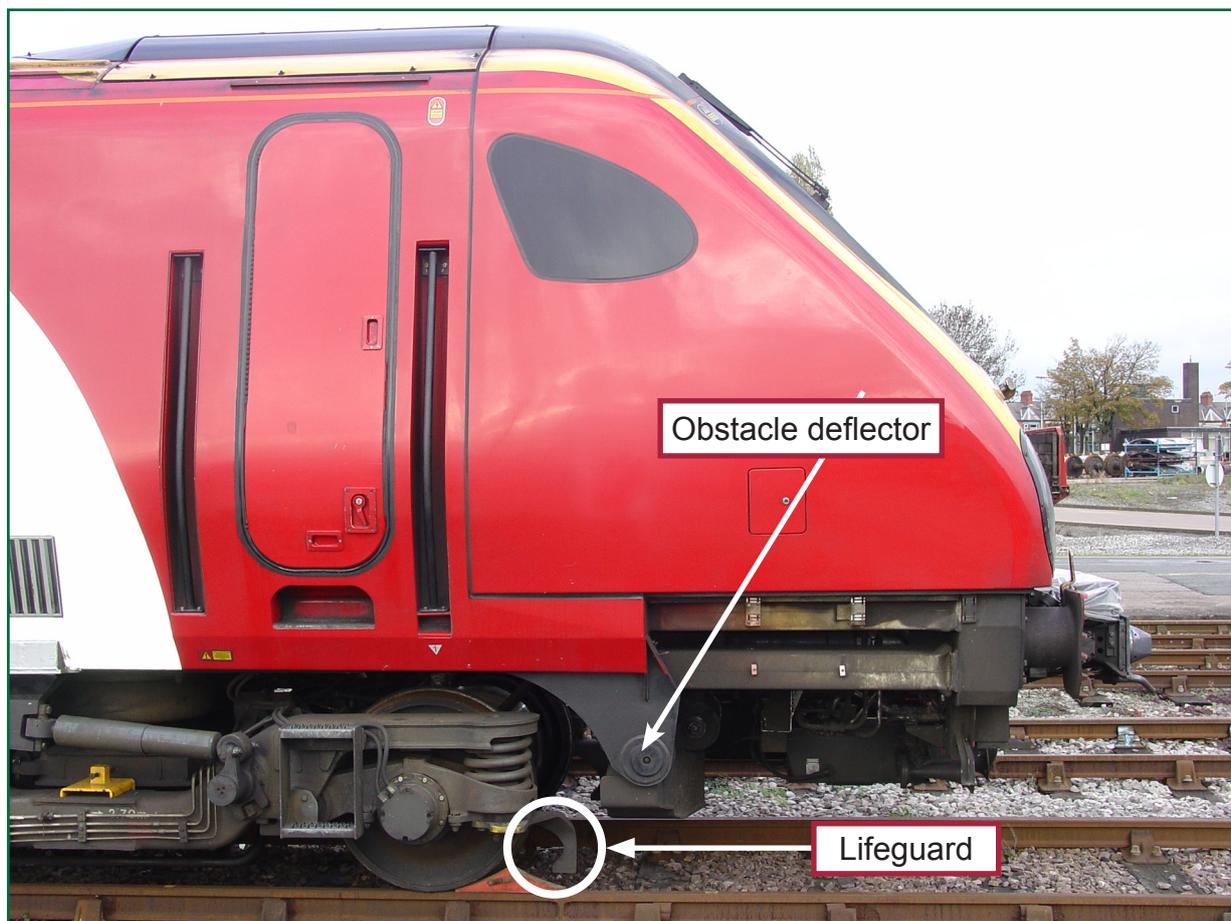
Figure 6: Location of obstacle deflector seen from side of train

83 Trains that are built to current *Railway Group Standards*, which include class 221 trains, are fitted with an obstacle deflector at the leading end. This is a steel structure, usually attached to the underside of the leading body shell in front of the first bogie, which is designed to prevent large objects from entering under the train (Figures 6 and 7).

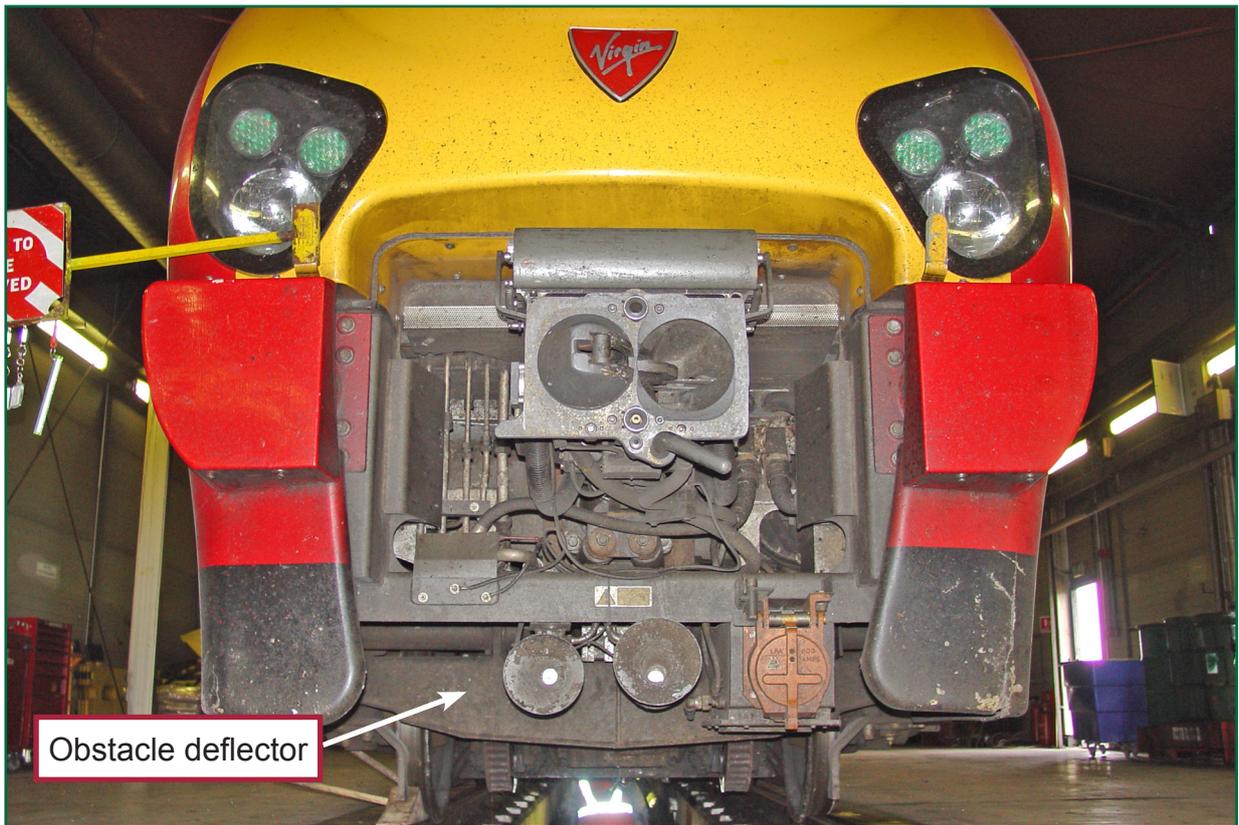
Figure 7: Undamaged obstacle deflector at the rear of the train (note that horn covers are missing)

84 The performance of the obstacle deflector was contributory to the train remaining in-line and upright after striking the car as it prevented the leading wheelset from derailing and also ensured that only relatively small bits of the car passed under the train (see Figure 8).
