Rail Accident Investigation Branch

Rail Accident Report

Derailment of a train at Croxton Level Crossing 12 September 2006

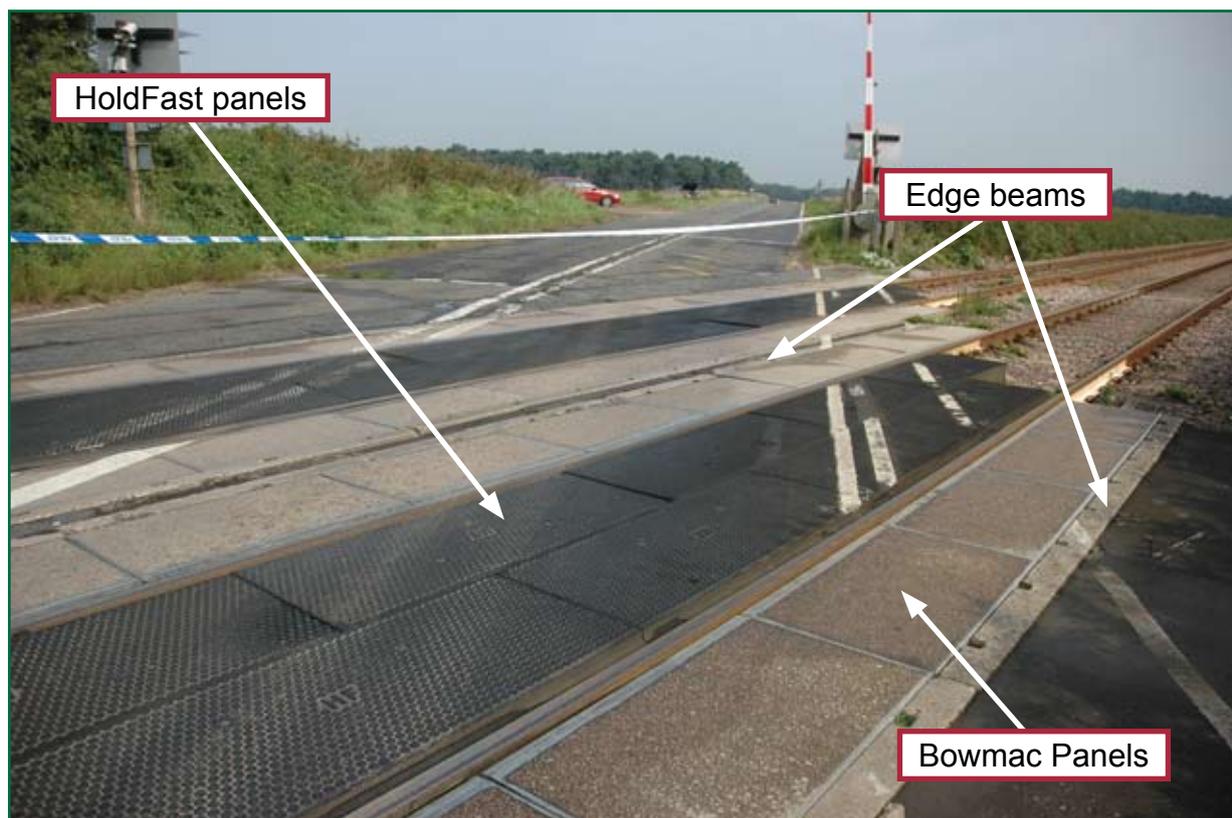
Figure 3: Croxton level crossing looking in a north-easterly direction

- 42 Local Railtrack management decided, after discussions with HoldFast, to install HoldFast panels in the four foot at Croxton, but to retain the Bowmac panels for the outer panels. Witness evidence indicates that this decision was driven by the higher damage rate of the four foot panels relative to those in the cess and six foot and in consideration of the cost of replacing the edge beams where the six foot panels meet the road (Figure 3).

- 46 Railtrack installed HoldFast panels in the four foot of the down line at Croxton during July or August of 2000. They ordered a second delivery of panels for the four foot of the up line, which they fitted over the weekend of 22/23 August 2001. They installed the panels with a stagger of 600 mm on the down line and 1200 mm on the up line, with the most north-easterly and south-westerly panels in each line leading by these respective amounts (Figure 3).

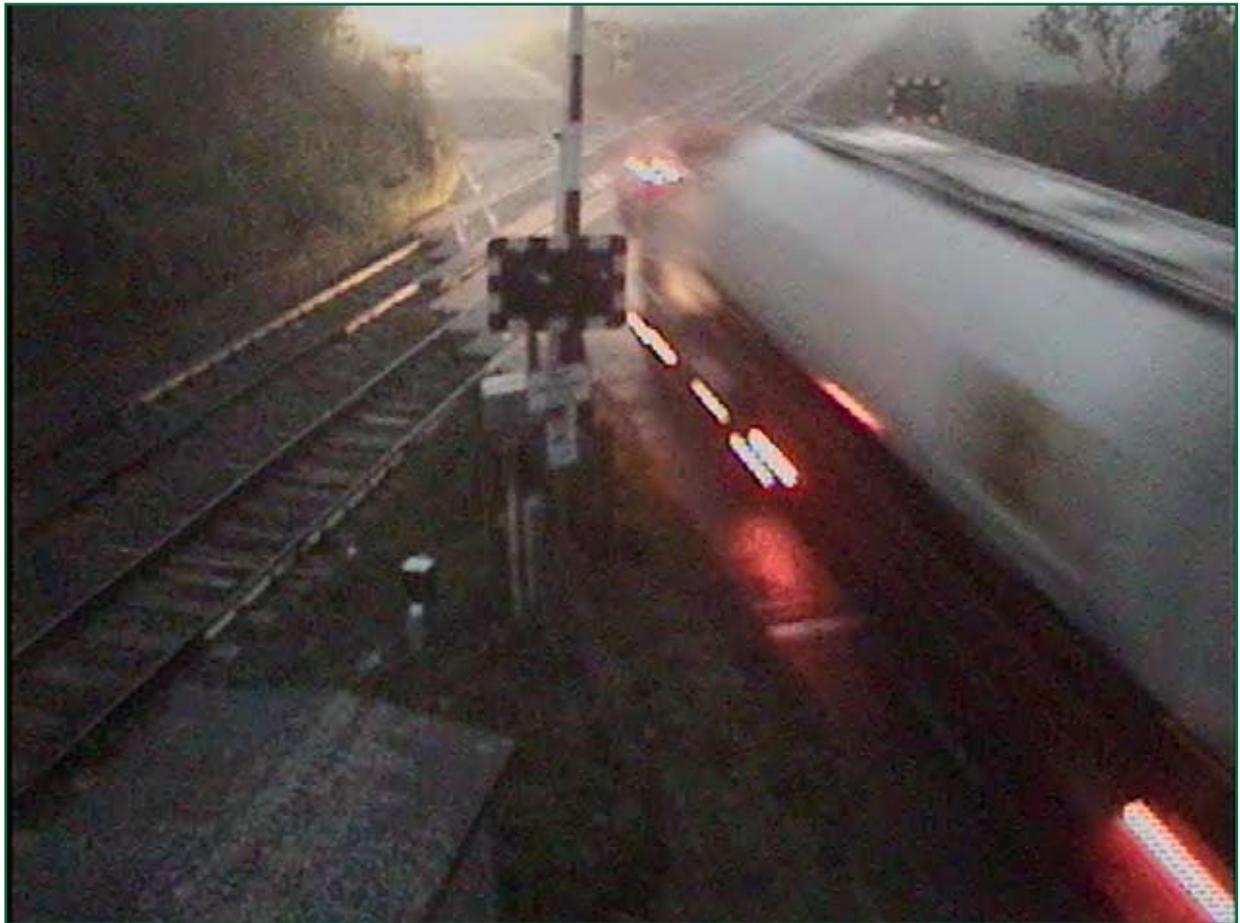
Figure 6: CCTV image of tanker trailer lorry passing over the crossing

- 77 At 05:54:34 hrs a tanker trailer lorry passed over the crossing (Figure 6). Examination of the CCTV image taken at 05:54:38 hrs shows that an object was present in the four foot of the up line, which had not been visible prior to the lorry's passage.

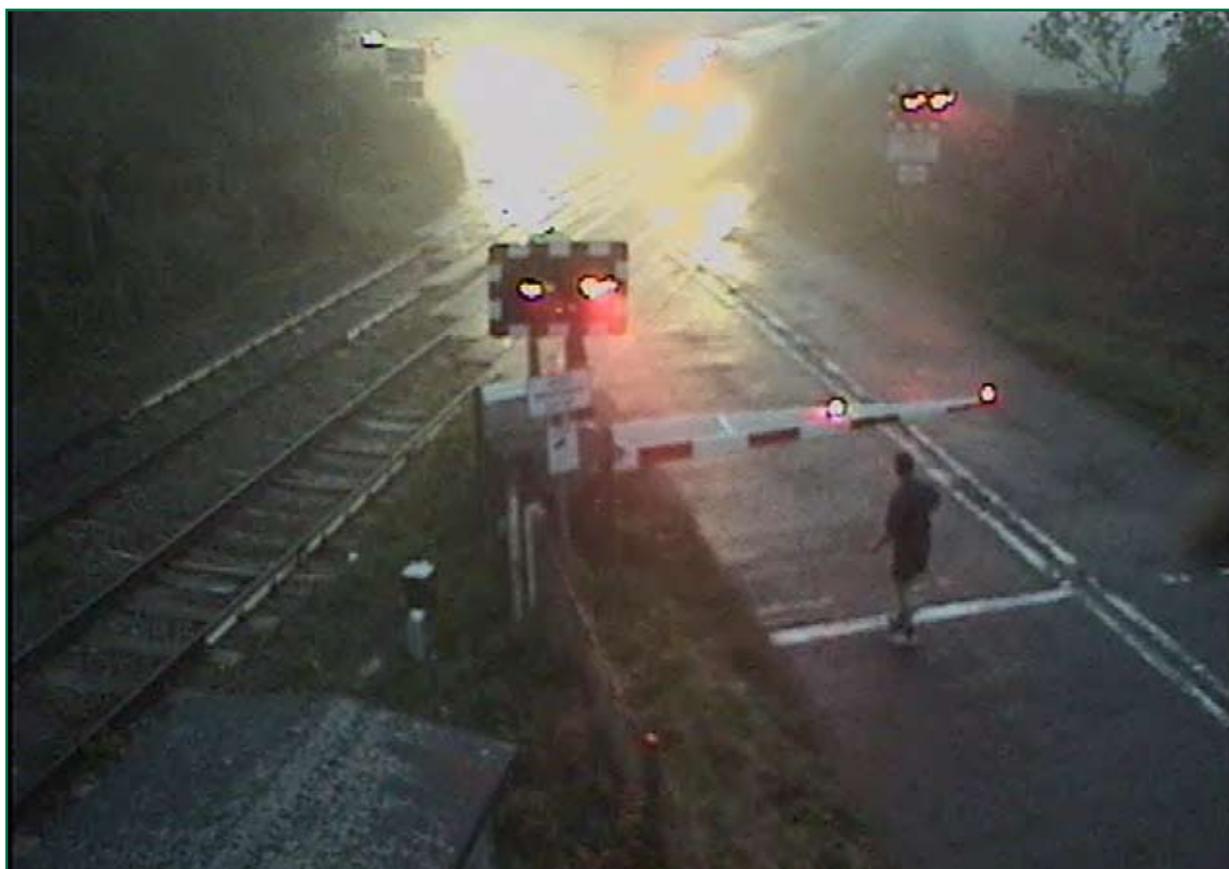
Figure 8: CCTV image of 1K55 approaching Croxton level crossing

- 89 At 06:03:23 hrs the train entered the crossing (Figure 8) and struck the dislodged panel. The collision derailed the leading bogie, but the rest of the train remained on the track. The train driver applied the emergency brake after realising that the train was running derailed, and the train ran 463 m before coming to a halt (Figure 2).

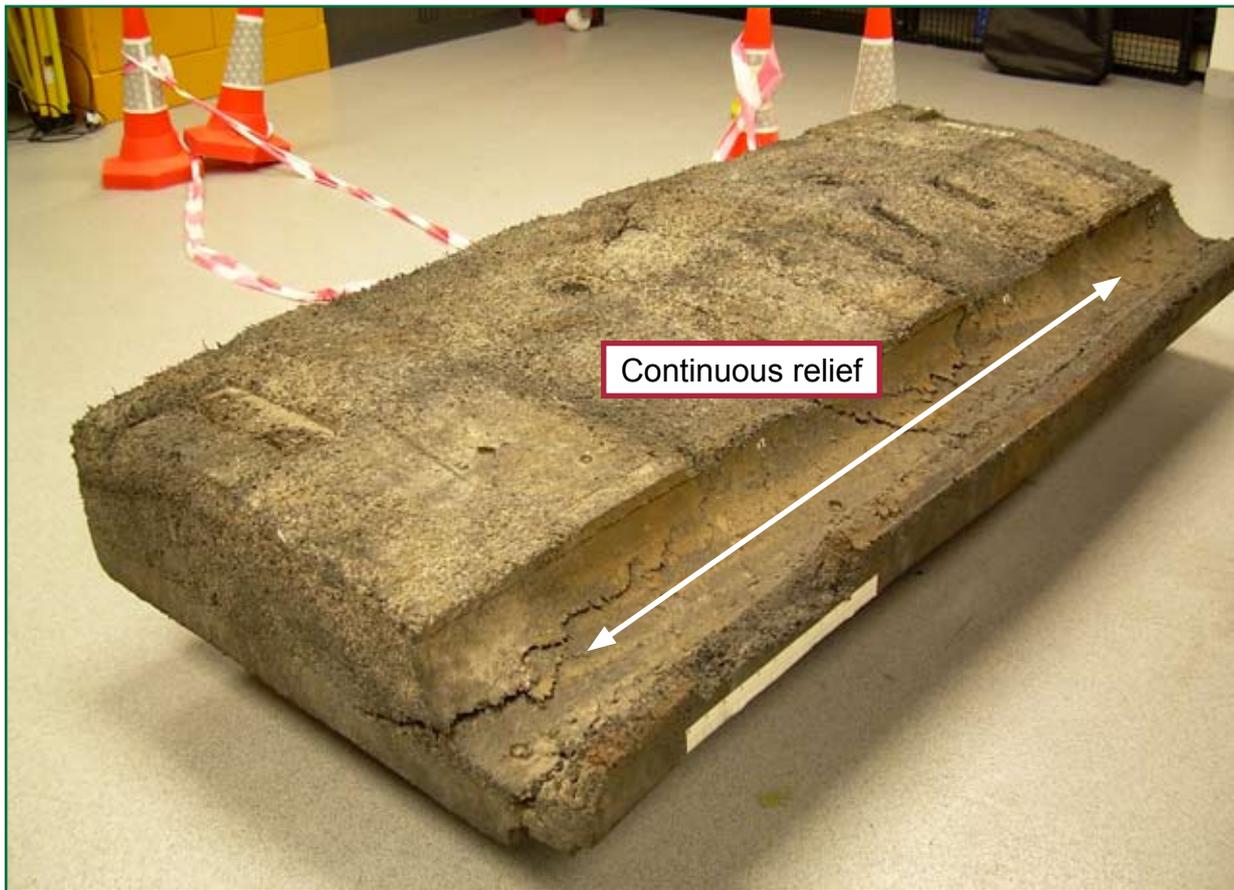
Figure 13: Continuous relief area on underside of panel B4

147 On the underside close to the rail foot, there is an arch-shaped recess known as the relief (Figure 13). This recess is required in order to give clearance for the rail clips.

- Continuous relief, where the relief was for the full length of the panel (Figure 13).
- Discontinuous relief, where the relief was restricted to short lengths over the length of the panel. The areas that were not relieved were solid and integral with the rest of the panel (Figure 14).

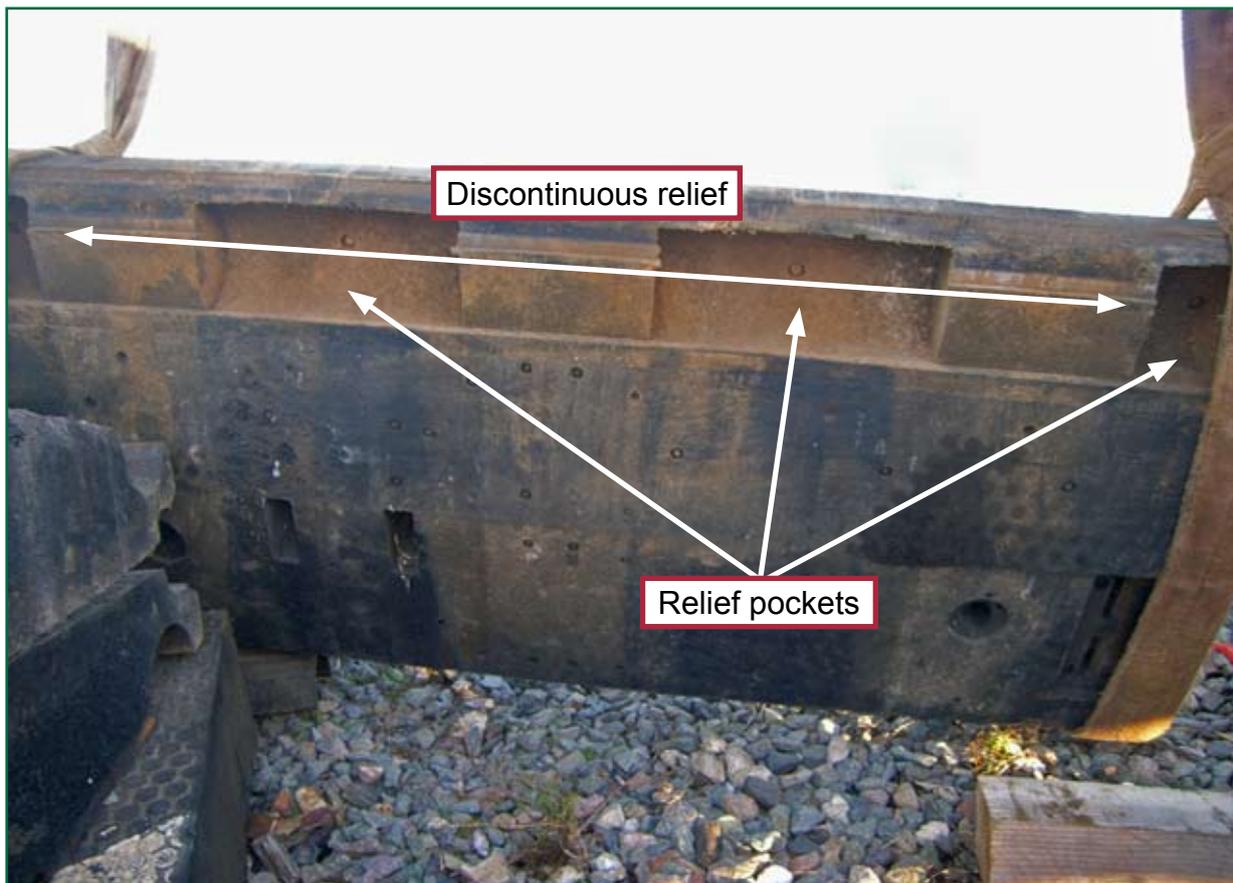
Figure 14: Discontinuous relief area on HoldFast panel underside

151 With discontinuous relief, although it was possible to install the panels without having their ends over a sleeper (as there is adequate clearance between the rail clips and the sides of the pockets to allow this) the panel had to be placed so that the 'pocket' was situated above the rail clip.

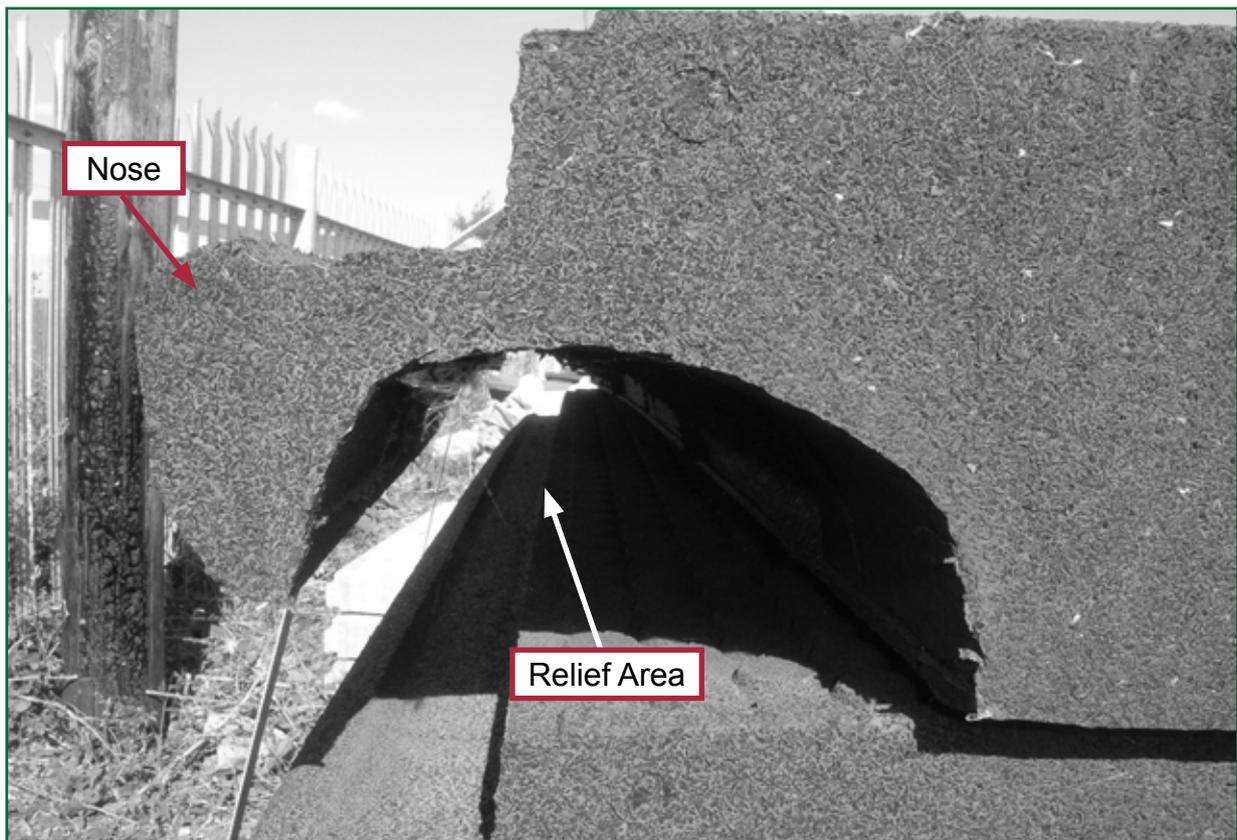
Figure 15: End view of panel nose area

155 The material in the relief area was relatively thin in comparison to the rest of the panel (Figure 15). As well as the relief on the underside, the upper surface had a channel close to the rail to provide clearance for train *wheel flanges* to pass through. This gave a relatively flexible area, known as the nose, as compared to the rest of the panel.

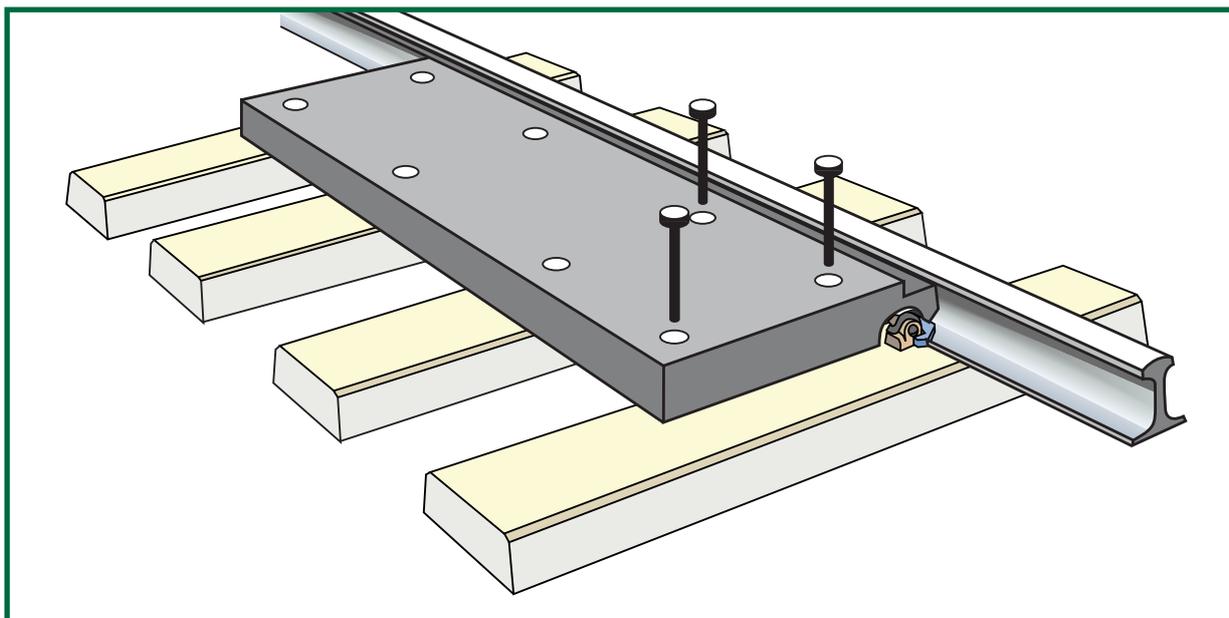
Figure 16: Original screw fixing of panels to timbers

164 The original OMNI panels were fastened down vertically to timber sleepers at 450 mm centres by screws that passed through moulded holes in the panels (Figure 16). The vertical retention of each panel was from the direct connection of the screw into the timber sleeper.

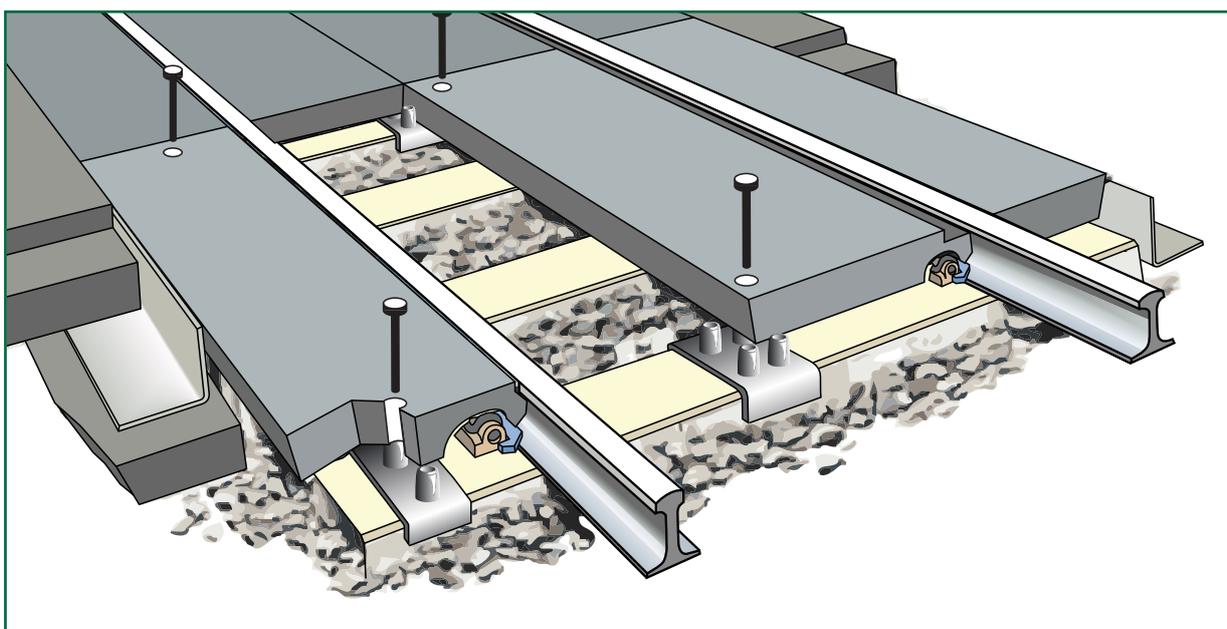
Figure 17: First version of base plate with threaded bosses

166 OMNI supplied a base plate for use with panels on concrete sleepers. The base plate sat upon the top of the concrete sleeper, but was not attached to it. The first design of base plate had four bosses on its upper surface that were internally threaded (Figure 17). The bosses located into recesses at the underside corners where four adjacent panels met. Screws were then added through the moulded panel holes and into the bosses.

169 BR and Railtrack fitted many panels of this design but the supply was discontinued following service experience of fretting of the screws and associated problems in removing them during panel lifting operations for track maintenance work.

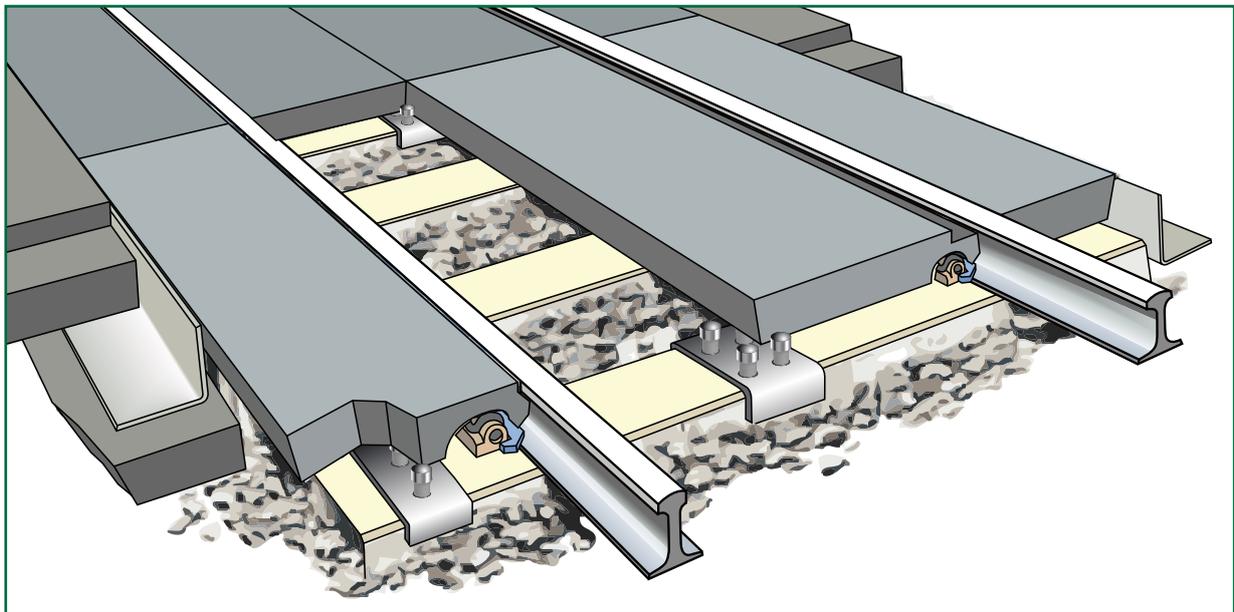
Figure 18: Second version of base plate with 'grip-tight nuts'

170 Around 1990, OMNI / HoldFast developed a second design of base plate to overcome this problem. This incorporated four unthreaded bosses on the base plate, known as 'grip-tight nuts' (Figure 18). These were 'bulb' shaped bosses that located in recesses in the underside of the panel. The sizes of the bulb and the recesses were such that an interference fit between the boss and the recess was created when assembled. This base plate also incorporated four bosses on a single base plate to locate the corners of four adjacent panels.

173 Subsequently HoldFast and Rosehill Polymers redesigned the base plate following reports received of panel ends splitting in the region of the 'grip-type nut' recesses.

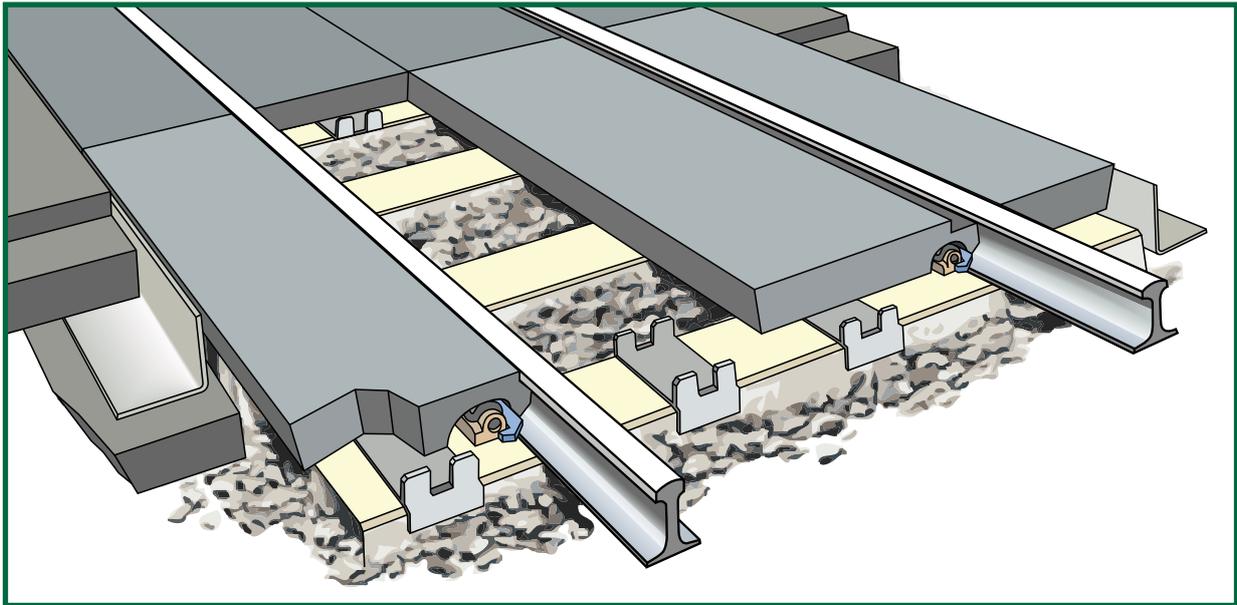
Figure 19: Turreted base plate design

174 This third design, known as a 'turreted' base plate, was a pressed steel plate with two uprights at each of its ends. HoldFast and Rosehill Polymers made an associated change to the recess in the underside of the panel into which these uprights engaged, changing it from a circular cavity to a parallel-sided slot (Figure 19).

- 175 HoldFast also moved this recess away from the panel's corner; the intent of the design change was to increase the contact area of the base plate's engagement with the panel and so reduce the risk of splitting to the panel's ends found with the approved design.

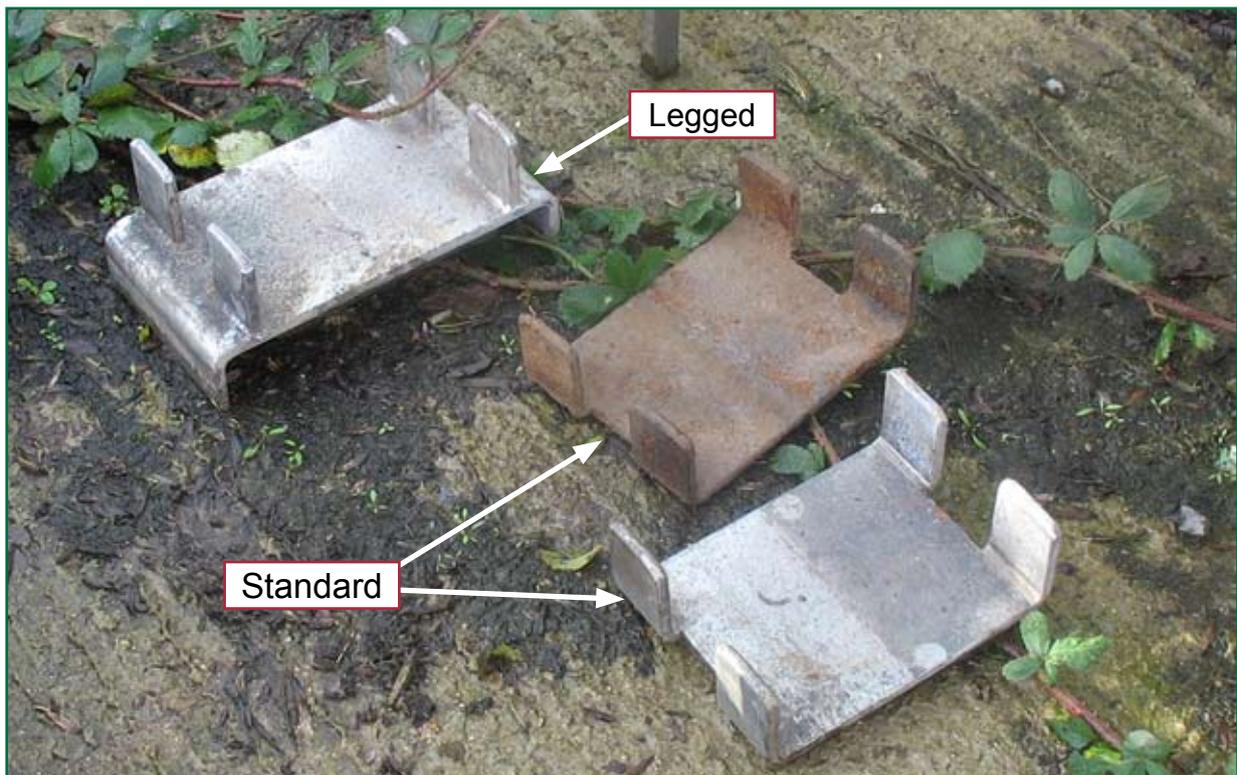
Figure 20: Legged turreted base plate (top) and two standard turreted base plates

183 This base plate had downward pointed legs at each of its ends which located either side of a sleeper; HoldFast recommended these to be fitted at the centre panels of a crossing to give longitudinal retention of the panels to the sleepers. This was required to prevent the panels from sliding along the track through forces induced by road traffic attempting to move the panels. The other function it provided was to give a reference of the panel to which it was attached to the sleeper over which it was located.

184 The second base plate type was known as a 'standard' base plate (Figure 20). This base plate had no legs and rested on the top a sleeper. Therefore, it gave no longitudinal retention, or reference of the panels to the sleepers. This was developed as it was found through previous experience that it was impractical to use 'legged' base plates throughout a crossing as this required the sleeper centre line intervals to be at, or very close to, 600 mm or the multiples thereof.

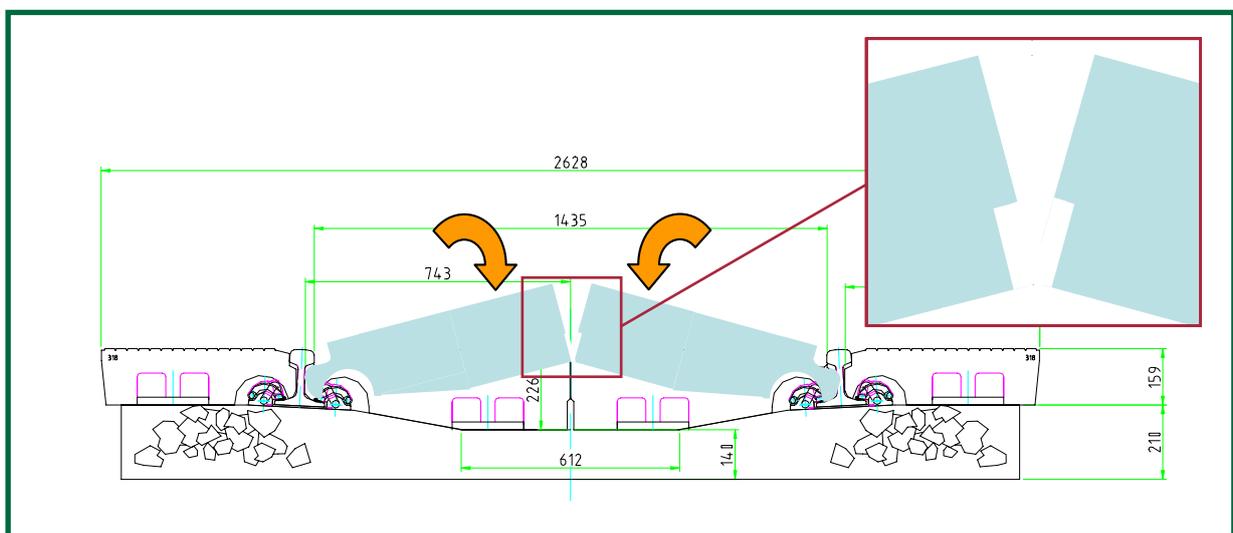
Figure 21: Installation method of HoldFast four foot panels and moulded profile on lower edge (inset)

192 In this latter method, the panels were added with their 'noses' located in the webs of the rails, with both panels being elevated towards the centre of the track (Figure 21). A downwards force was then applied to the raised ends of the panels to push them into their final position – for example by using an excavator backactor.

193 There is a moulded profile on the vertical panel face at the centre of the four foot (Figure 21 inset). This gives some clearance to the panels' lower edges when installing them in the latter method described above to assist in their fitting.

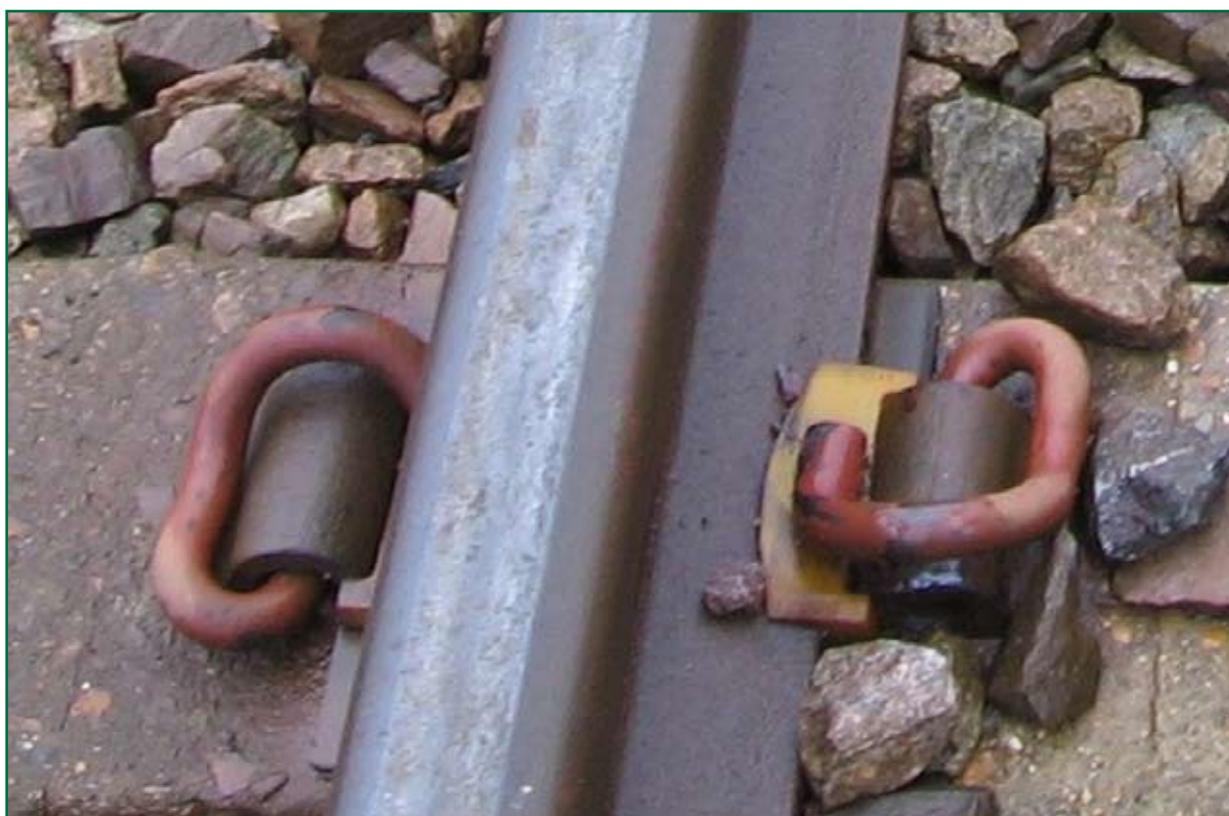
Figure 22: Pandrol rail clip and insulators

- 221 The rails were fastened to the sleepers by Pandrol clips. The Pandrol clip is a spring clip that has been used, with various developments, since the early 1960s. It holds the track firmly to the sleepers, but has sufficient resilience to allow movement. In order to function both mechanically and electrically a plastic insulator is placed between the toe of the clip and the foot of the rail, and a pad is placed between the rail and the sleeper (Figure 22).

- 222 Standard NR/SP/TRK/001 recognises that there will be occasions when clips will be missing from the track, and sets a limit as to how many may be missing. For a line with a line speed of between 65 mph (105 km/h) and 100 mph (161 km/h) there is an allowance of three defects, such as missing clips, in a single 60 ft (18 m) length of rail, with at least two sound fastenings between any defect.
- 223 Of the six sleepers under panels B3 and B4 none had all four Pandrol clips in position. Some had broken ends of Pandrol clips corroded into the housing. The sleeper closest to the unsupported end of panel B4 had no Pandrol clips in any of its housings (Figure 23).

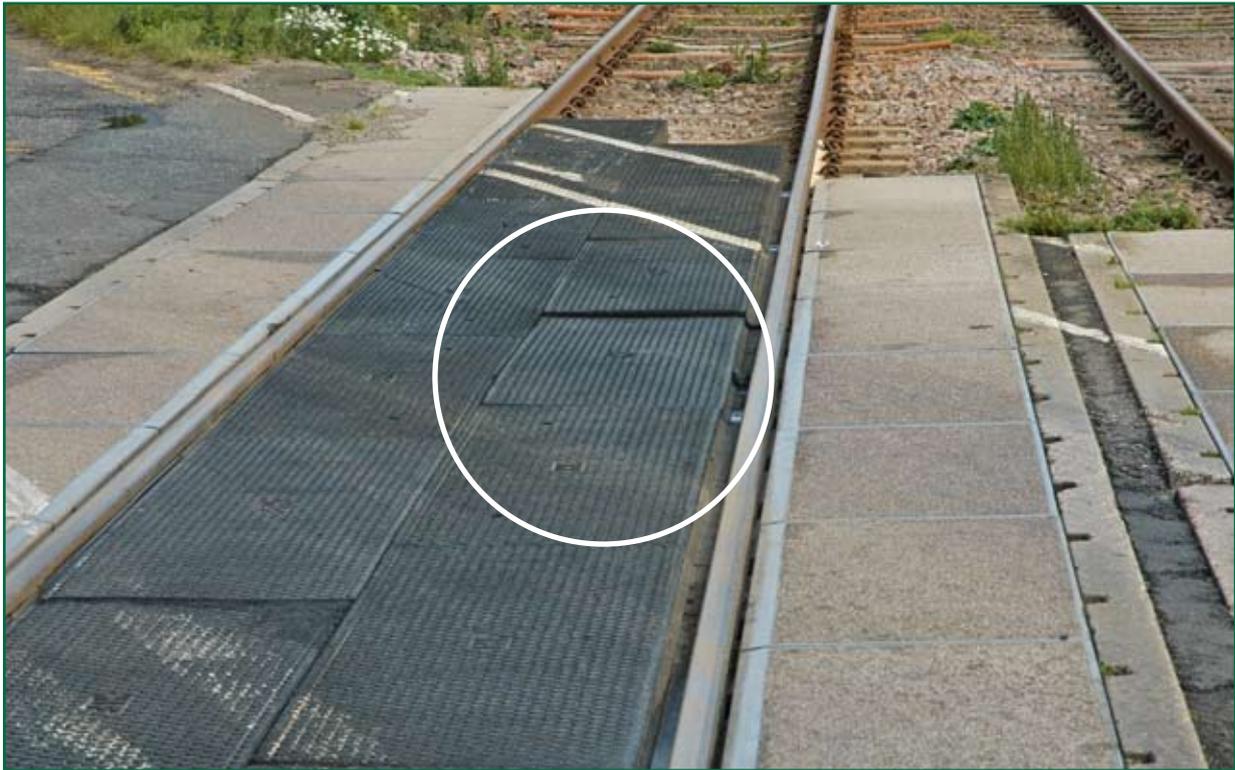
Figure 31: Diagonally opposite panel to panel B4 (in the down line of the other road carriageway)

- 205 The HoldFast quotation to Railtrack's contractor for the second order for panels for the up line in 2001 quoted for 'exactly the same crossing that was installed in April 2000'. The traffic conditions are documented as 'fast and heavy although the duty is quite light'. It was also recognised that the road profile in one direction was poor and led to 'driving down into the crossing'. It also mentioned that the angle of the railway to the road was 'approximately 45 degrees' and that the panels were for the four foot only.

281 The Norwich end of the selected panel was located on its intended supporting sleeper but only by approximately 20 mm, rather than in the order of 110 mm, ie half the sleeper's width. The standard base plate present had no pad on its underside.

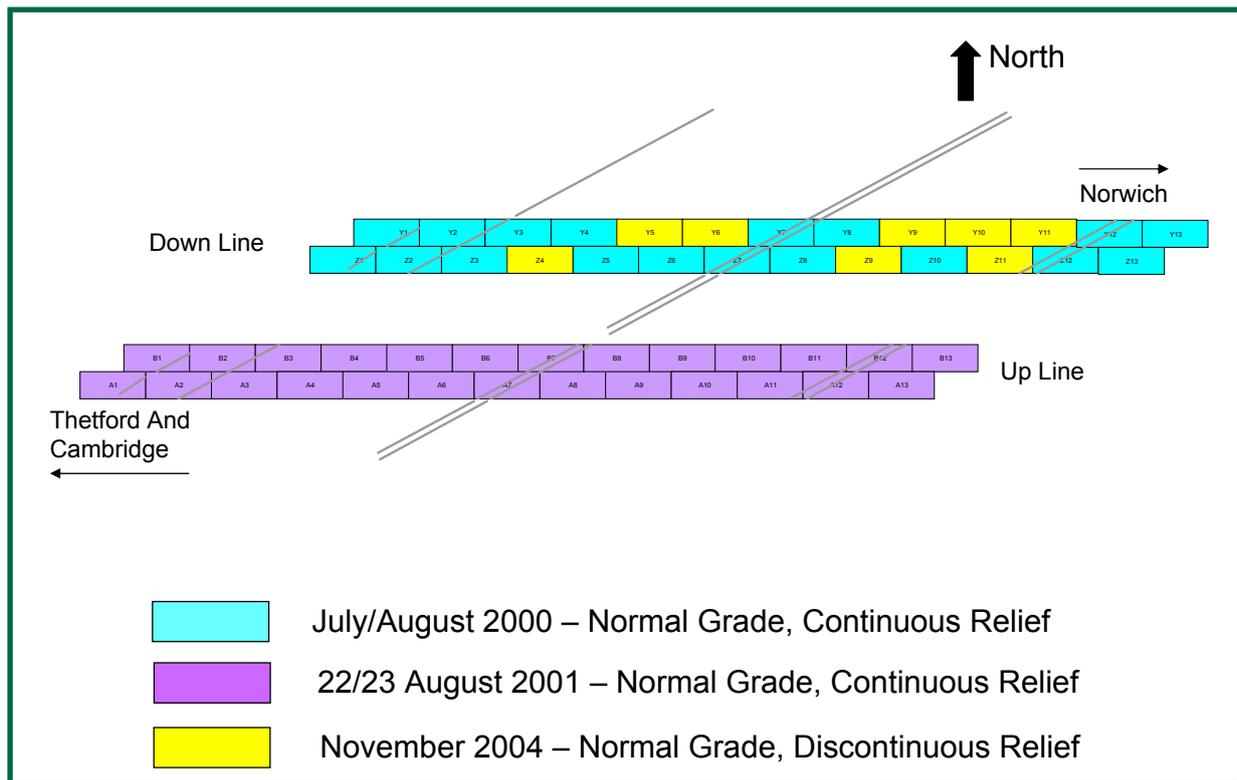
Figure 34: Panel types ages and positions fitted at Croxton at time of accident

- 210 The third order from HoldFast to Rosehill Polymers for the replacement of panels damaged in the fire (paragraph 47), requests that the panels are the same as supplied previously. Rosehill Polymers supplied these from stock; they were of type 00324GPN, that is of the discontinuous relief type.

Installation
