Rail Accident Investigation Branch

Rail Accident Report

Locomotive runaway near East Didsbury 27 August 2006

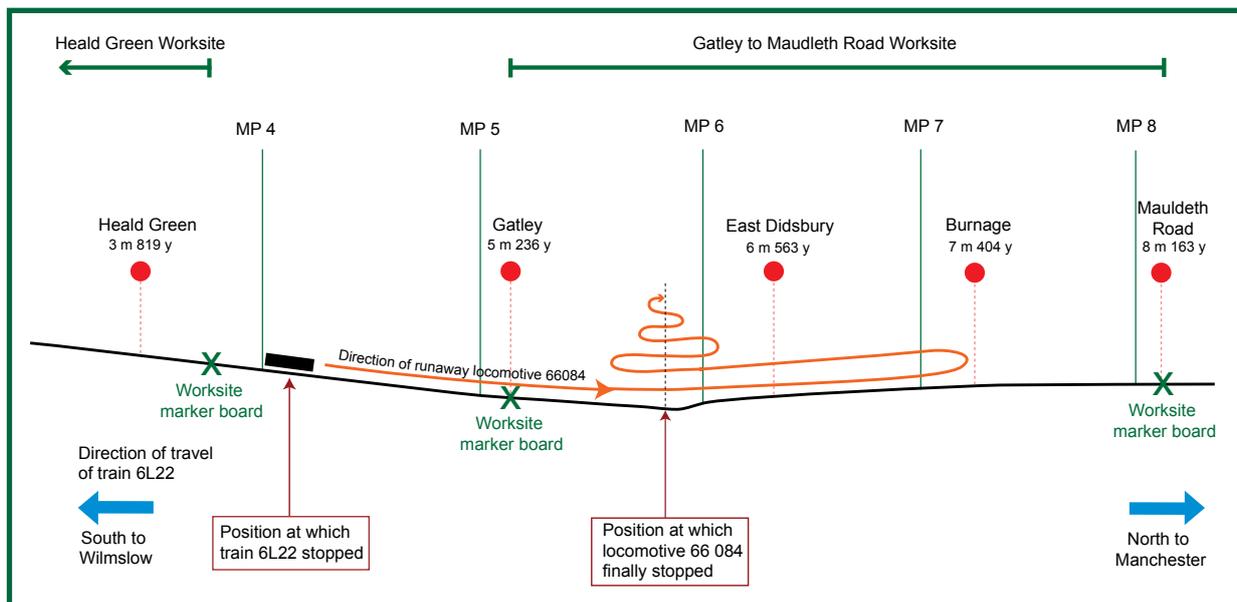
Figure 2: Locations and track gradients associated with the incident

- 23 Figure 2 shows the location of the incident. The front (south end) of locomotive 66 084 was 384 m north of milepost 4 on the Styal line when the runaway started. At this location, the locomotive was on a 1 in 141 gradient, falling to the north.
- 24 The locomotive ran northwards to Burnage station, stopped, ran southwards and then oscillated about the low point just to the south of East Didsbury station. It was finally stopped 150 m south of milepost 6, by a combination of the gradient profile and workers pushing a wooden post in front of a wheel.
- 25 The total distance covered by the runaway locomotive was around 5 miles (8 km).

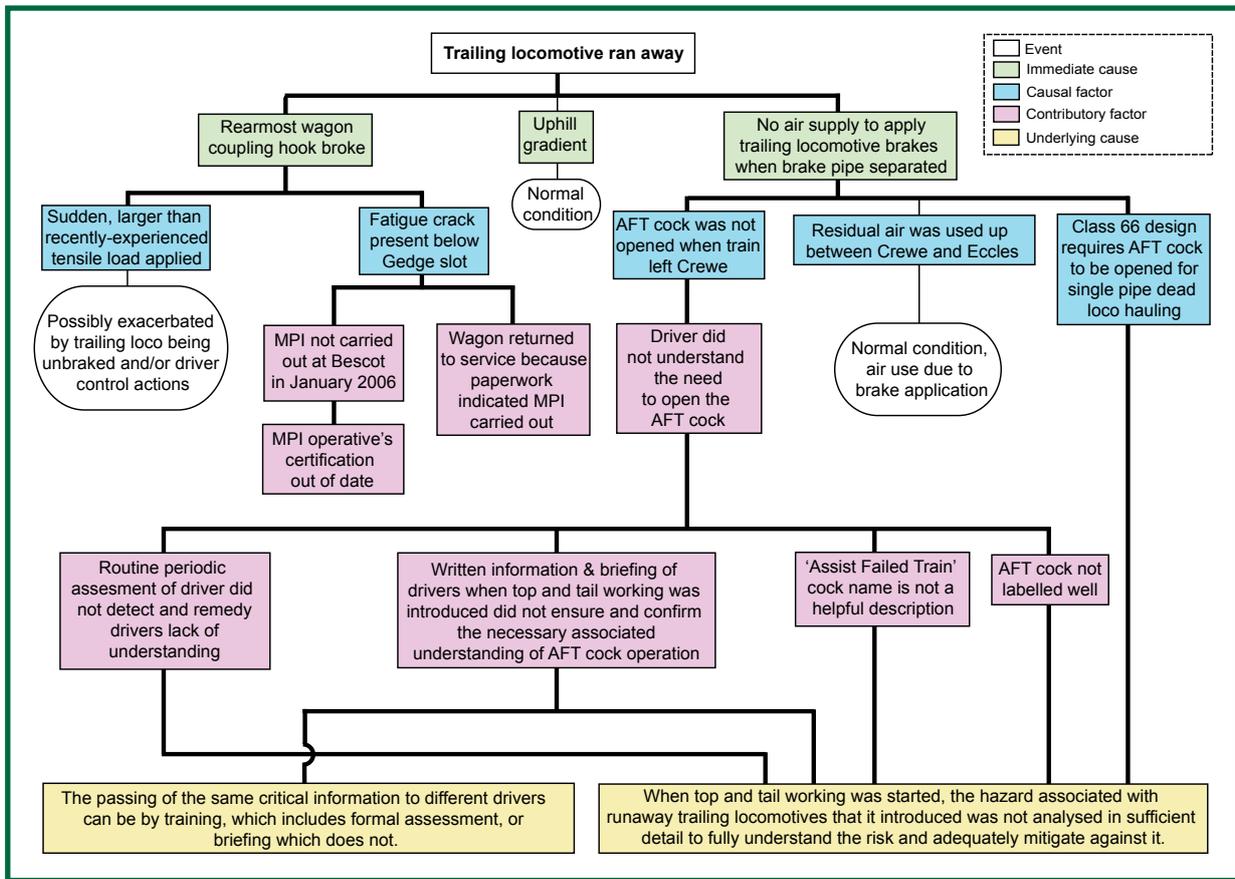
93 The diagram shown in Figure 9 illustrates the causal, contributory and underlying factors graphically.

Figure 9: Diagram showing chain of events and factors
