Rail Accident Investigation Branch

Rail Accident Report

Fatal accident involving a train driver, Deal 29 July 2006

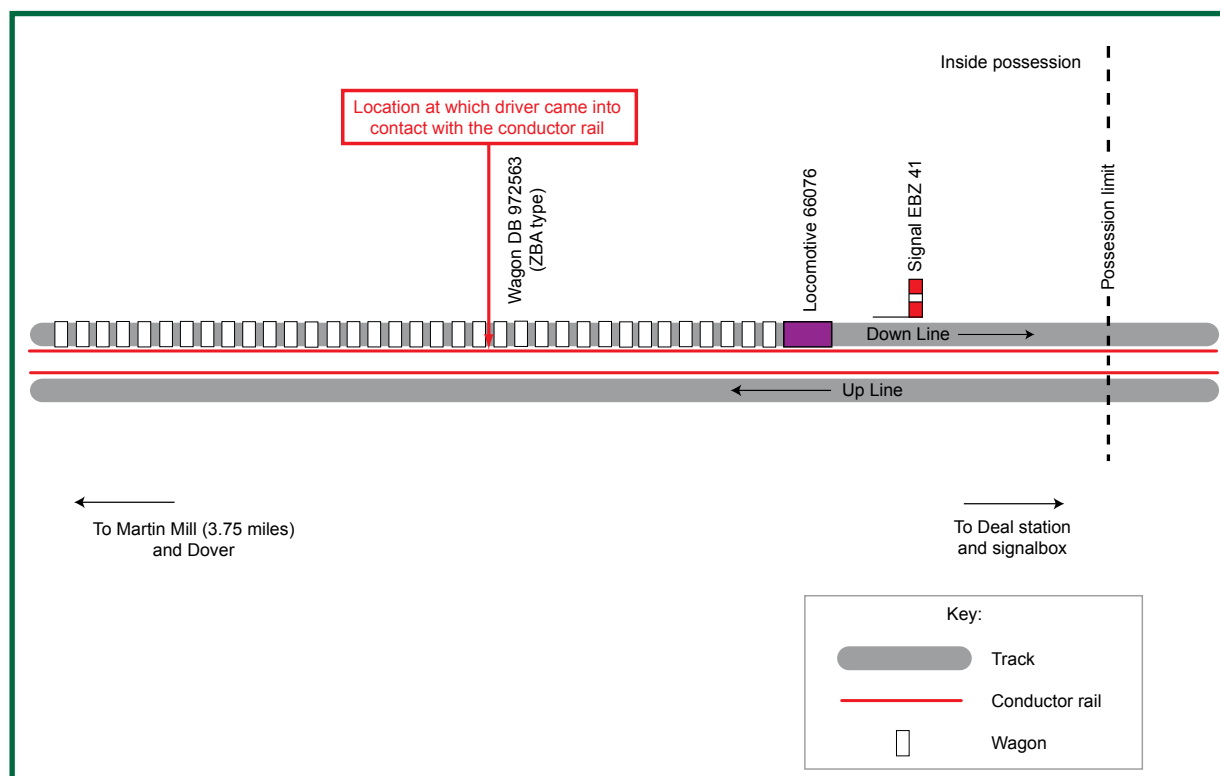
- 17 The ambulance service arrived on site within 15 minutes of the first call and attempted resuscitation.
- 18 An overview of the site of the accident is to be found at Figure 2.

Figure 2: Overview of the accident site

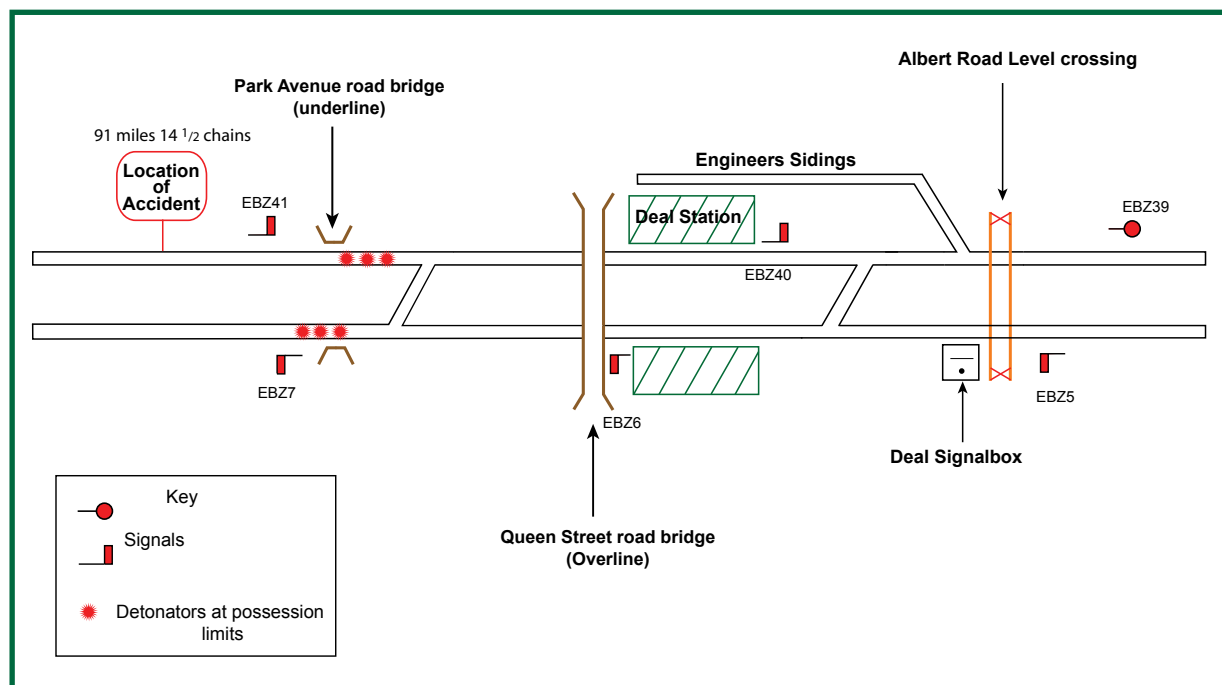
- 19 The accident occurred on the down line, on the approach to signal EBZ41, 700 metres south of Deal station (Figure 3). Signal EBZ41 is a semaphore type signal controlled from a signal box located north of Deal station.

Figure 3: Deal station and environs

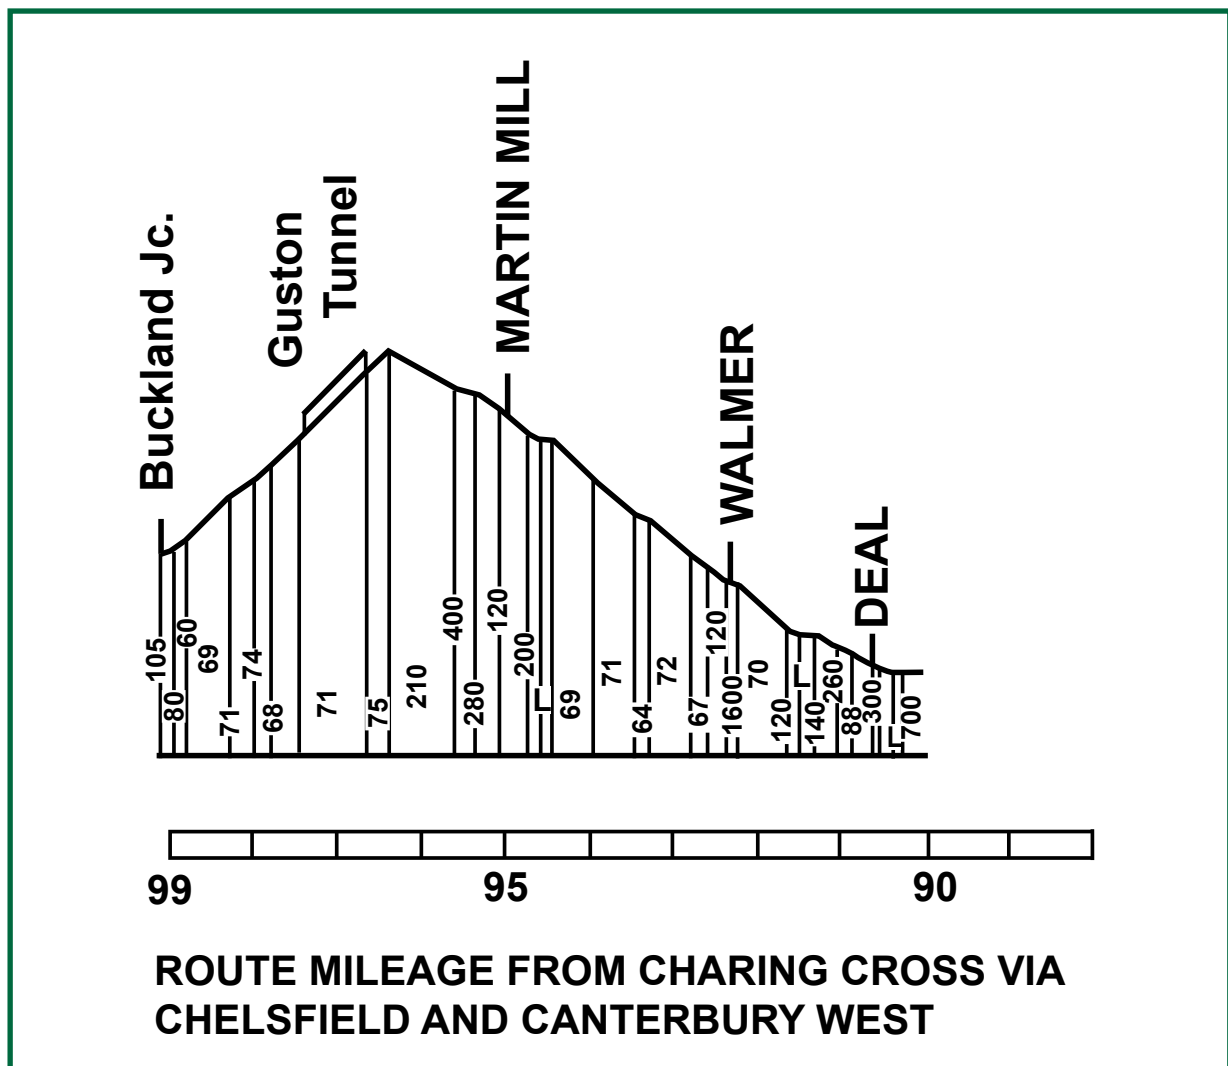
Figure 4: Gradient plan between Buckland Junction and Deal

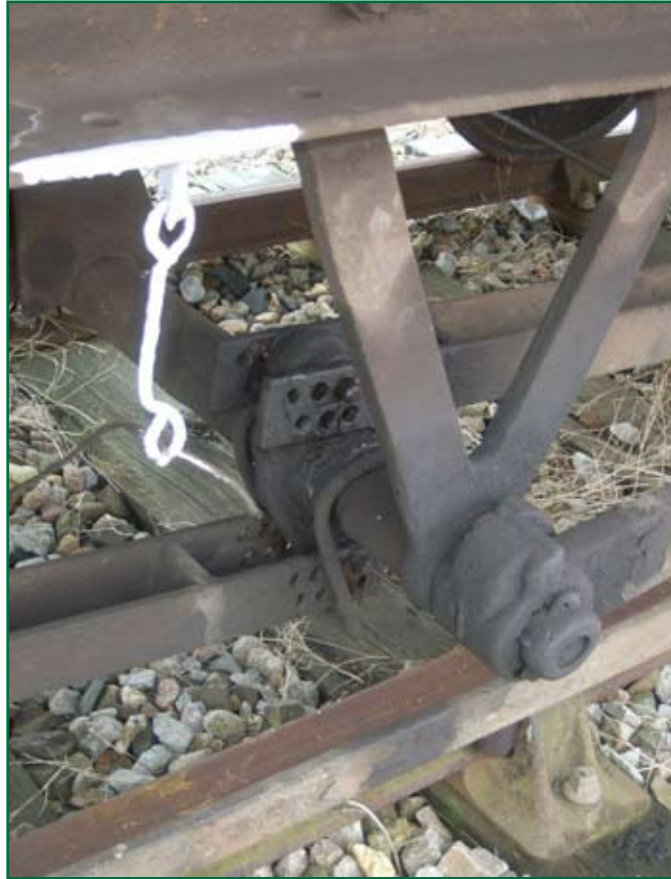
- 140 All of the wagons on train 6Z25 were of the ZBA type. These wagons are all fitted with a simple air brake system. This comprises a distributor feeding a single large cylinder. When air is fed into the cylinder from the distributor it drives a piston. Each brake block is connected to this piston by mechanical linkages.
- 141 The application of an even brake force at each wheel is dependant on the correct adjustment of the mechanical linkages. This adjustment is performed by moving pins along a series of holes in the *push rod* associated with each individual brake block (see Figure 8).
- 142 Typically the adjustment of the push rod will be performed when a new brake block is fitted. This is necessary if the new brake block is not to be forced too hard against the wheel tread.

Figure 8: Adjustment of the push rod on ZBA type wagons
