# Rail Accident Report

## Passenger train derailments on the Ravenglass & Eskdale Railway 29 May & 5 July 2006

Report 07/2007  
March 2007

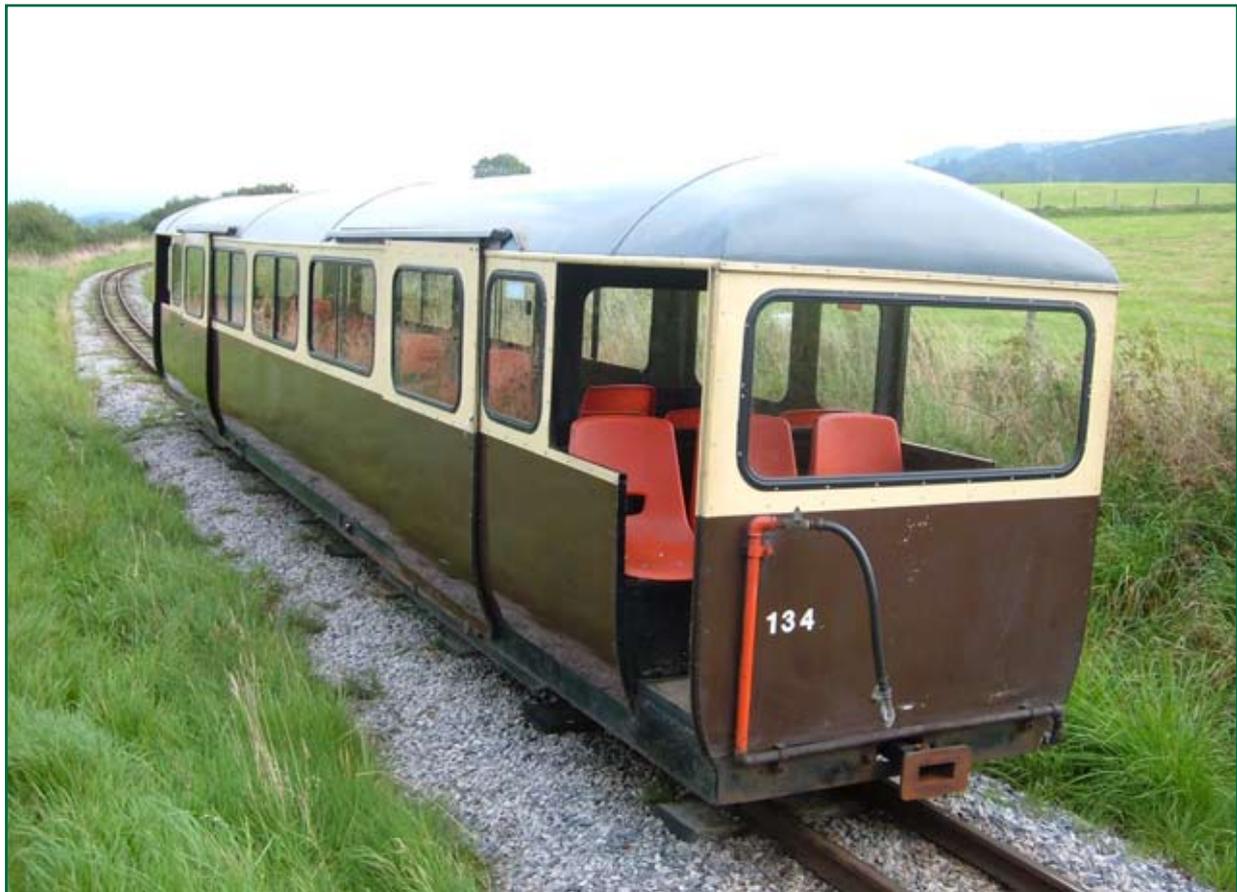
Figure 4: 'Maxi' Coach No. 134

- 34 The train entered the left hand curve at Spout House Farm, located between the stations at Beckfoot and Fisherground (Figure 1) at a speed of 12-13 mph (19-21 km/h). As coach 134 exited the curve, its leading bogie derailed to the right hand side of the track. The bogie's right hand side suspension then collapsed and the equalising beam and springs (Figure 6) on that side came adrift. Both wheelsets remained sufficiently guided by the bogie frame for the wheels to continue running on the sleepers with the vehicle body upright. The derailment site is shown in Figure 2.

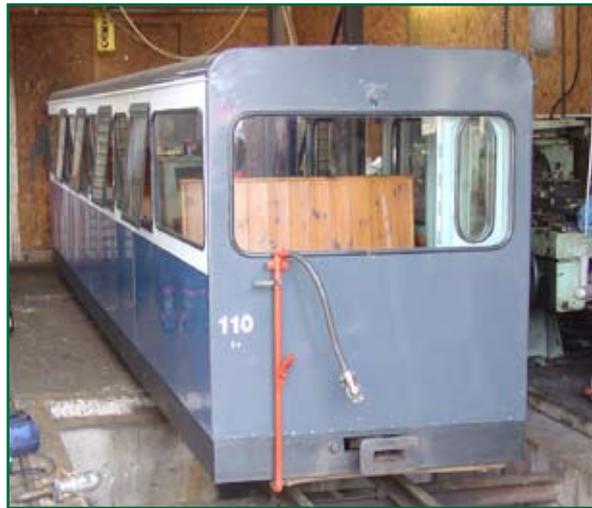
Figure 7: Saloon Coach No. 110

- 72 At around 10:45 hrs and at a location approximately 180 m from Miteside Halt, the leading wheelset of coach 110 derailed to the right hand side of the track. The derailment site is shown in Figure 3. Neither the driver nor the guard were aware of the derailment and the train continued towards Muncaster Mill in this condition. There were no passengers in coach 110.
