Rail Accident Report

Runaway permanent way trolley at Notting Hill Gate 24 May 2006

Report on a runaway permanent way trolley at Notting Hill Gate, 24 May 2006

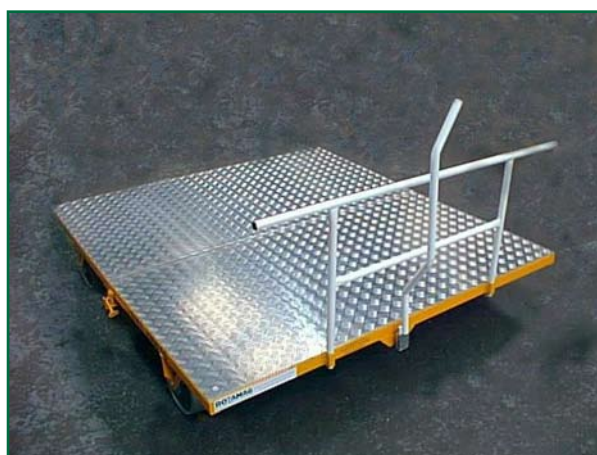
- 26 The trolley involved was a Rotamag split trolley (manufacturers number UD524-13). This type of trolley has been in service with LUL and the main line network for many years. A Rotamag split trolley is shown in Figure 3.

Figure 3: A Rotamag split trolley.
