Rail Accident Investigation Branch

Rail Accident Report

Runaway permanent way trolley at Notting Hill Gate 24 May 2006

Report 12/2007
May 2007

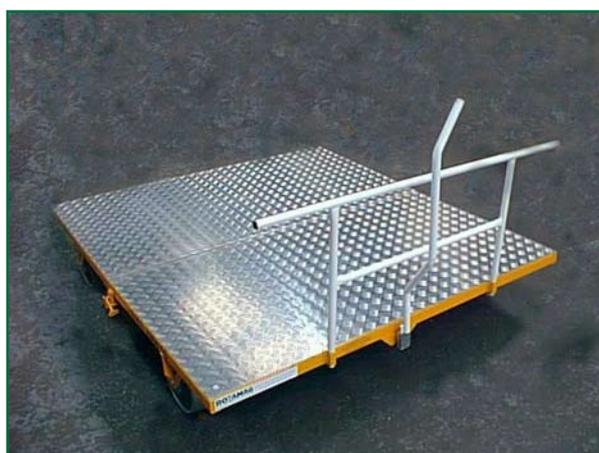
Figure 3: A Rotamag split trolley.

- 26 The trolley involved was a Rotamag split trolley (manufacturers number UD524-13). This type of trolley has been in service with LUL and the main line network for many years. A Rotamag split trolley is shown in Figure 3.

- 73 The inspection and testing of the trolley identified significant deficiencies in braking performance. With the brake handle removed and the brake in the fully 'on' position, the resistance of the braked wheels to rotation was negligible. It was possible to rotate each wheel easily by hand.
