Rail Accident Investigation Branch

Rail Accident Report

**Broken Rails at Urchfont and Kennington
following the passage of a freight train
5 January 2006**

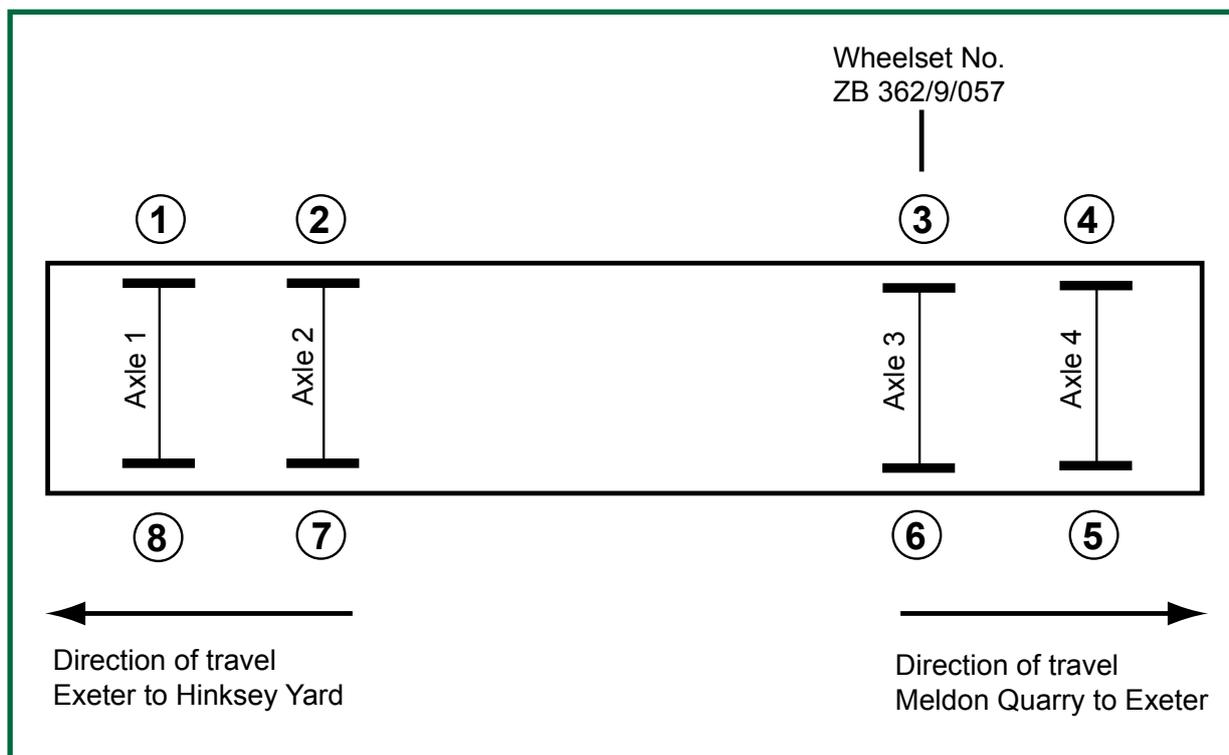
Figure 3: Wagon NLU 29553 directions of travel with respect to wheel and axle number

- 57 Wagon NLU 29553 was subject to further examination at Derby on 17 & 18 January 2006 by Network Rail and the RAIB. The wheel flats were on axle 3 (wheel numbers 3 and 6), which was the trailing axle of the leading bogie from Meldon (Figure 3). The flats were well defined, indicating that they had been freshly created during the last journey.
