Rail Accident Investigation Branch

# Rail Accident Report

## Collision at New Addington on Croydon Tramlink, 23 November 2005.

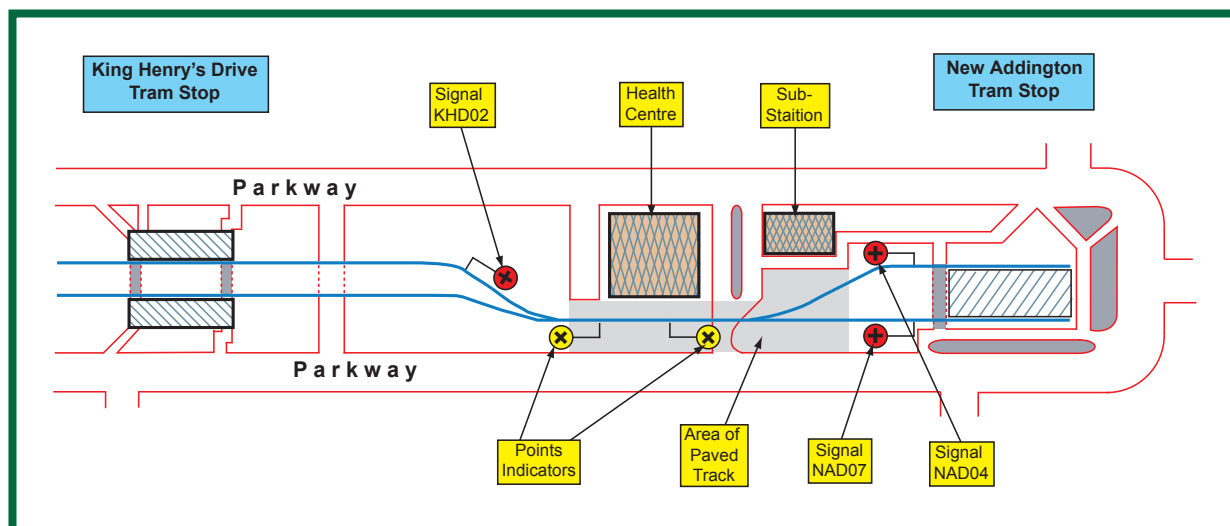
Figure 4: Diagrammatic representation of the line between King Henry's Drive and New Addington

- 21 The single track section is located immediately north-west of the New Addington terminus; the reason for this is its proximity to a building (used as a Health Centre) where there is inadequate room for double track. It is located on the apex of 0.68% and 0.63% rising gradients from New Addington and King Henry's Drive respectively. A shallow right hand curve is apparent on departure from New Addington. The entry to the single line is controlled by a motorised point and NAD04 and NAD07 signals at New Addington and a *spring point* and KHD02 signal from King Henry's Drive. *Points Indicators* are provided at both ends of the single line. Good sighting of the collision point is possible from at least 50 m distance under conditions of moderate visibility.

- 22 The entry to the single line at New Addington is controlled by signals at each end. The controls are triggered by track-located sensors, one at King Henry's Drive tramstop and one adjacent to KHD02 signal. Similar sensors are provided at New Addington. Apart from the sensor at King Henry's Drive tramstop which operates automatically, a proceed request is activated by the driver initiating a 'Ready-to-Start' signal from the cab. The system normally operates on an automatic first come – first served basis, although manual over-ride from the control centre at Therapia Lane Depot is possible.
