# Rail Accident Report

## Trackworker fatality at Trafford Park 26 October 2005

## 26 October 2005

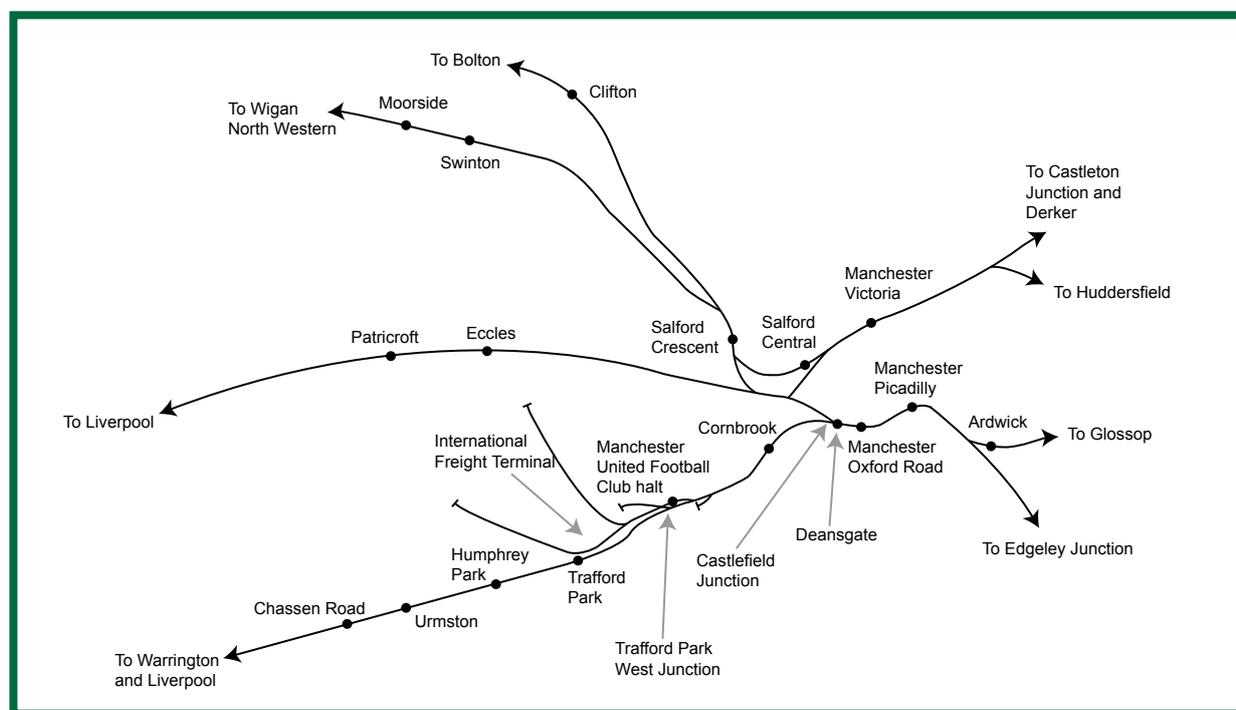
Figure 2: Railway map of the area

- 25 A railway map of the area is shown in Figure 2. Trafford Park West Junction (grid reference SJ807962) is on the line from Manchester to Liverpool, 2 miles west of Deansgate Station. Mileage is measured from Liverpool along the route known as the CLC (Cheshire Lines Committee) and the site mileage is 31 miles 1452 yards. The *Engineer's Line Reference* (ELR) is MAJ.

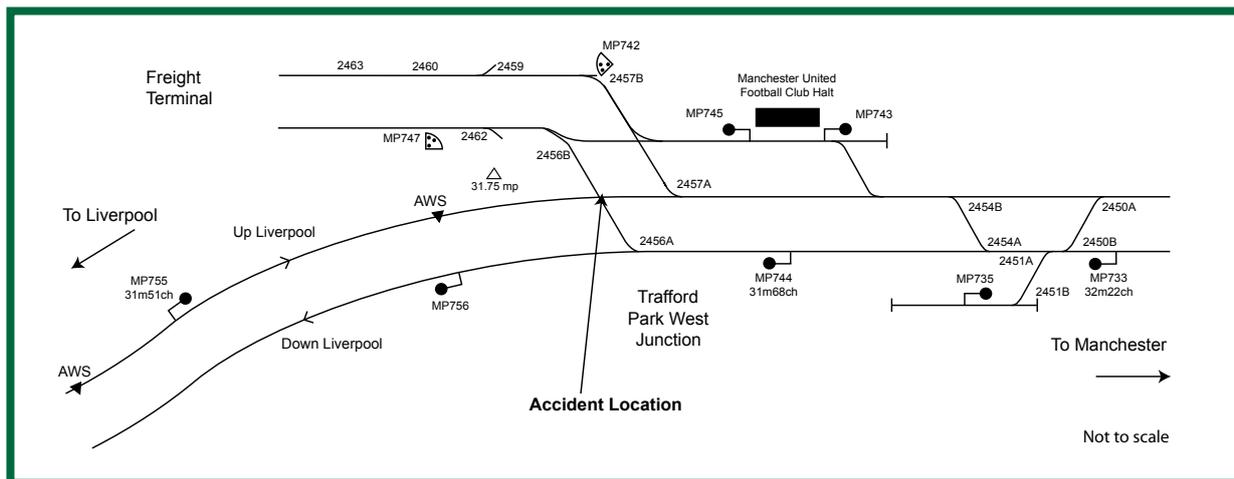
Figure 3: Track layout at the accident site

- 26 The track layout at the accident site is shown in Figure 3. There are two main running lines at Trafford Park West Junction – the Up Liverpool and the Down Liverpool. The Up direction is towards Manchester.
- 27 To the west and north of the main lines is the Trafford Park freight terminal complex. This is accessed via a double junction, which allows access to and from the Manchester direction.
- 28 To the east of the junction on the north side, is a single platform, the Manchester United Football Club Halt. This is accessed by a loop line from the Up Liverpool line which can also be used to provide an access to and from the freight complex.
- 29 The main lines from Manchester, as far as and into the freight terminal, including the loop line, are electrified on the 25 kV overhead line system.

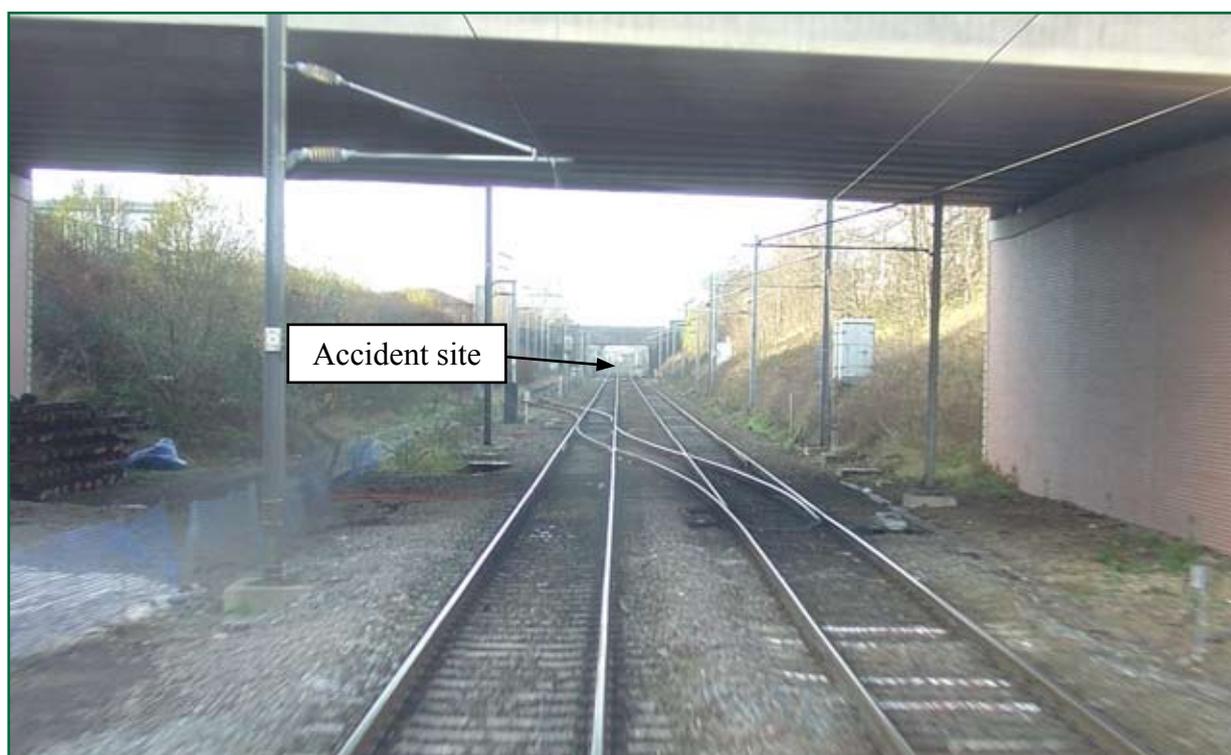
Figure 4: Approach to Trafford Park West Junction from the east

- 32 The lines at Trafford Park West Junction are in a shallow cutting. This cutting continues eastwards towards Castlefields Junction. The alignment is straight, with good visibility for approximately three quarters of a mile. To the west, the railway has a reverse curve initially turning southwards. To the south of the line there is a cutting slope and houses. To the north, the railway is bounded by the freight terminal and Manchester United football stadium. Between the railway and freight terminal is a metal palisade fence. A pedestrian bridge for football spectators spans across all of the railway lines at the site.

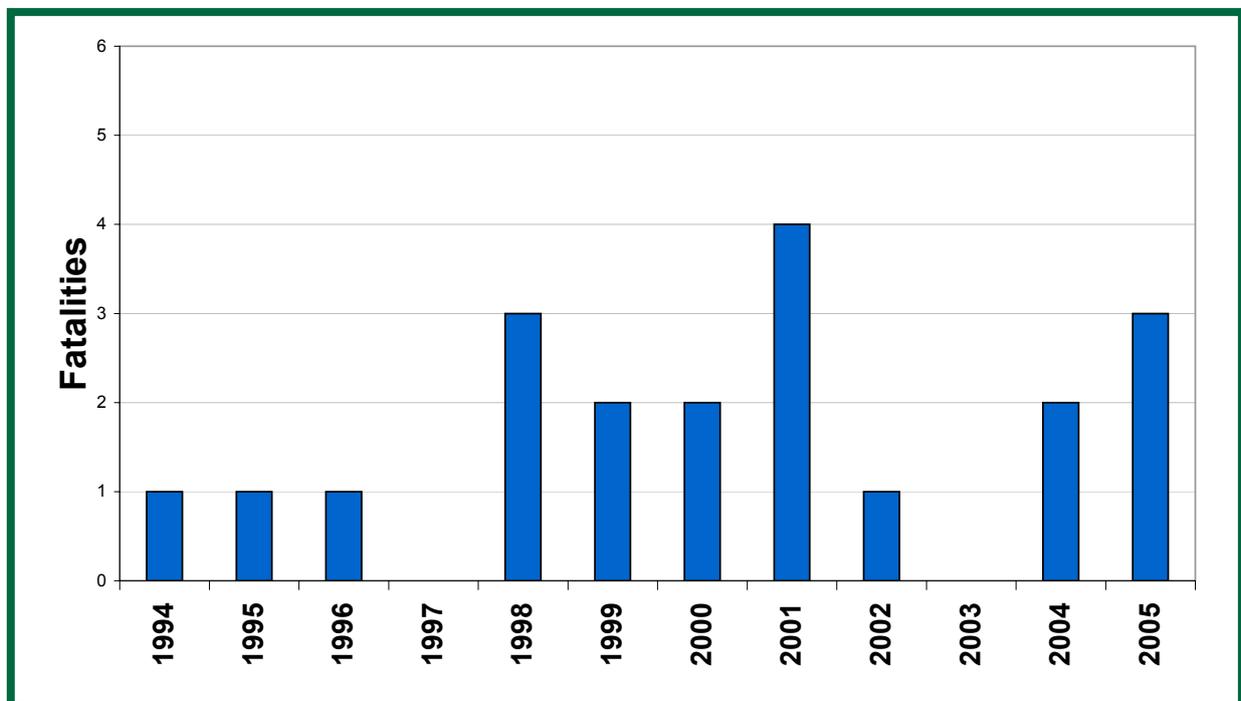
Figure 10: Trackworker fatalities (struck by trains)

- 136 Appendix D shows a table of all trackworker fatalities from 1994 to 2005. Figure 10 shows the numbers by year where these fatalities resulted from being struck by trains. In all of these instances, a major contributor to the cause of the accident was non-compliance with rules and instructions forming part of track safety certification by the individuals concerned.
