Rail Accident Investigation Branch

Rail Accident Report

Derailment near Liverpool Central underground station 26 October 2005

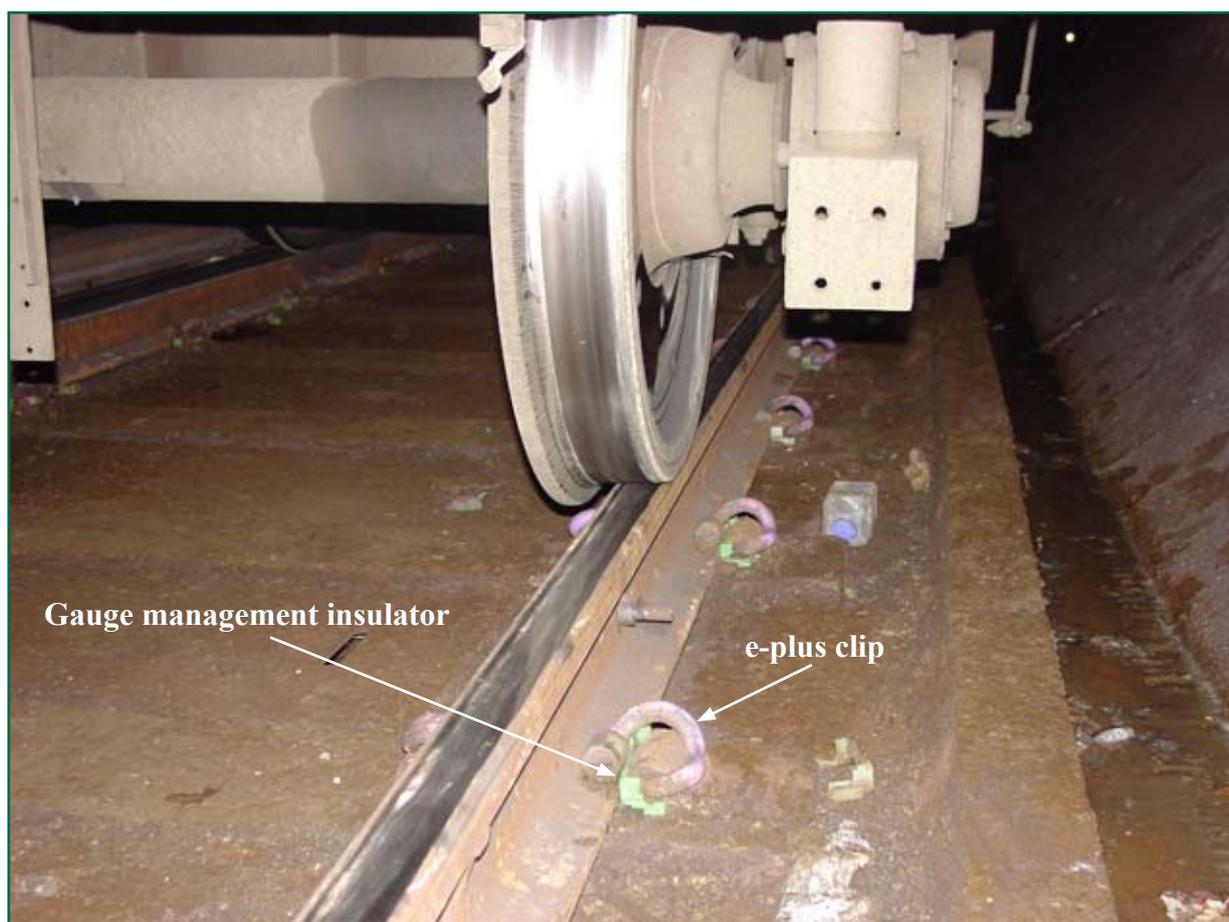
Figure 6: Pandrol e-Plus clips

- 62 Around the end of 2004, Network Rail sought the advice of Pandrol UK Ltd, the UK subsidiary of Pandrol Rail Fastenings Ltd, on the type of track fastening best suited to the tunnel environment. Pandrol advised the use of their *e-Plus clips*, in conjunction with *toe insulators* and *gauge management insulators* as a stopgap measure, pending complete renewal of the track. The e-Plus clips have the benefit of providing a high *toe load* on the rail foot, with the aim of preventing movement. Network Rail decided to fit e-Plus clips to the Loop, but they had not completed the programme of fitment between Lime Street and Central, and they had not been fitted where the derailment occurred. Figure 6 below shows fitted Pandrol e-Plus clips and gauge management insulators beyond where the derailment occurred.

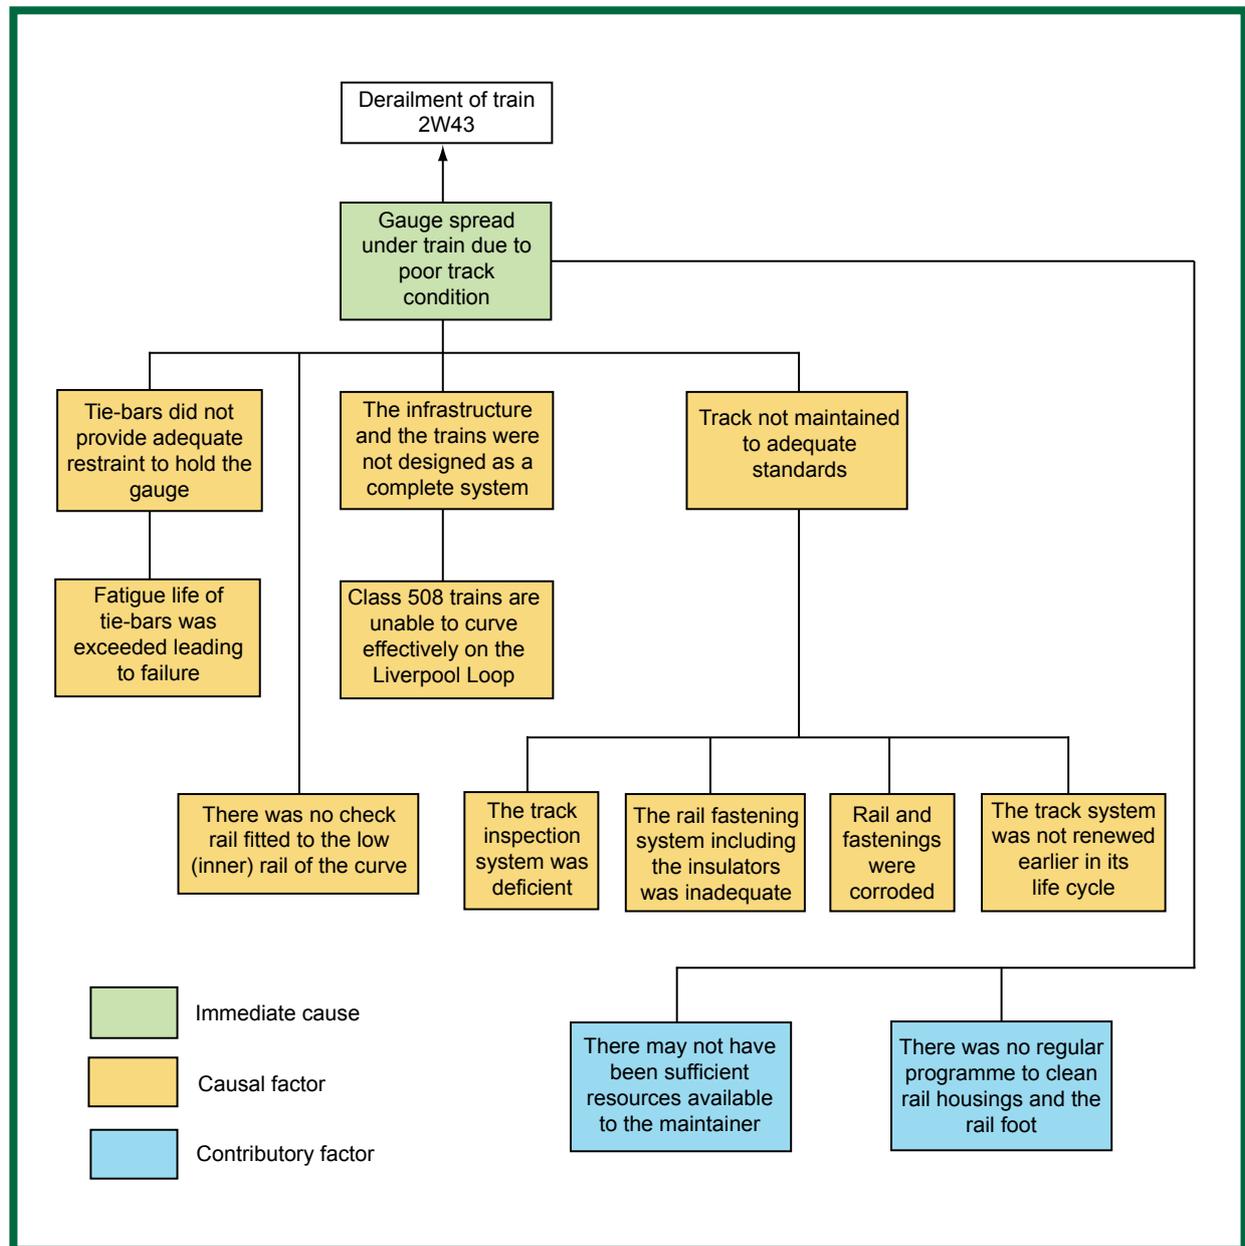
Figure 14: Causal analysis diagram

181 A diagram showing the immediate cause, causal factors and contributory factors is summarised in Figure 14.

- 185 The causal analysis diagram at Figure 14 showing the causal and contributory factors that led to the derailment has already been referred to.
- 186 Neither the handling of the train nor the signalling system contributed to the derailment.

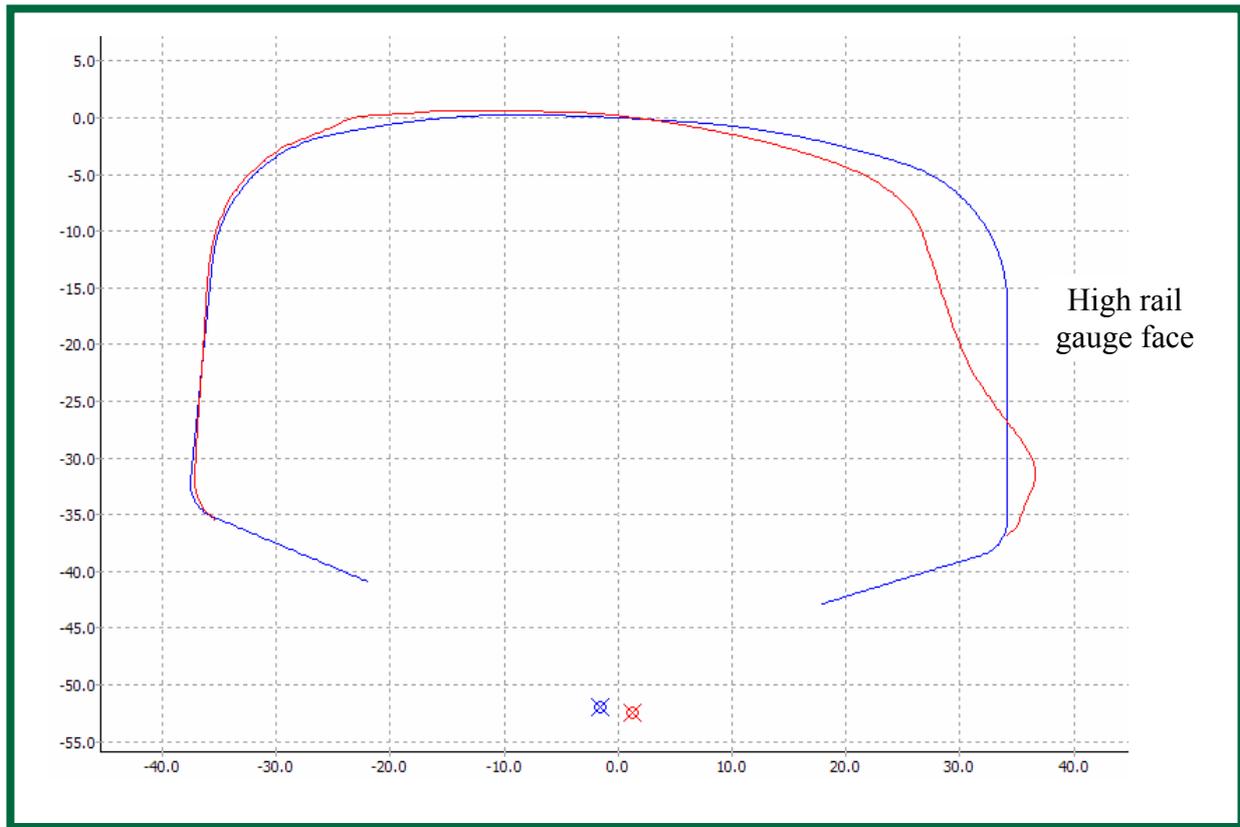
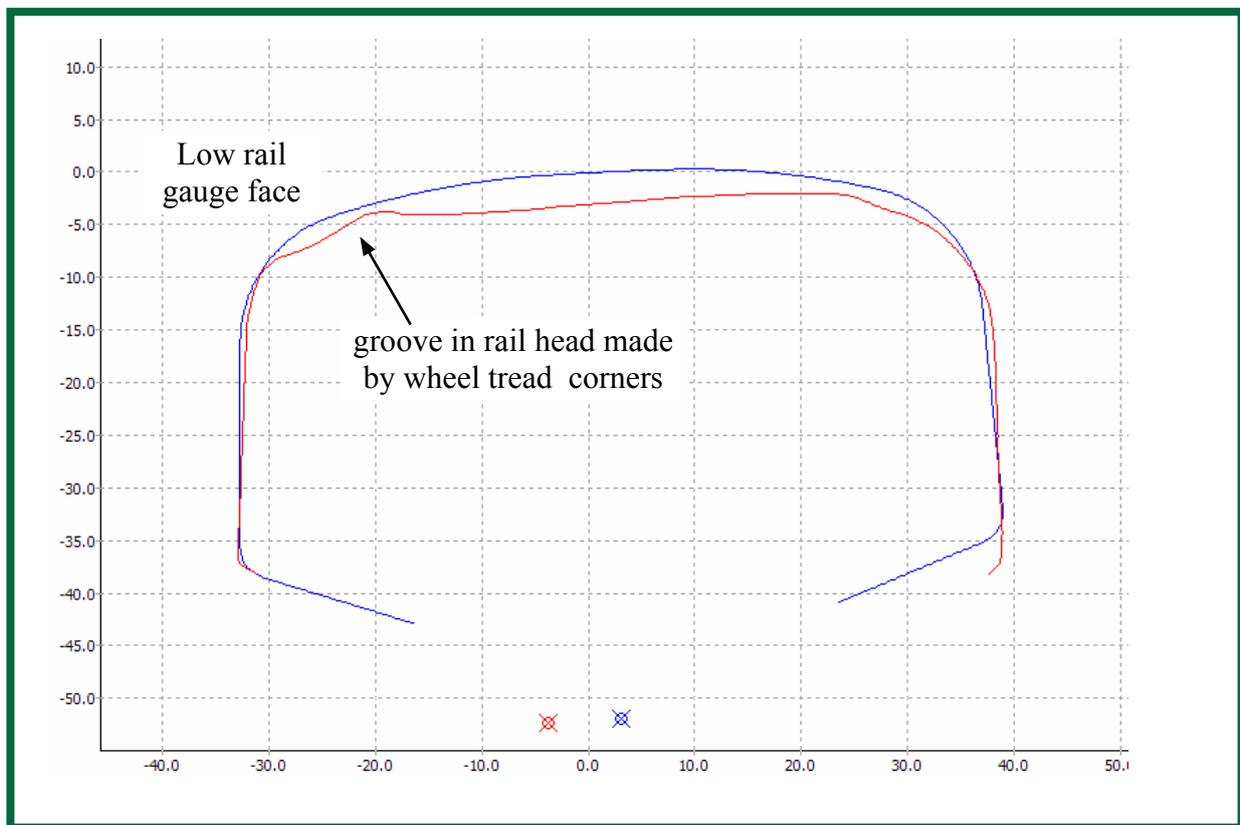
Note: the red outlines are the rail profiles as measured at the derailment site
