INTERSTATE AVIATION COMMITTEE

FINAL REPORT

| Aircraft type | Airplane, Boeing 737-505 |
| Registration | VP-BKO (Bermuda) |

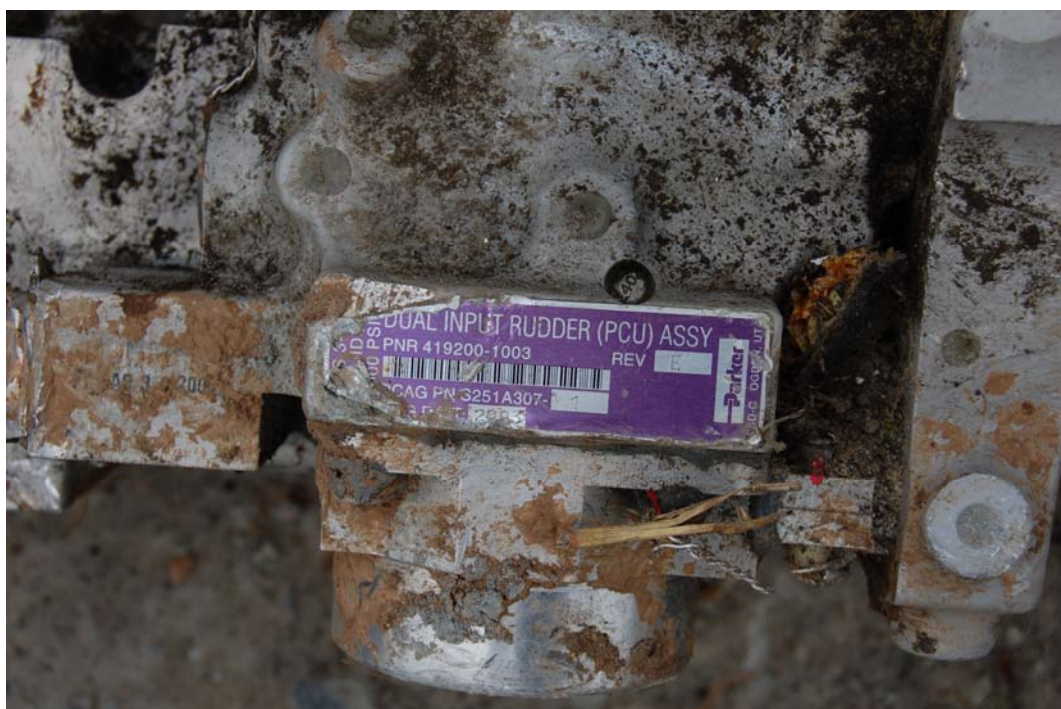
Main Rudder PCU

The actual operations of the aircraft by Aeroflot-Nord started on May 30, 2008. By that time its flight time was 43491 hours, 34619 flight cycles. Before that the aircraft had been operated in China. In 2005, within the framework of Rudder Control Improvement Program, in accordance with the AD 2002-20-07R1 FAA, the aircraft was fitted with a new main rudder PCU (see picture below).

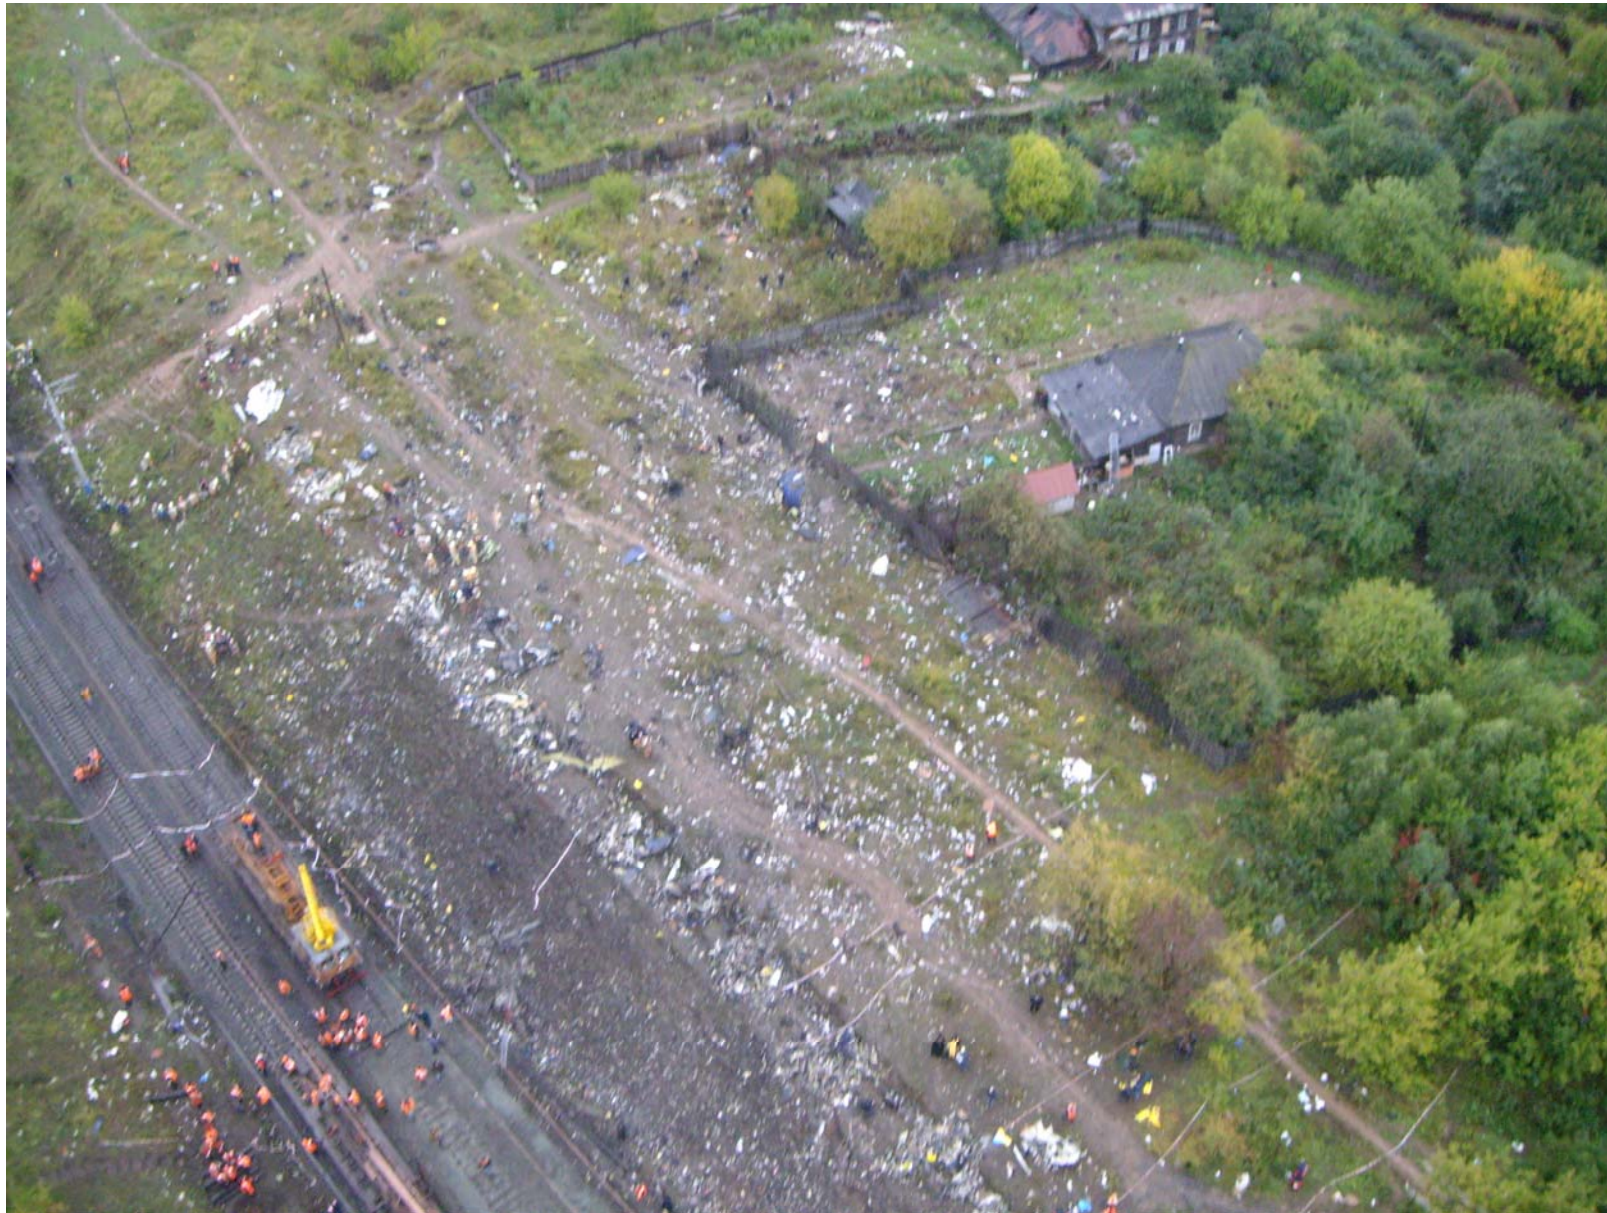
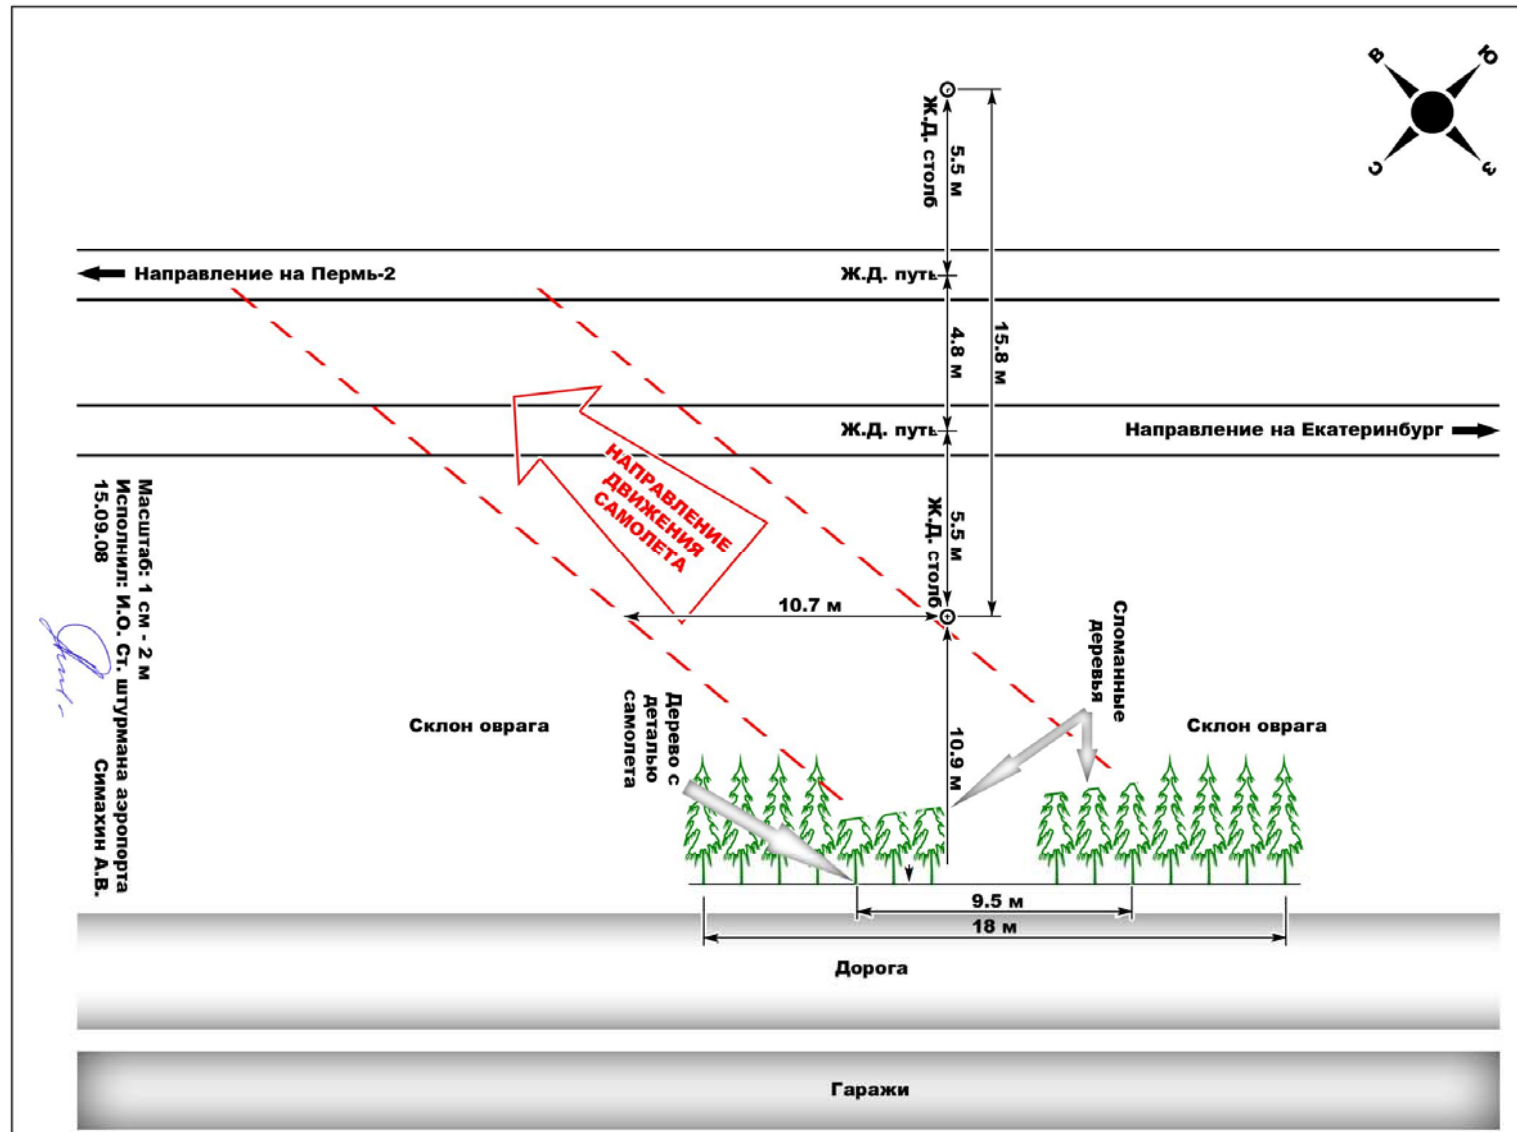
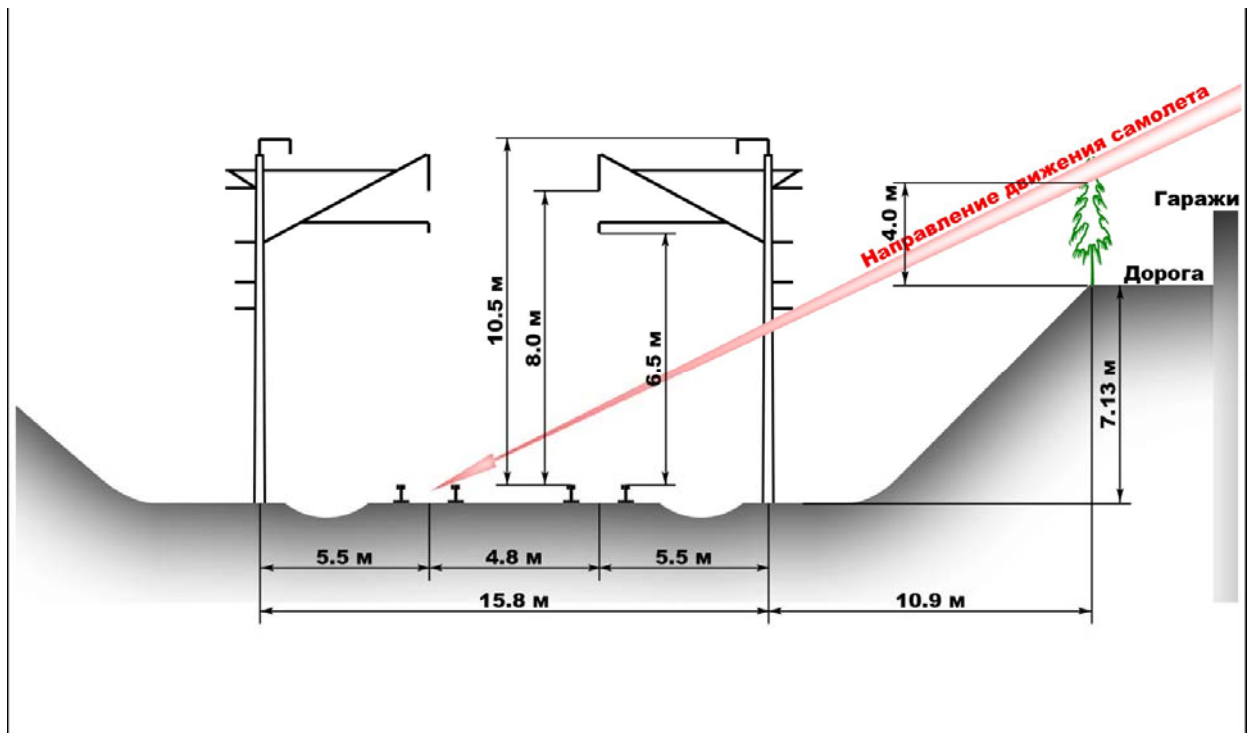
The aircraft was complete until the impact, judging by the absence of debris before the impact site along its track, and also by the closed outflow valve of the pressurization system.

As the tree tops were not burnt and there was no evidence of fire in the air, it can be concluded that the fire started on the ground from the spilt fuel.

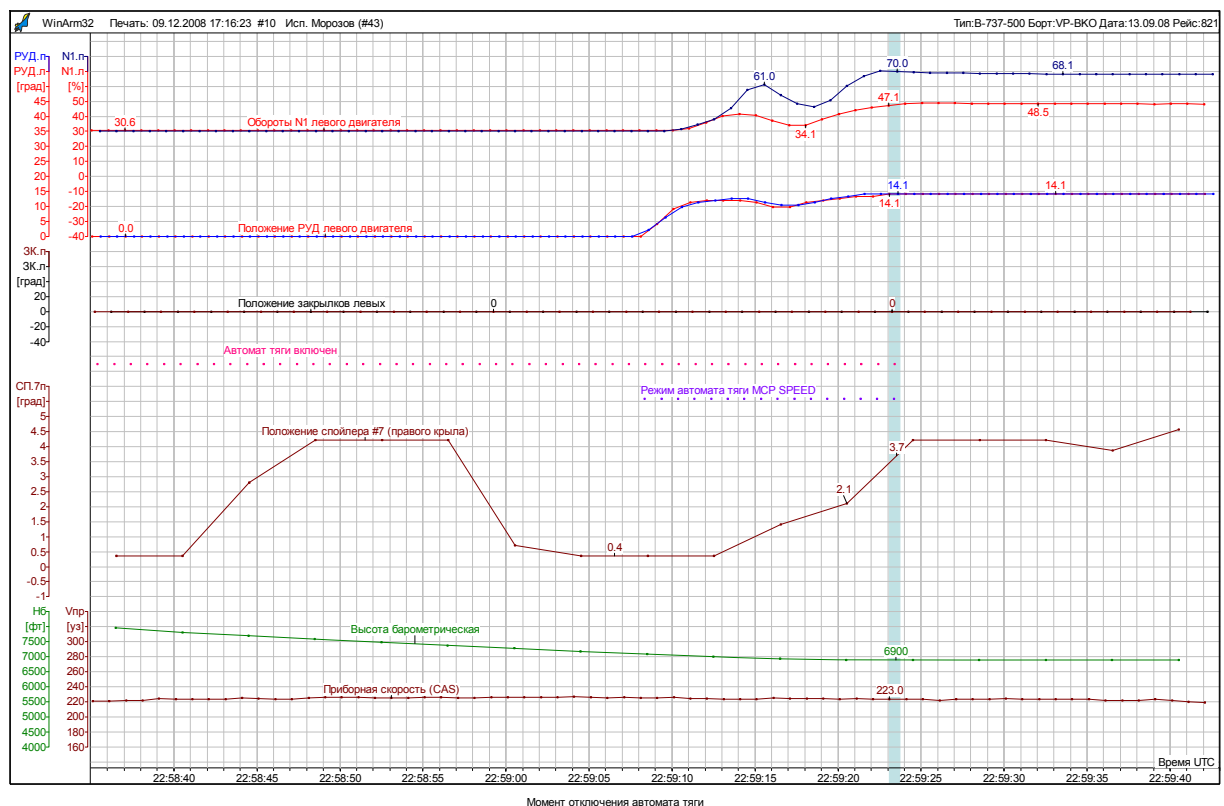
During cruise flight the autothrottle is controlled by the Cruise Split Monitor. The autothrottle is automatically disengaged if all of the following occurs simultaneously: flaps are less than 12.5°, the thrust split is more than 700 lb and any wing spoiler is extended more than 2.5°. These conditions were met at 22:59:23, when the autothrottle was disengaged automatically.

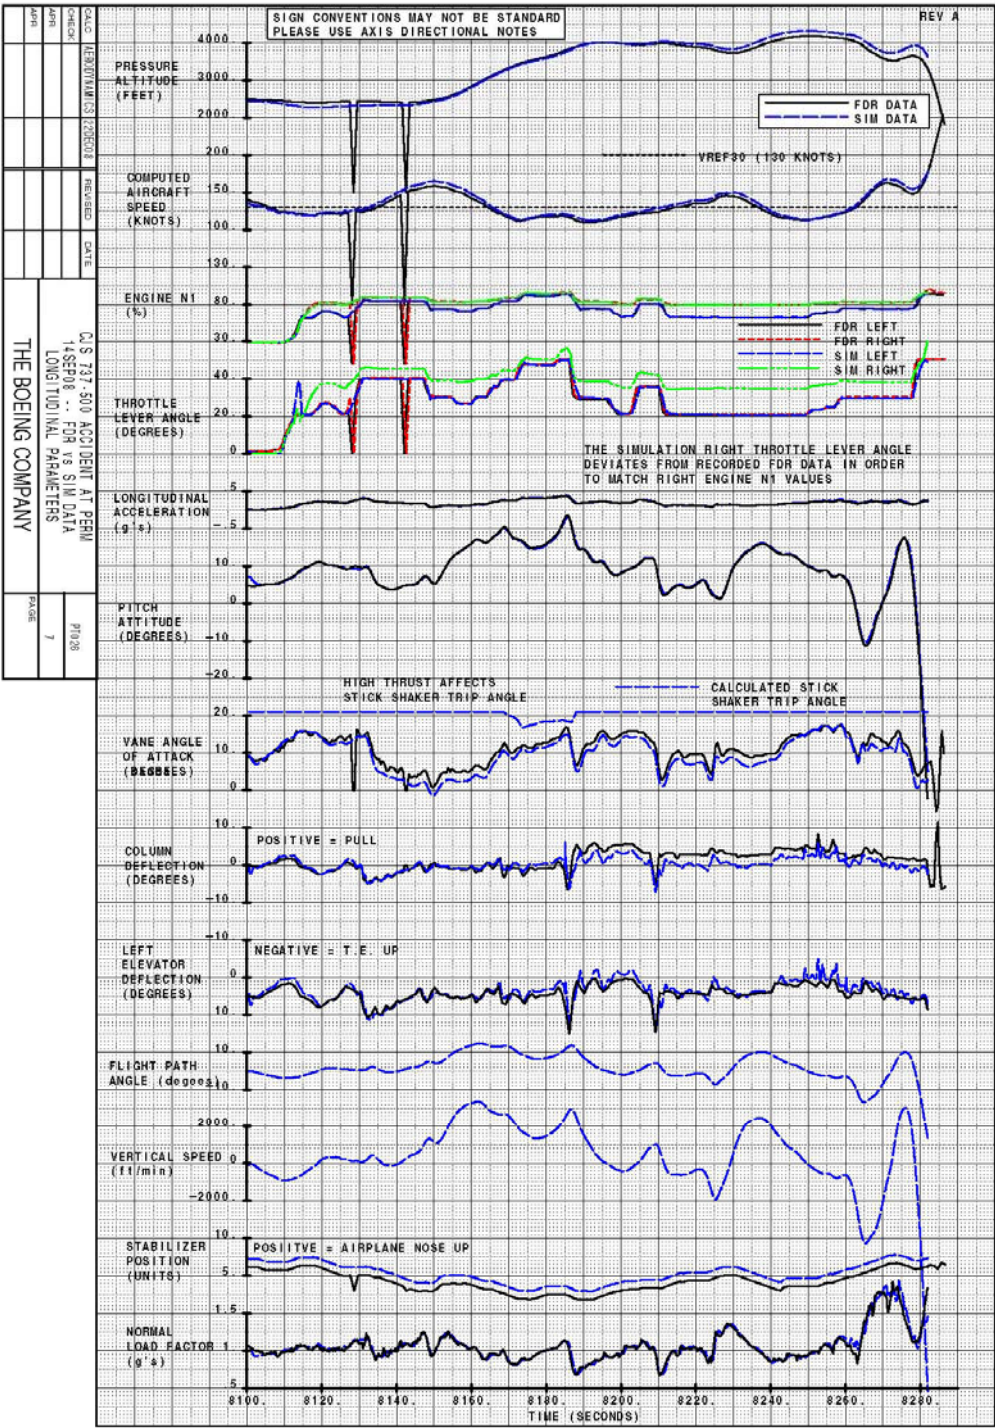
FDR and Simulation Pitch

- The stability and controllability characteristics in the accident flight matched the aircraft type characteristics;
- There was no indication of external forces (turbulence, windshear, etc.) that would affect the aircraft;
- As the IAS decreased, the thrust split required greater wheel to stabilize the aircraft position, however the required wheel was significantly lower than the available;
- During the upset situation no angles of attack were recorded that would exceed the stick shaker AOA.

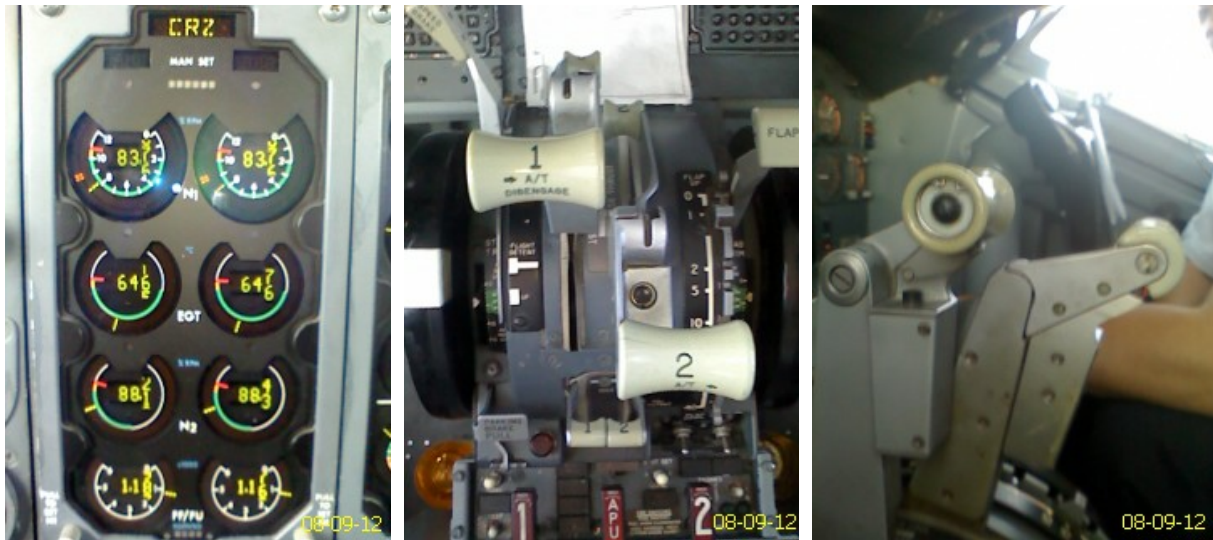
1.18.1. Photographs of the Actual Throttle Stagger in Flight

The investigation group received the following photographs taken by the crew who had performed one of the flights preceding the accident flight on the same aircraft on September 12, 2008. The photos were taken during cruise flight, with the autothrottle engaged.

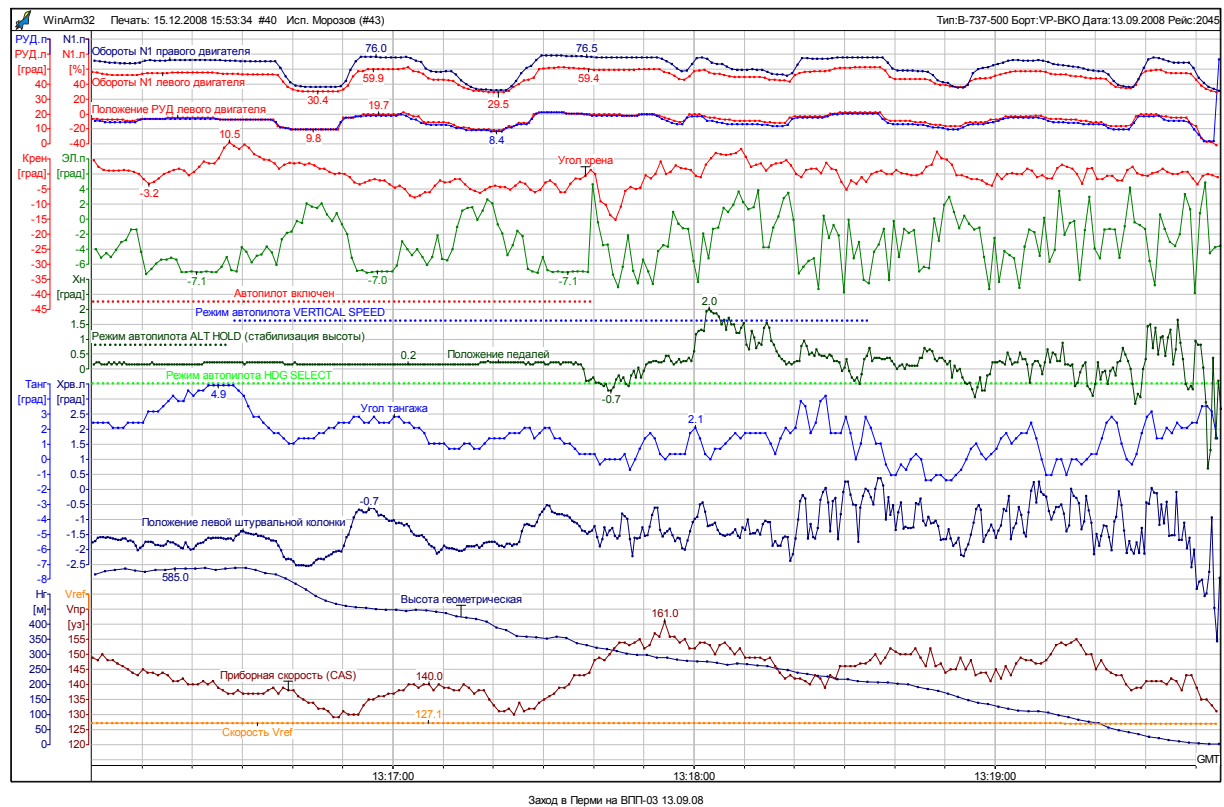
A selective analysis of a number of flights performed by other crews (the plot below shows the approach to RWY 03 at Perm Airport, executed a day before the accident, on September 13, 2008) showed that they did not try to match the N1 or use the rudder to trim the asymmetric thrust (some pilots used the rudder to compensate significant yaw moment).

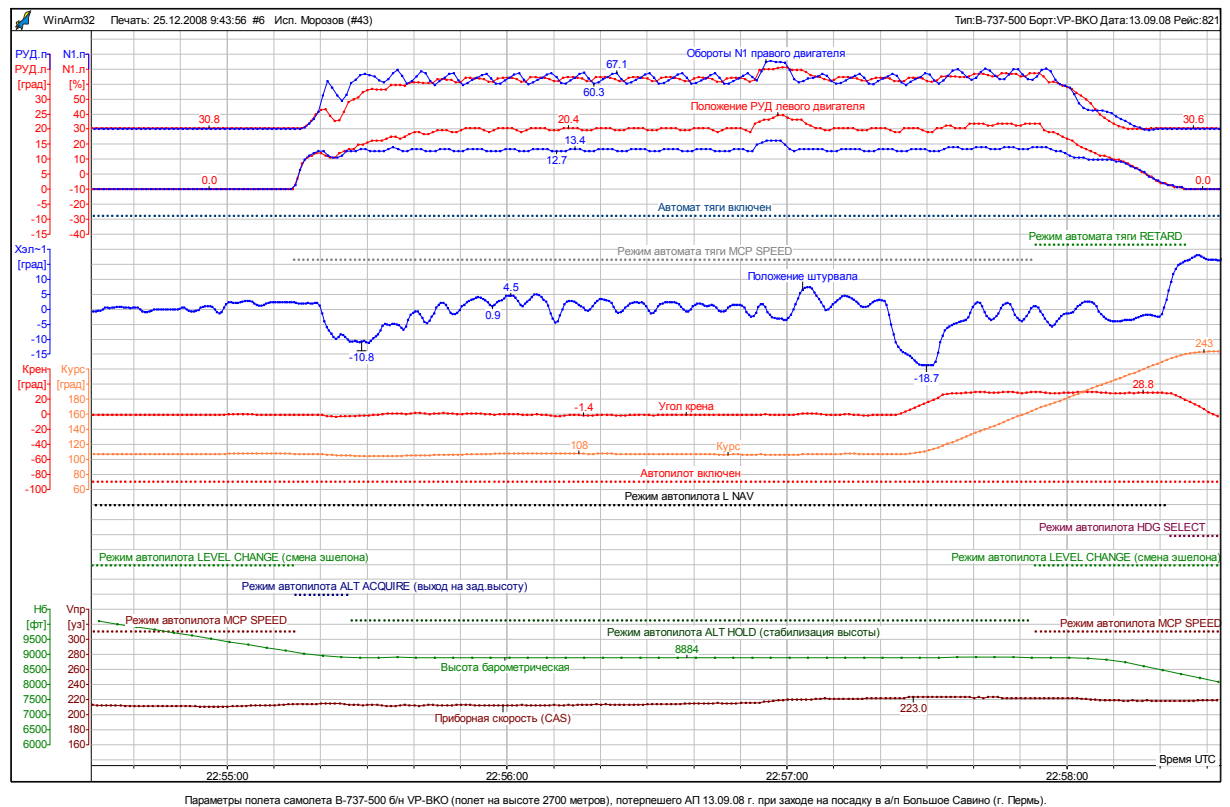
The aircraft continued descent. At 10000 ft the crew did not check the altimeters or cabin pressure. They reached 2700 m (~8900 ft) at 22:55:25 (see chart below) and the Co-pilot reported it to the Controller at 22:55:54. The Controller instructed them to maintain 2700 m.

After reaching 2700 m, the longitudinal mode of the autopilot changed to ALT HLD. From that time until the top of descent to 2100 m at 22:58 there were sinusoidal oscillations of N1 (ranging within 6%), accompanied with control column deflection (ranging within 4°) and throttle deflection (range of 1°), which went unnoticed by the crew according to their communications. Such oscillations were caused by the operation of the autothrust that was "hunting" the N1 (provided the split was significant).

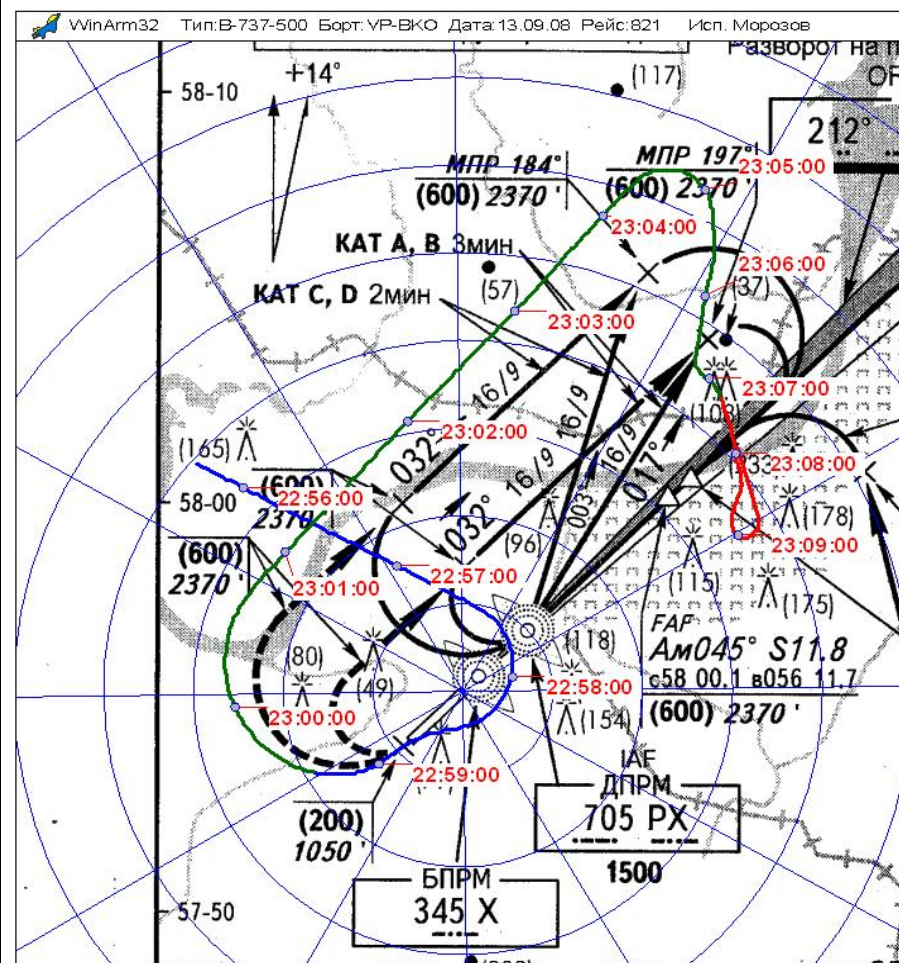
The aircraft was maintaining 2700 m. By that time the error in the FMC aircraft positioning was over 4.5 km. Such an error was caused by the natural drift of the IRS during the flight as well as the initial error made by the crew while entering the aircraft position during the alignment, and also by the inability to correct the positioning via the GPS or with the help of signals from nav aids which are not present along the flight route or at the destination airport. The crew should have observed the warning IRS NAV ONLY.

The chart below shows the actual flight path (left-hand chart), that goes approximately through the runway center and also the path that the crew saw on the navigation display (right-hand chart), that goes through the PX outer marker. The difference between the actual aircraft path and the one observed by the crew, taking into account the Controller's instruction to proceed via the marker, assumes that the crew did not use the ADF to monitor their position, nor did they tune the frequency of the outer marker.

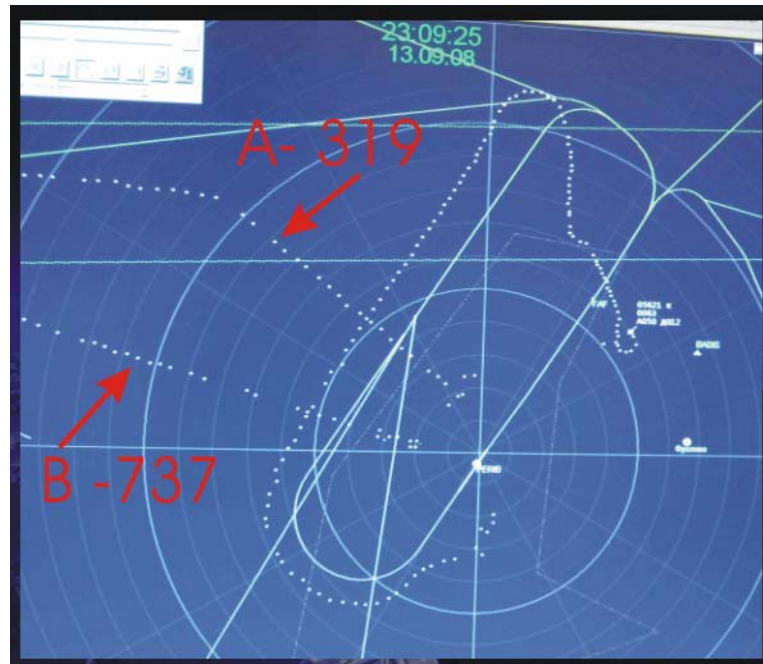
The Controller was monitoring the flight on the radar (see picture below). According to his written explanations, he did not inform the crew that the aircraft was not moving directly to the marker beacon and did not require the crew to change the course, as their flight path provided safer separation between the taking off A-319 and the Boeing 737. At 22:56:30 the A-319 and the Boeing 737 were at a minimum distance of 6 km from each other, and their altitudes were 1100 and 2700 m respectively.

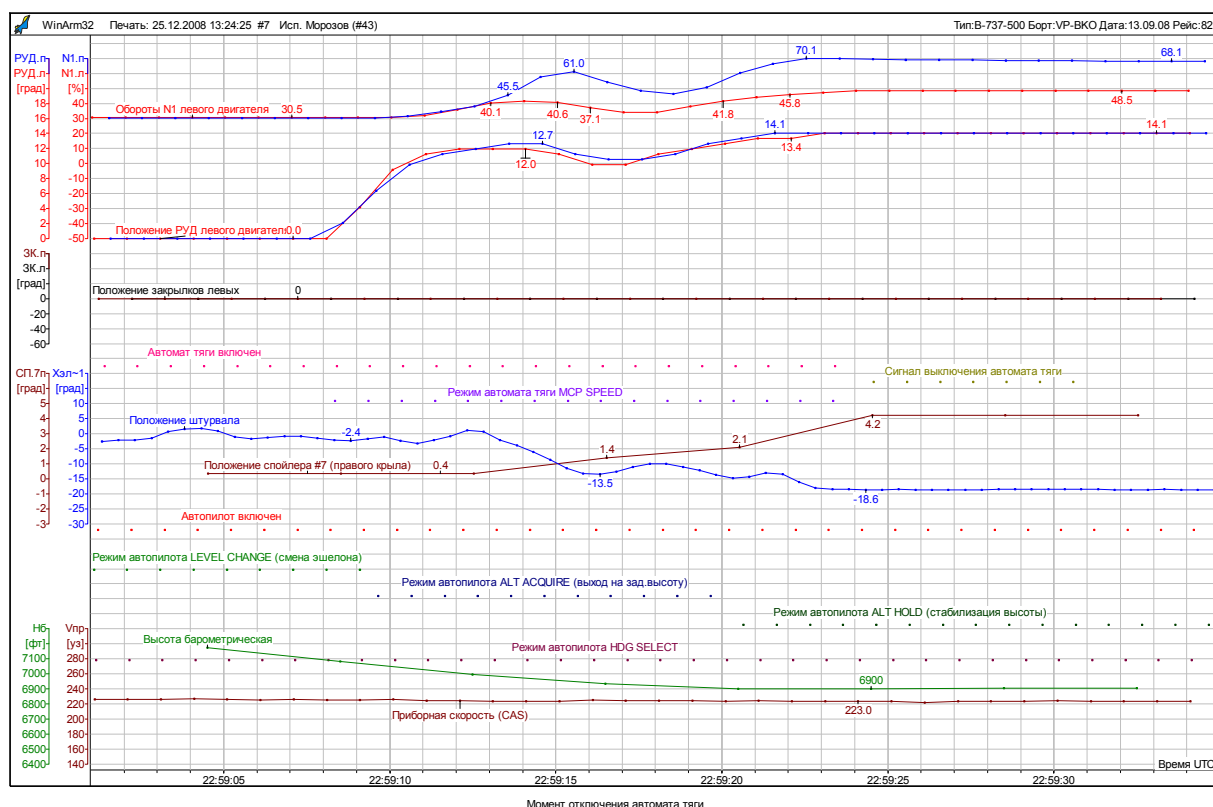
During the turn, while reaching 2100 m, the autothrottle was automatically disengaged. The analysis showed that the autothrottle disengagement was as per design⁴⁹, as the following conditions were met simultaneously at 22:59:23 (see the chart below): flaps less than 12.5°, thrust split more than 700 lb, and spoiler on any wing deflected more than 2.5°.

These conditions were caused by the following chain of events. The aircraft, being in the LVL CHG mode, was reaching the assigned flight level of 6900 ft (~2100 m). Laterally, HDG SEL mode was active, and the aircraft was turning with a bank of 20°. Both engines were operating at idle. This was set by the autothrottle before starting descent from 2700 m. According to the logics of the joint operation of the autopilot and the autothrottle, idle mode is maintained until LVL CHG is changed to ALT ACQ⁵⁰. After the autopilot mode was changed, the autothrottle switched to SPEED mode. To maintain the speed when reaching the assigned flight level, the autothrottle starts moving the throttles synchronically to increase thrust. When

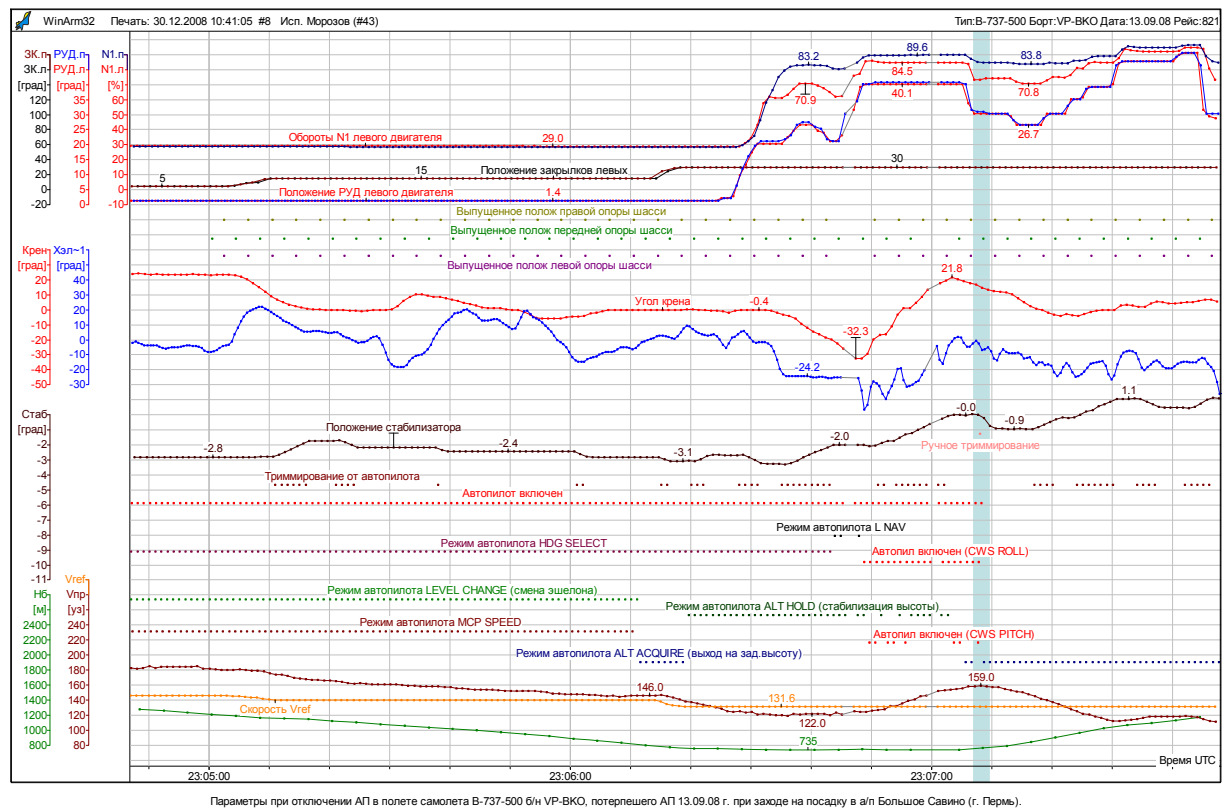
the increasing vertical acceleration created by the autopilot to enter level flight, and as the flaps were extended to 30, the airspeed started decreasing briefly. At 23:06:20 the autopilot pitch mode changed to ALT HOLD to maintain the altitude of 600 m.

At 23:06:22 the airspeed reached the Vref, which equaled 130 knots for the actual landing weight, and continued decreasing.

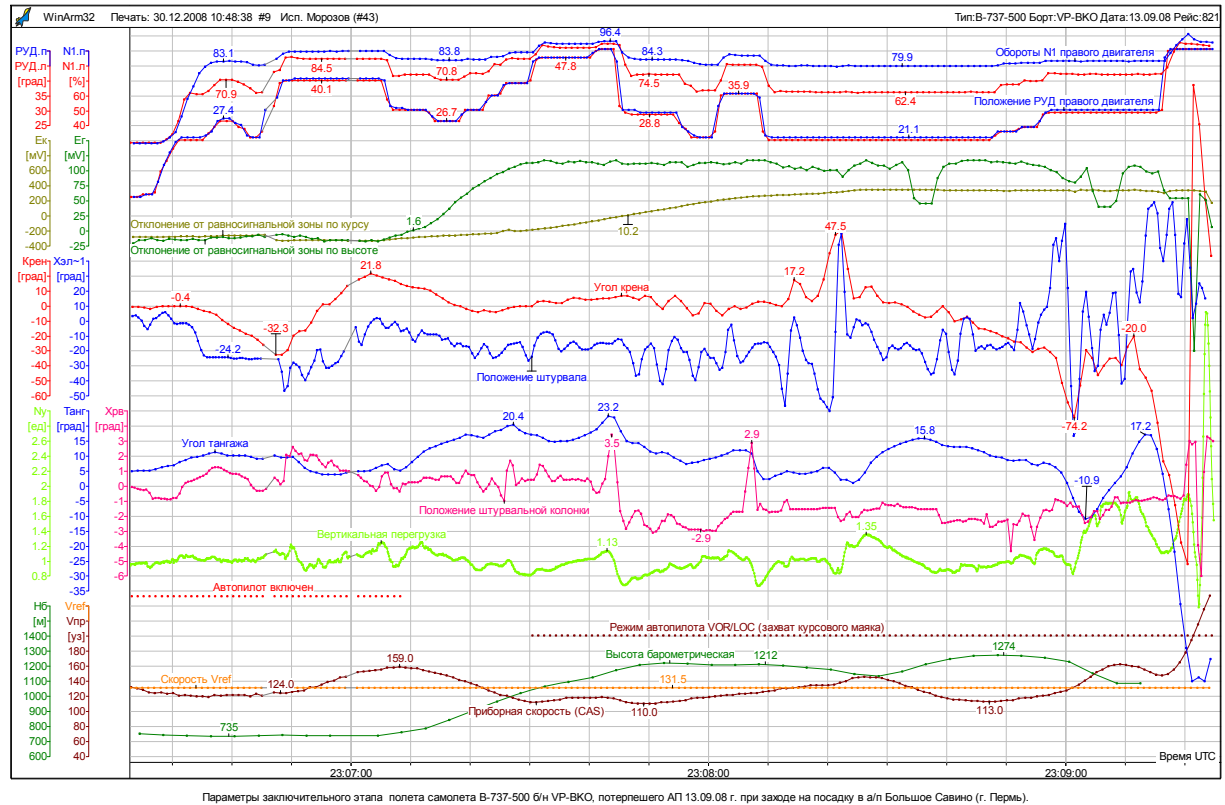
The chart below shows the aircraft flight parameters during the final portion of the flight, after the autopilot was disengaged. The FD's on both EADI's were active.

The Co-pilot noticed only the increase in speed, and he reduced the engine thrust (at 23:07:07) without monitoring the pitch.

As the Co-pilot did not try to compensate the noseup pitching moment and did not notice the increase in pitch (up to 20° by 23:07:27), the Co-pilot again allows the speed to drop to 110 knots (~200 km/h), which is 20 knots (~35 km/h) lower than the Vref.
