**SERIOUS INCIDENT**

| <b>Aircraft Type and Registration:</b> | ATR 72-202, EI-SLG | |
| <b>Location:</b> | Near Edinburgh Airport | |

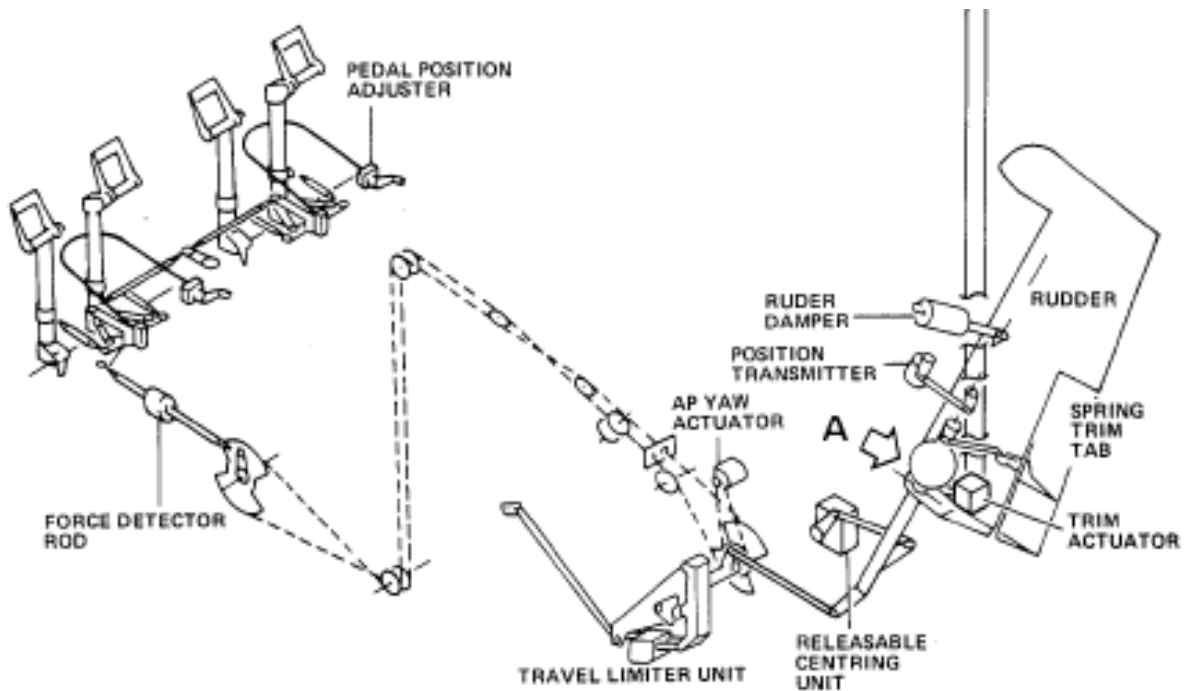
**Figure 1**

ATR 72 Rudder control system

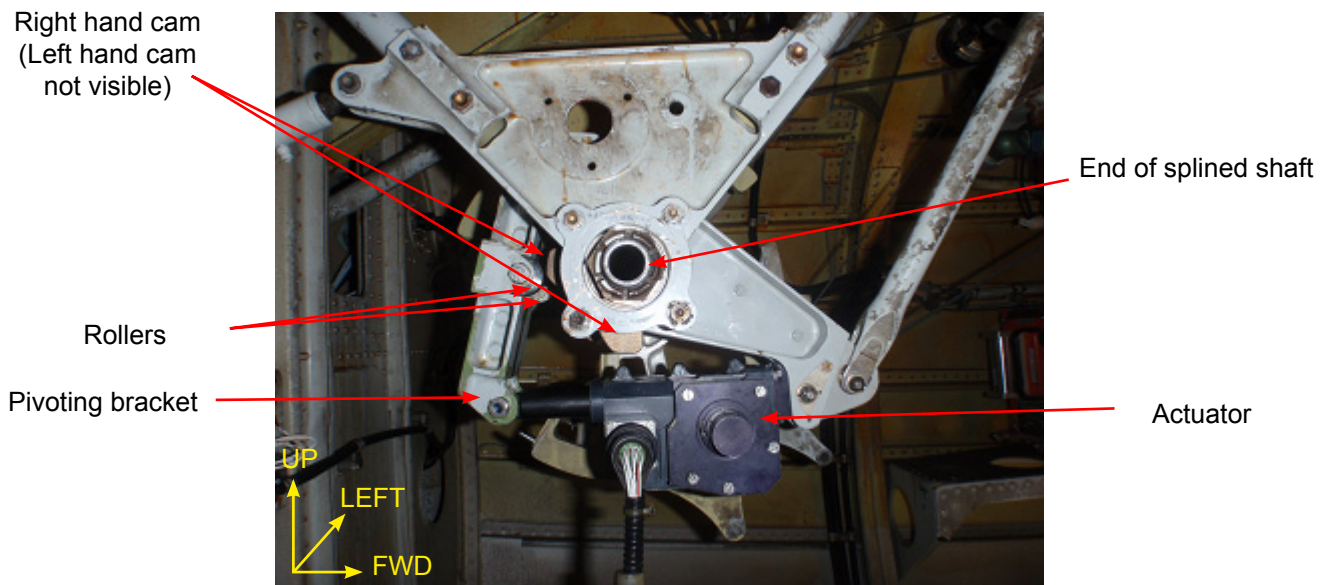
**Figure 2**

Rudder Travel Limitation Unit

engaging in the vee groove of the cams and caused an uncommanded rudder input and corresponding rudder deflection.

When the AMM operational test was performed with the right hand cam incorrectly installed, rudder pedal travel was found to be restricted in an asymmetric sense. A FLT CTL fault light was generated only if the PTT button was depressed for a minimum of 25 seconds. The AMM task does not state how long the test button should be depressed.

It is recommended that ATR amends the Aircraft Maintenance Manual task '*Operational Test of the Rudder Travel Limitation Unit*' to state that: (1) the test should be carried out for a minimum of 30 seconds and (2) should an asymmetric restriction of the rudder pedals be detected or if the FLT CTL light illuminates, further inspection of the TLU system should be conducted.
