ACCIDENT

Aircraft Type and Registration:	Cessna 525A Citation CJ2+, N380CR	
No & Type of Engines:	2 Williams FJ44-3A-24 turbofan engines	
Year of Manufacture:	2010 (Serial no: 525A0465)	
Date & Time (UTC):	31 December 2013 at 1100 hrs	
Location:	5.7 nm north-west of Coventry, Warwickshire	
Type of Flight:	Private	
Persons on Board:	Crew - 1	Passengers - 1
Injuries:	Crew - None	Passengers - None
Nature of Damage:	Structural damage to left and right wings, broken HF antenna, dent to fin leading edge	
Commander's Licence:	FAA Private Pilot's Licence	
Commander's Age:	69 years	
Commander's Flying Experience:	3,900 hours (of which 600 were on type) Last 90 days - 16 hours Last 28 days - 5 hours	
Information Source:	AAIB Field Investigation

Synopsis

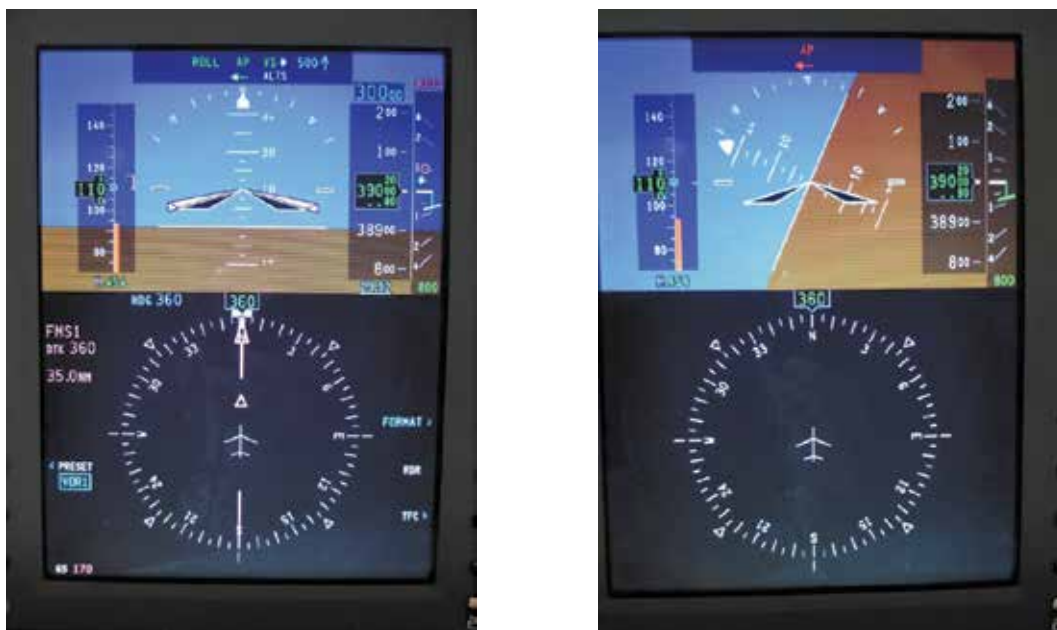
Figure 6

Nominal PFD (left) and PFD declutter mode after roll attitude greater than 60 degrees (right)
Picture courtesy of Rockwell Collins

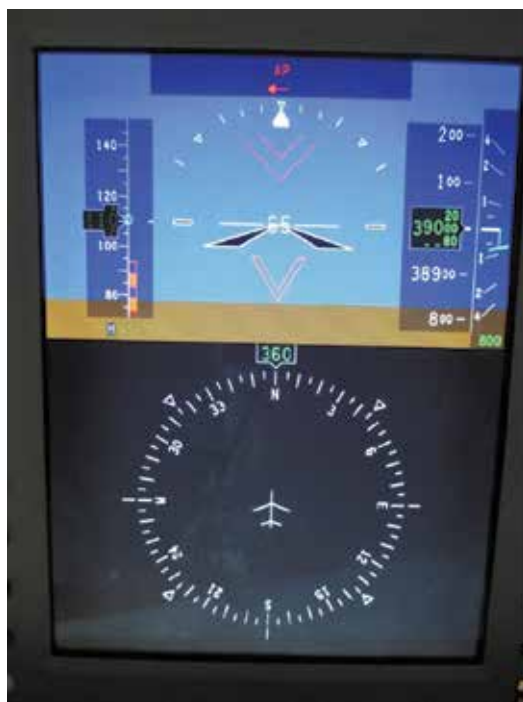
Figure 7

PFD declutter mode at a pitch attitude of +65°
Picture courtesy of Rockwell Collins
