Report of the Chief Inspector of Marine Accidents
into the failure of the Lifeboat
Launching Equipment on mv NORSEA
on 5 February 1992
With the loss of 2 lives

Marine Accident Investigation Branch
5/7 Brunswick Place
SOUTHAMPTON
Hants SO1 2AN

1. SUMMARY

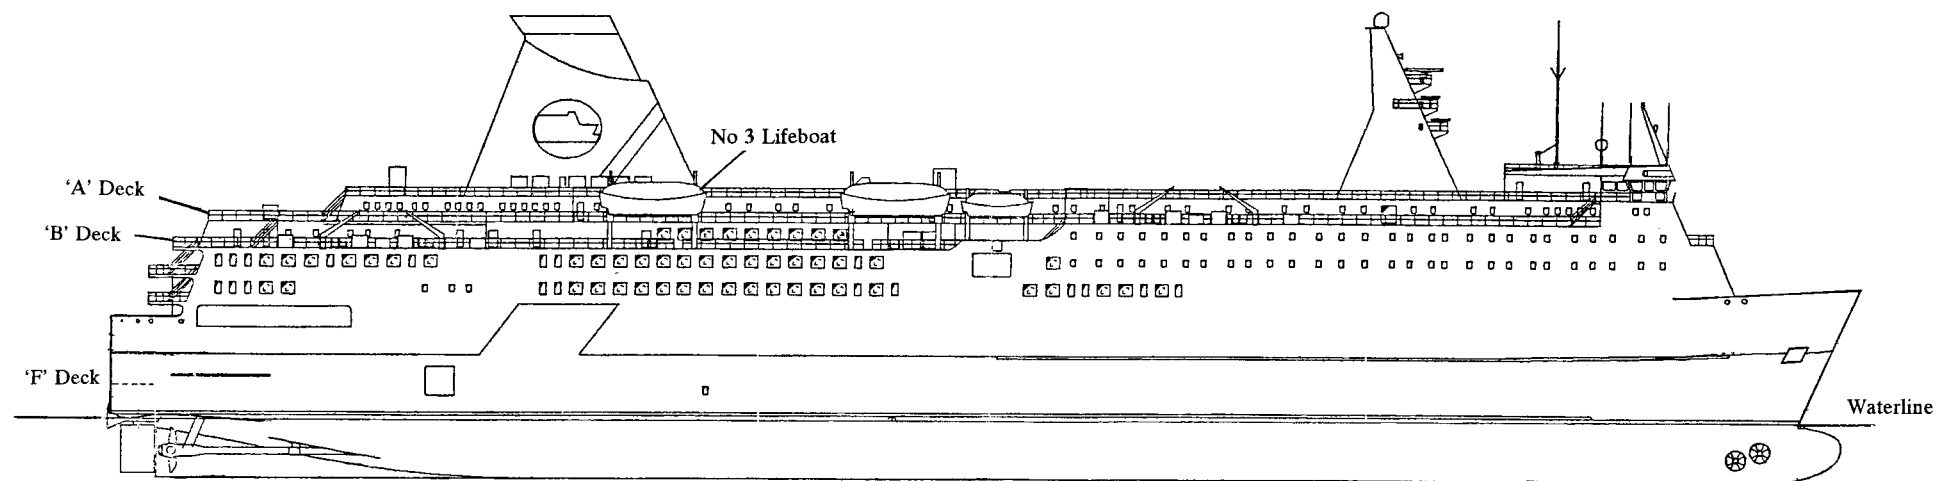
Diagram of Passenger Ferry NORSEA

The lifeboats and rescue/lifeboats are stowed in their respective davits at A Deck level and embarkation takes place on the next deck down at B Deck, (see figure 1). The six boats are identified by Nos 1 to 6. Even numbered boats are positioned on the port side with odd numbered boats on the starboard side. The two most forward port and starboard boats are the rescue/lifeboats.

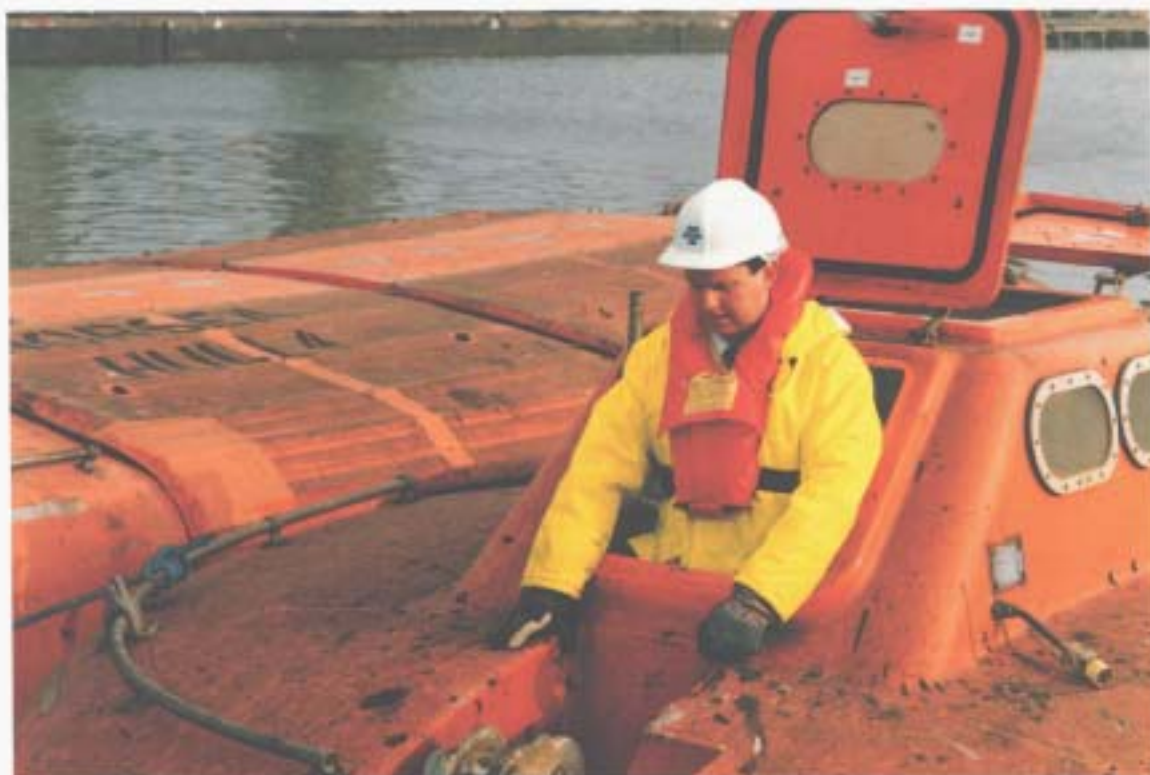
Aft end of Lifeboat showing hatch

The canopies at the forward and aft ends are fixed, while the central area of the lifeboat is covered by a folding canopy which has entrances at both ends and one each side. A hatch is fitted in the fixed canopy forward to enable handling of the hook. The aft fixed canopy incorporates a closed steering tower for the helmsman which has a hatch to enable handling of the aft hook. These hatches can be opened and closed from inside and outside, (see figure 2). The lifeboats are not self-righting.

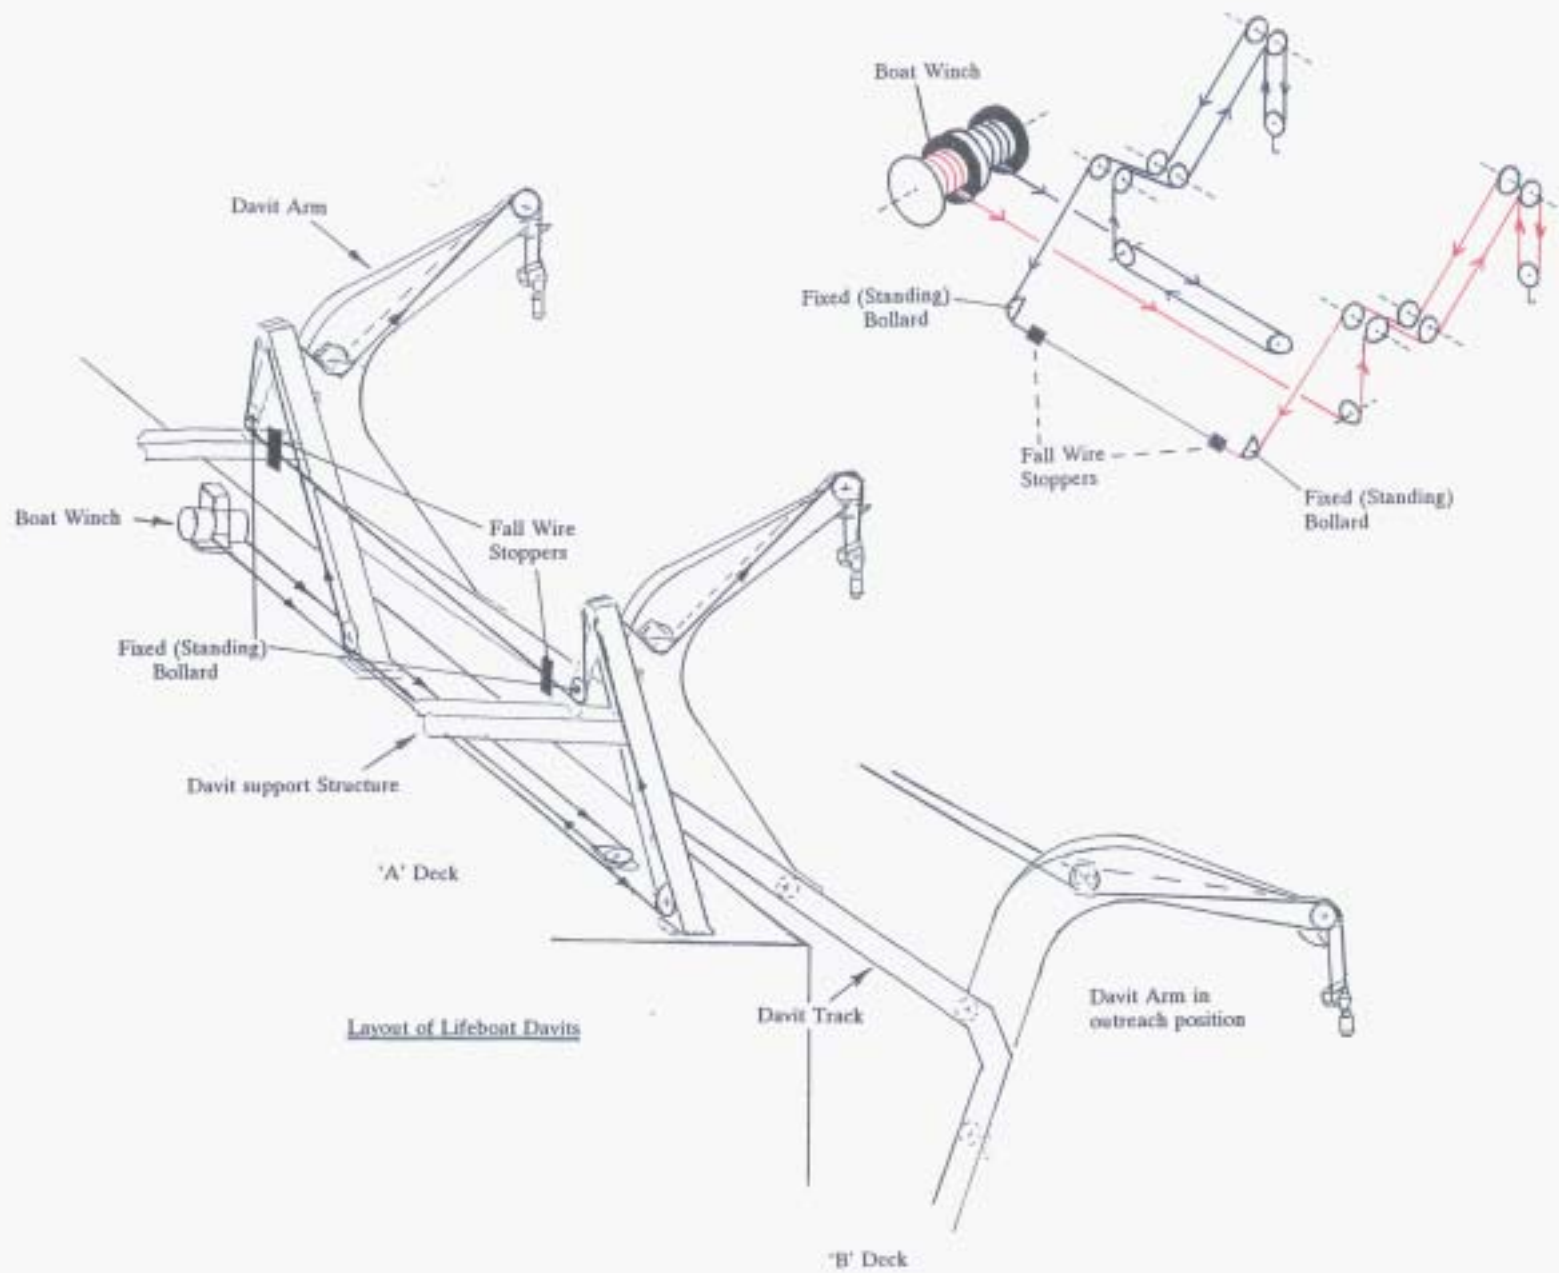
The fall wire consists of a single steel wire which is rigged through davit sheaves, two fixed bollards and the lower blocks with each of its two ends wound around the two drums of the davit winch, which is rigidly connected to the ship. The function of the fall wire is to support and control the davit arm in the trackway and to suspend the lifeboat during its embarkation and launch. Such a falls system is known as 'continuous wire falls' (see figure 3).
