MARINE SALVAGE

SEA EMPRESS
General Arrangement and Tank Layout

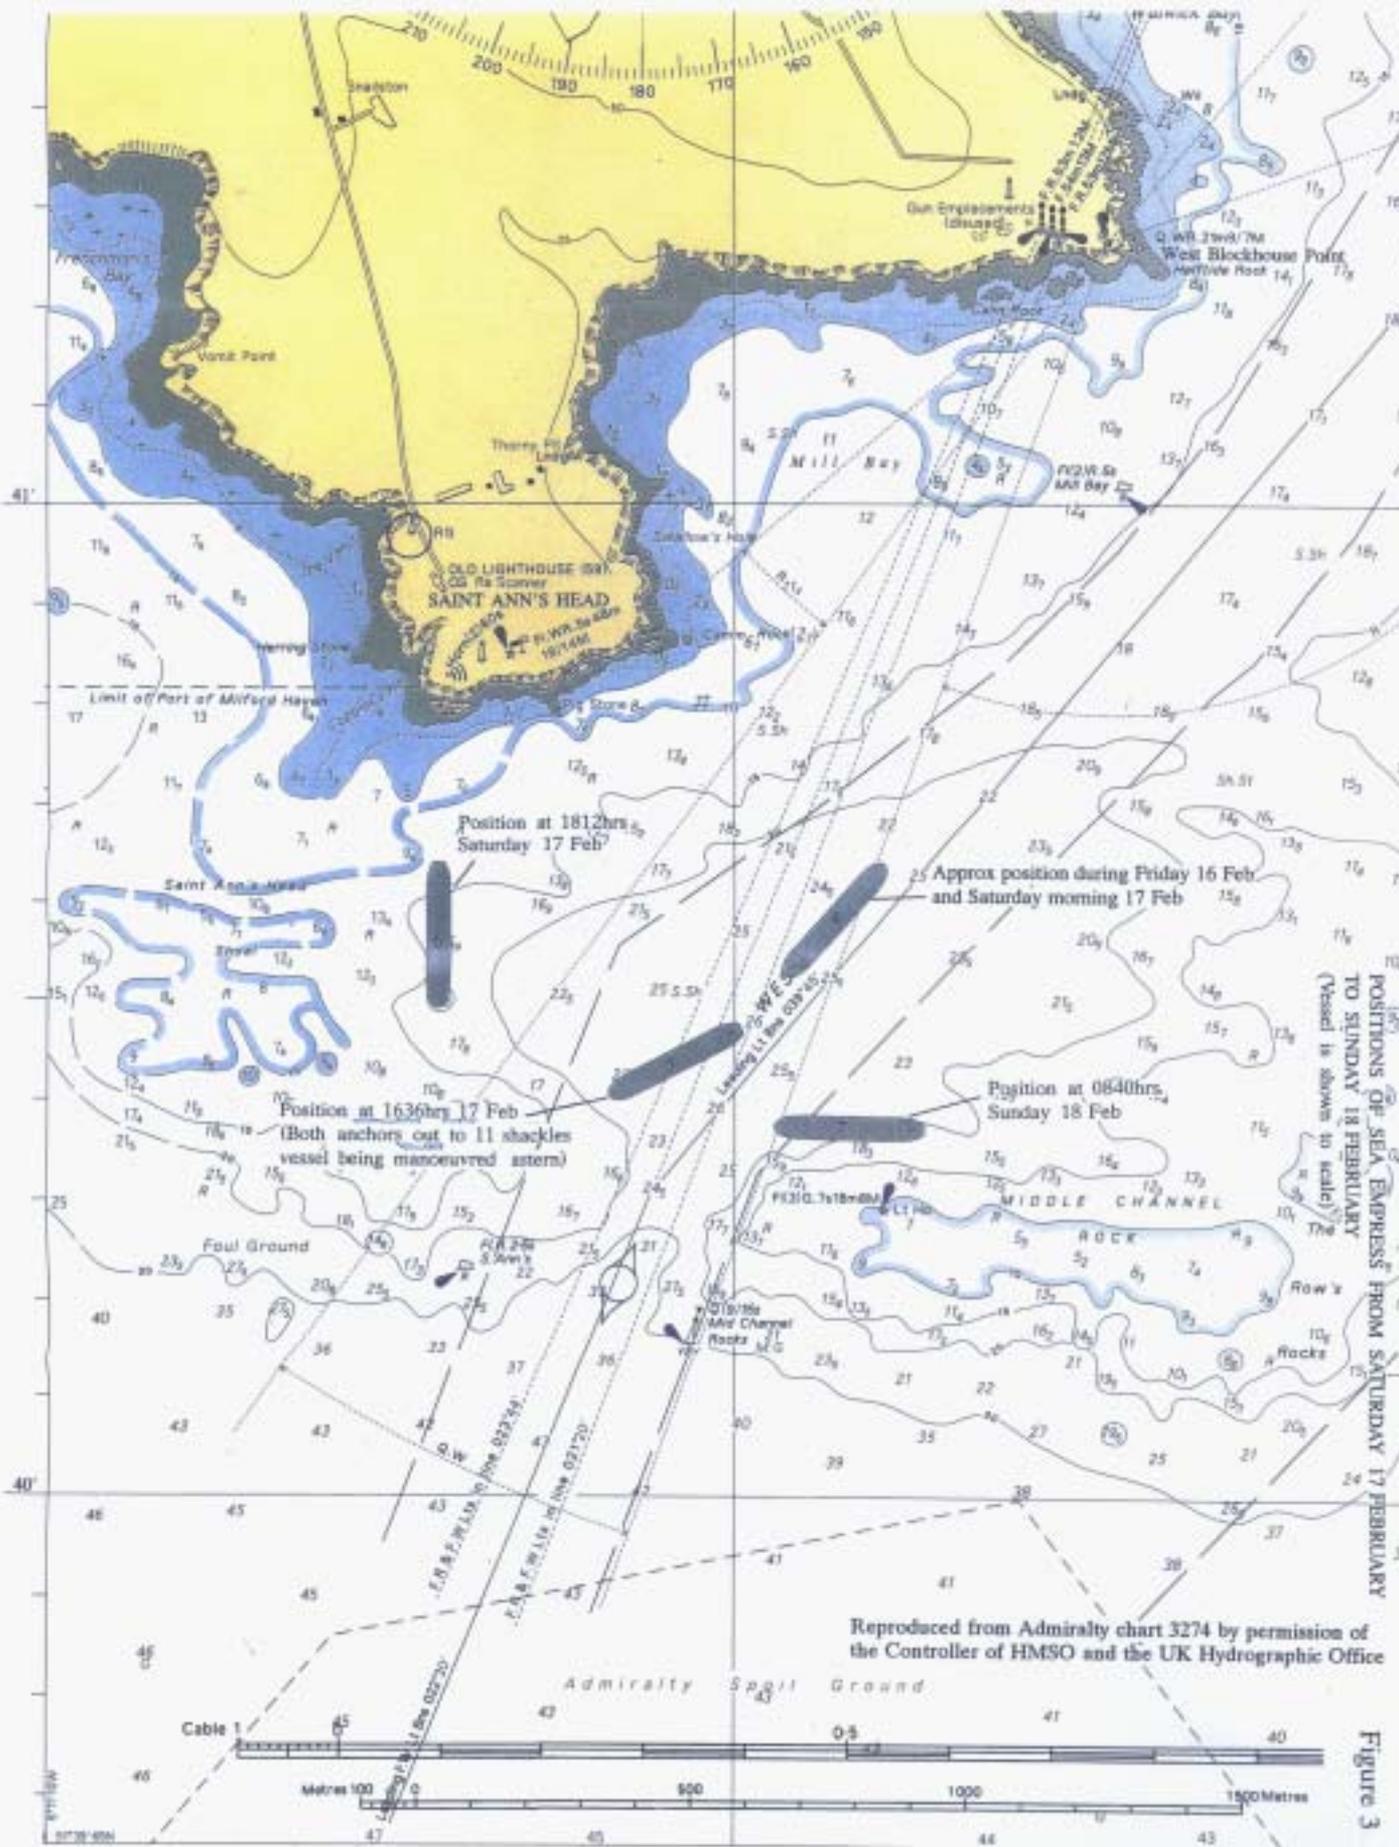
Figure 3

D.2.28 The Smit Tak salvage crew under the Salvage Master's instructions released the bitter ends of the anchor cables at 1812 hrs. However, with the anchor cables slipped, the casualty did not behave as had been predicted and the tugs were unable to refloat her. The casualty was fast aground with the stern about 2.5 cables southwest of Saint Ann's Head Lighthouse on a falling tide (see Figure 3).

- D.3.17 Throughout the period up to predicted high water at 0530 hrs and for about three hours after, ANGLIAN DUKE (100 tbp) and ANGLIAN EARL (84 tbp) maintained station without undue incident. At about the time of the half tide at 0820 hrs the Master of ANGLIAN DUKE (100 tbp) noticed that SEA EMPRESS was moving and it became apparent that she was being carried easterly across the 'pool' but the tugs were unable to hold her. In an attempt to control the movement ANGLIAN EARL (84 tbp) parted her tow line which had snagged on the bottom and ANGLIAN DUKE (100 tbp) alone tried to keep the stern of the casualty away from the Middle Channel Rocks Light. However at about 0840 hrs she grounded to the north of the Light and ANGLIAN DUKE (100 tbp) had to slip her tow because she herself was manoeuvring too close to the rocks and in danger of grounding (see Figure 3).

POSITIONS OF SEA EMPRESS FROM SATURDAY 17 FEBRUARY TO SUNDAY 18 FEBRUARY (Vessel is shown to scale)

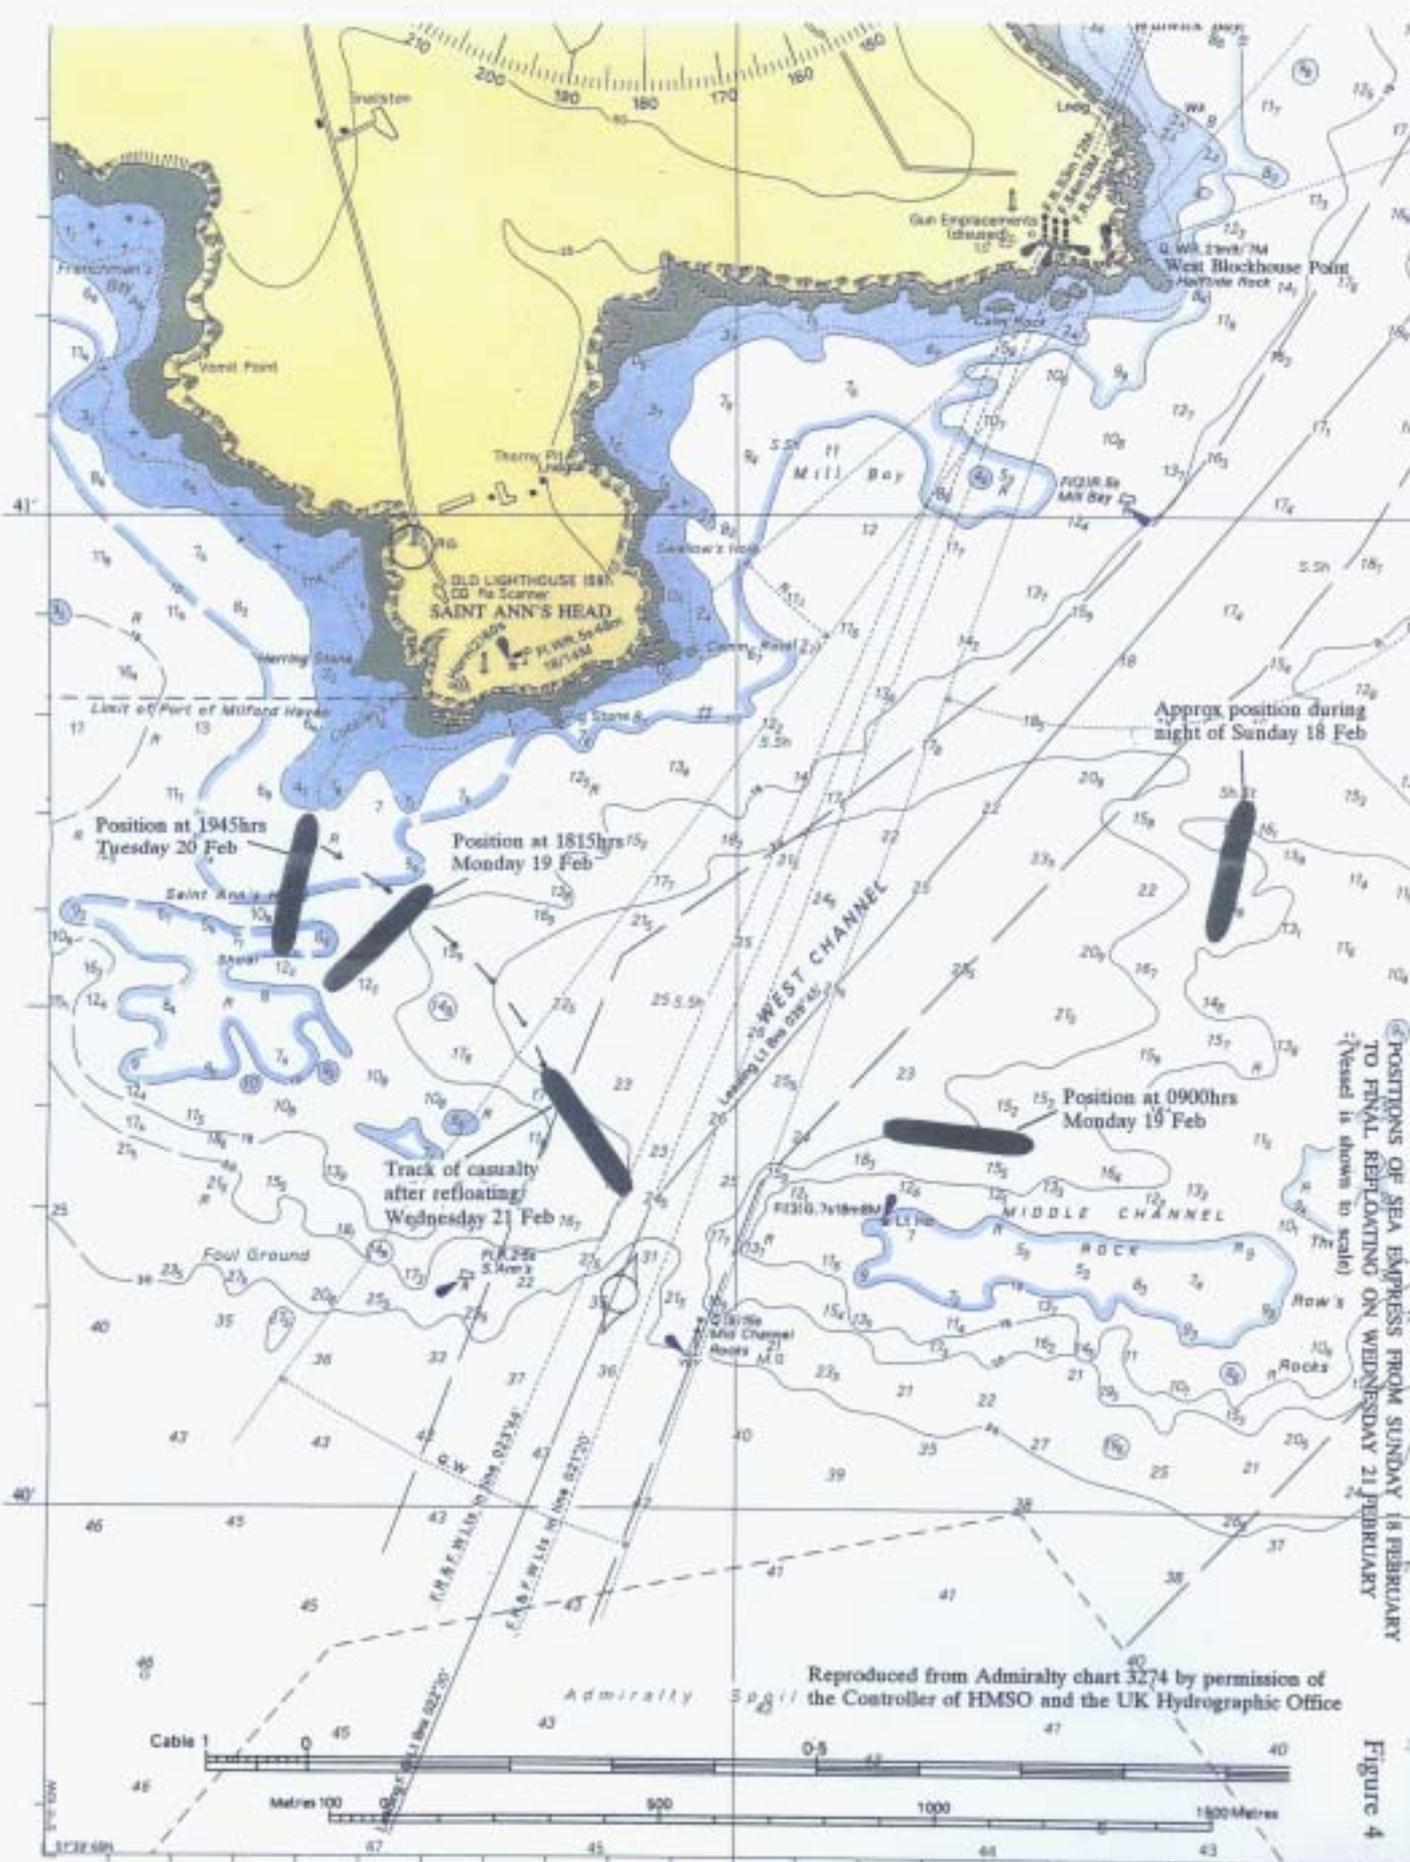
Figure 4

- D.4.13 Subsequently ANGLIAN DUKE (100 tbp) was instructed to assist DE YUE (200 tbp) and she made fast with one of her mooring ropes to the port bow of DE YUE (200 tbp) but at about 1700 hrs this mooring line parted. ANGLIAN DUKE (100 tbp) was then repositioned to push on the starboard bow of DE YUE (200 tbp), however in the swell conditions both tugs began to sustain damage and this operation was quickly aborted. At about this time ANGLIAN EARL (84 tbp) made fast on the port bow of the casualty after which the salvors had to leave the casualty as the helicopter (R169) had to return to its base at Chivenor. The casualty at this time was aground about 6 cables northeast of Middle Channel Rocks Light (see Figure 4).

- D.4.22 ANGLIAN DUKE (100 tbp) and ANGLIAN EARL (84 tbp) remained connected to SEA EMPRESS with instructions from the Senior Salvage Master, to hold the casualty on the east side of the 'pool'. At about 0600 hrs, immediately prior to the time of the predicted high water, the Masters of ANGLIAN DUKE (100 tbp) and ANGLIAN EARL (84 tbp) observed that the casualty was again moving. The stern was beginning to swing to starboard towards the Middle Channel Rocks Light. Despite the efforts of the tugs to control the casualty, at about 0900 hrs SEA EMPRESS ran aground again on an easterly heading, to the north of the Middle Channel Rocks Light (see Figure 4). The two tugs remained connected to the casualty laying to their tow lines.

- D.5.19 By the time the 1630 hrs Marine Team meeting was reconvened SEA EMPRESS was once again aground. Under the influence of the tidal stream she had been swept aground at 1815 hrs and she lay, heading 040°, 3.3 cables south-southwest of Saint Ann's Head (see Figure 4). On this occasion the casualty had grounded at the top of high water and in effect the situation had therefore been stabilised by default, albeit in a very exposed location.

D.6.12 Again the casualty grounded, probably over the greater part of her length (see Figure 4). There were creaking sounds from low down in the area of amidships and it was decided to evacuate her for the night. Prior to departure the salvors depressurised the cargo tanks in order to reduce the buoyancy in the hull. The tugs which had been pushing were dismissed but ANGLIAN DUKE (100 tbp), ANGLIAN EARL (84 tbp) and VIKINGBANK (62 tbp) remained made fast to the bow of SEA EMPRESS by their tow lines, though they extended the length of them and also anchored. Plans were then made to obtain more salvage equipment for the following day's operations.

casualty began to float and at 1915 hrs she was towed into the channel at an observed mean draught of 11.95 metres (see Figure 4).

POSITIONS OF SEA EXPRESS FROM SUNDAY 18 FEBRUARY TO FINAL REFLOATING ON WEDNESDAY 21 FEBRUARY (Vessel is shown to scale)

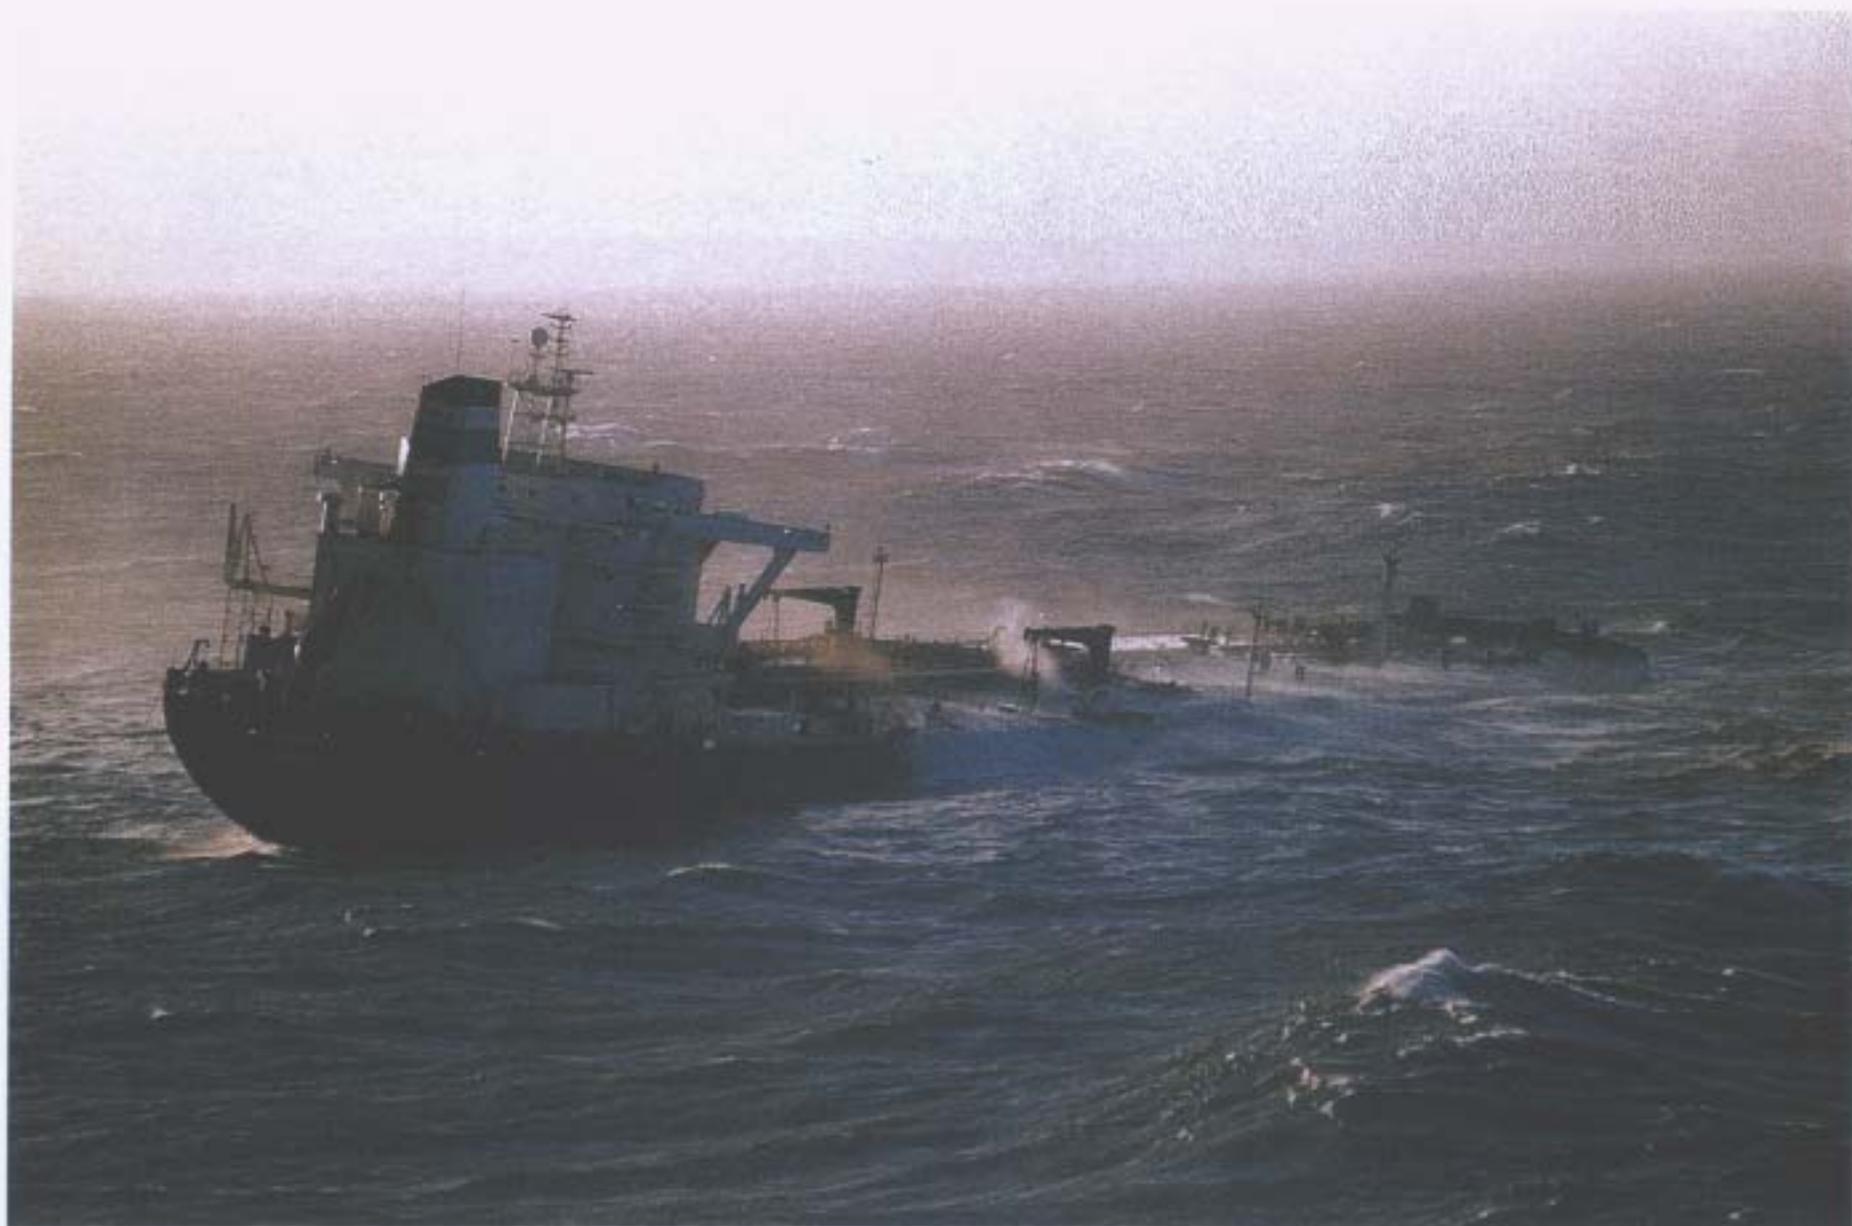
SEA EMPRESS on Sunday 18 February

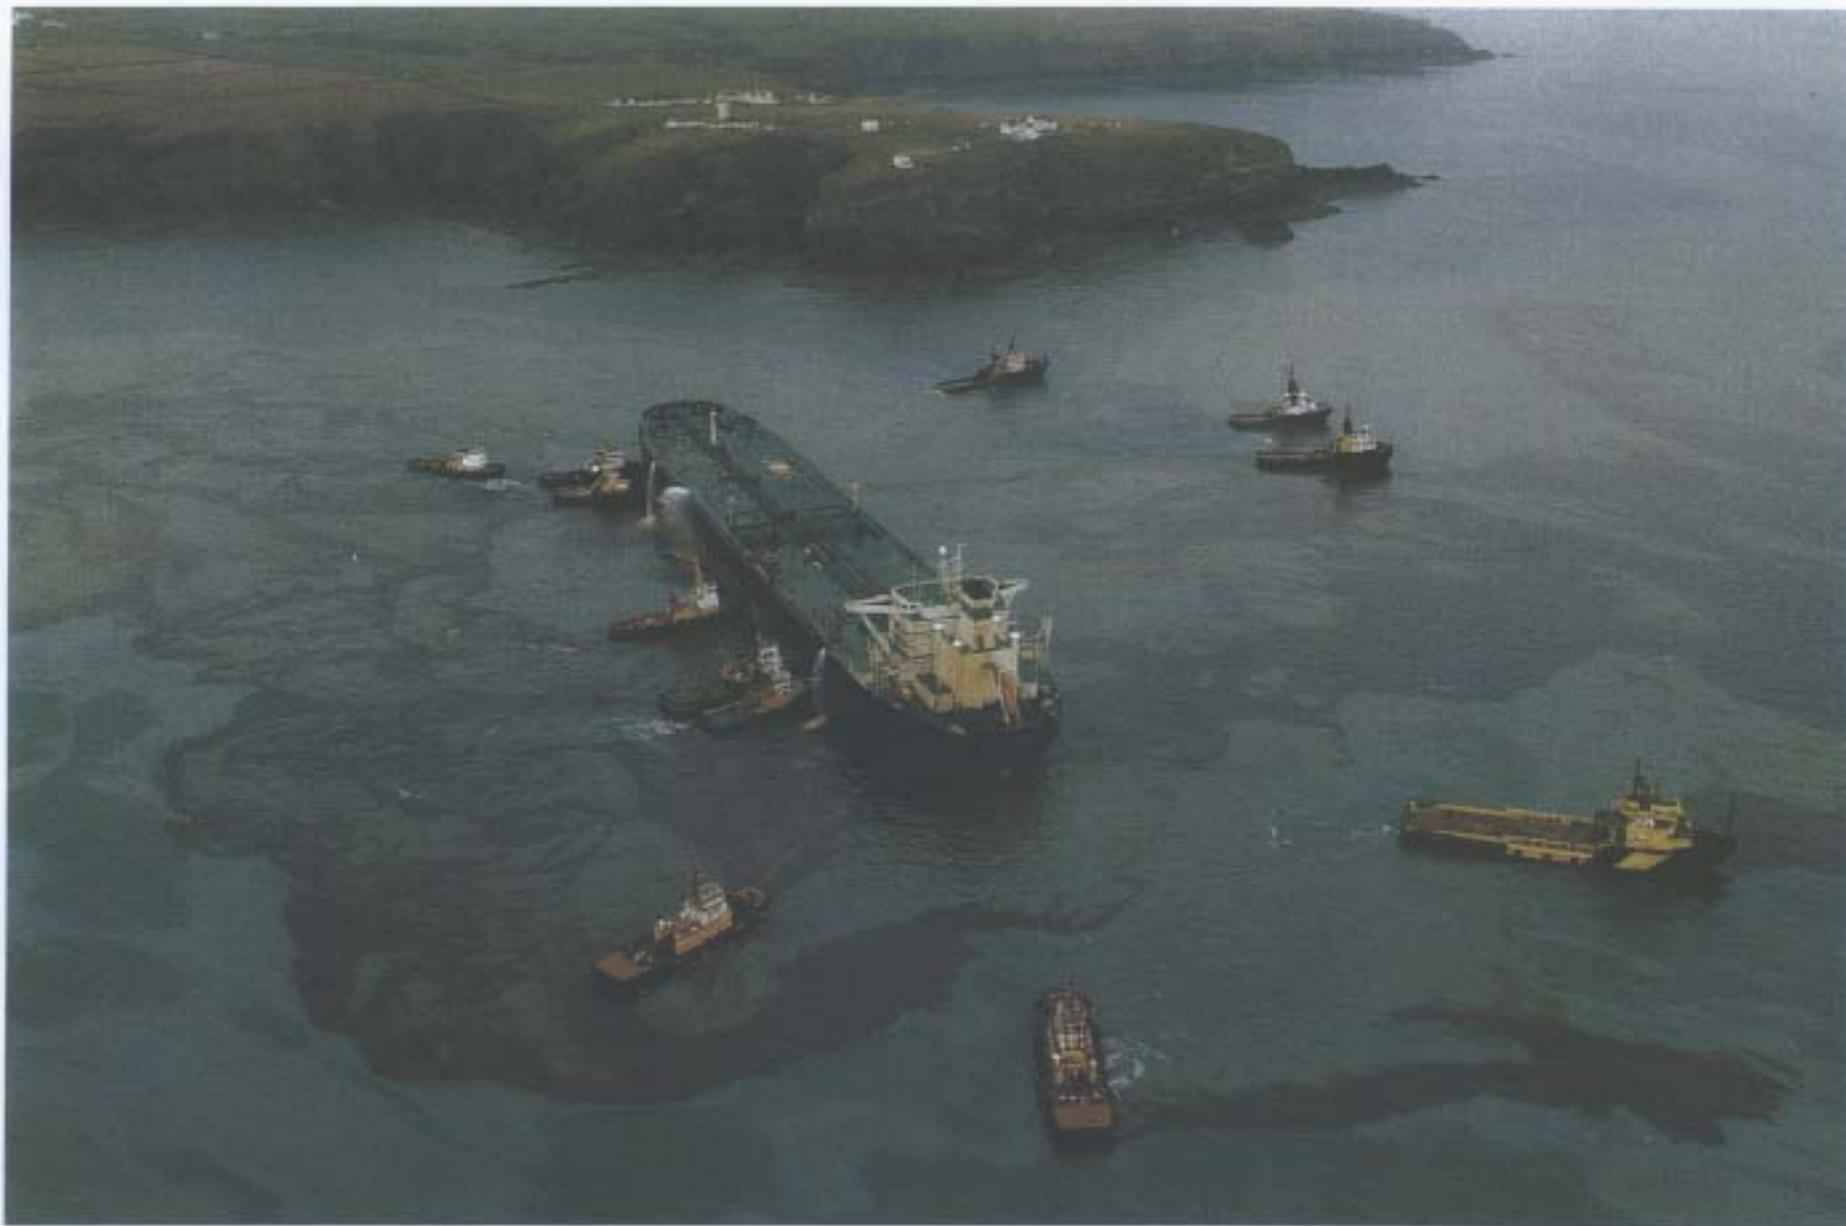
SEA EMPRESS and tugs on Wednesday 21 February
