Report of the Investigation into the  
Loss of the Fishing Vessel

**OCEAN HOUND**

with the loss of five lives  
on 10/11 August 1991

Marine Accident Investigation Branch  
5/7 Brunswick Place  
SOUTHAMPTON  
S01 2AN

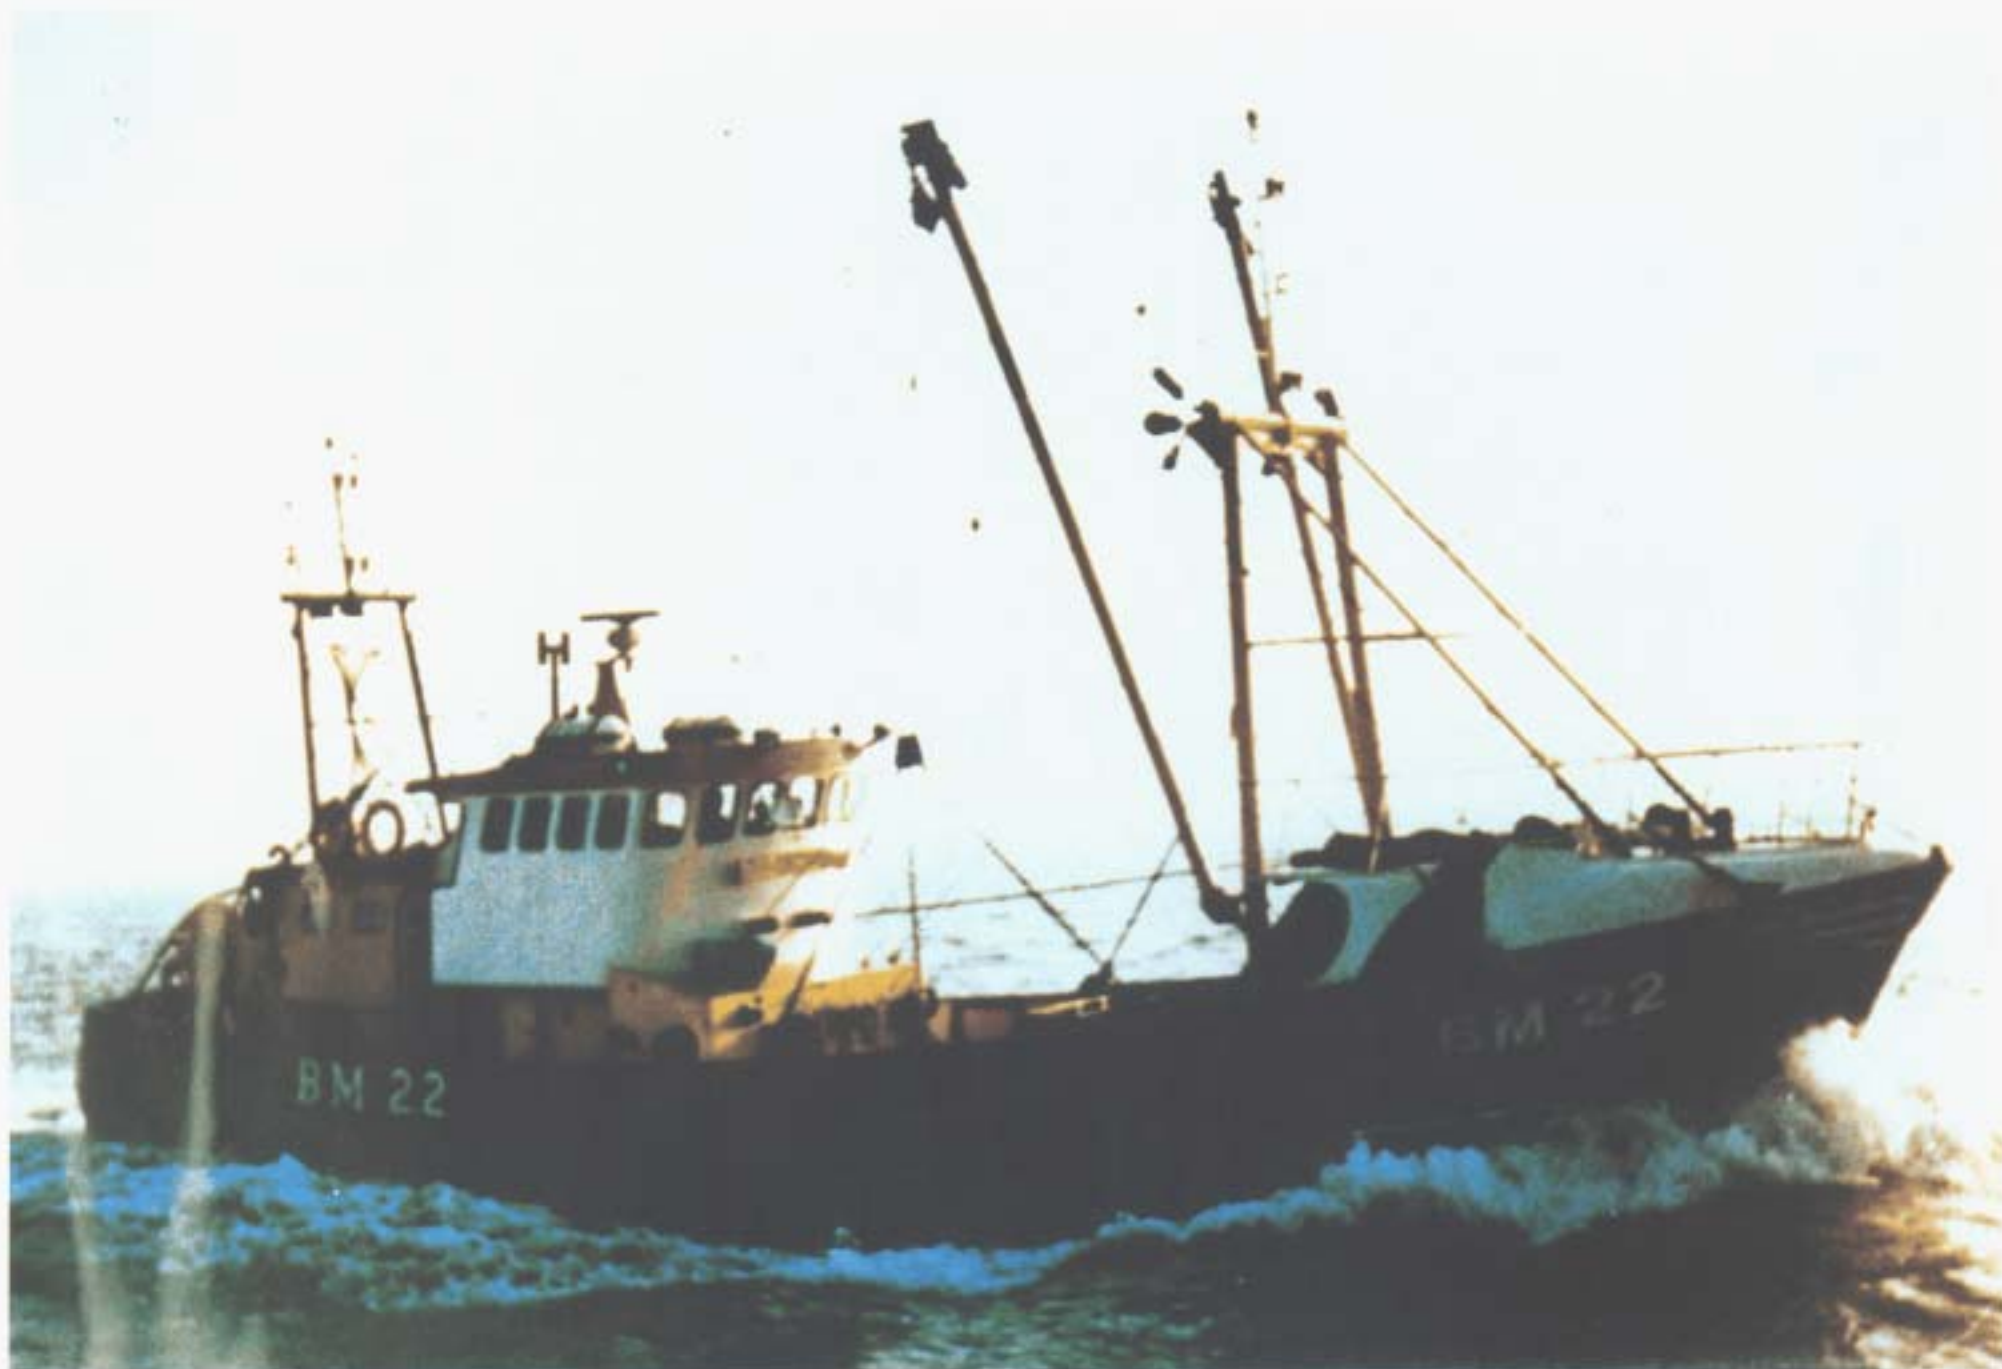
FV OCEAN HOUND at Sea

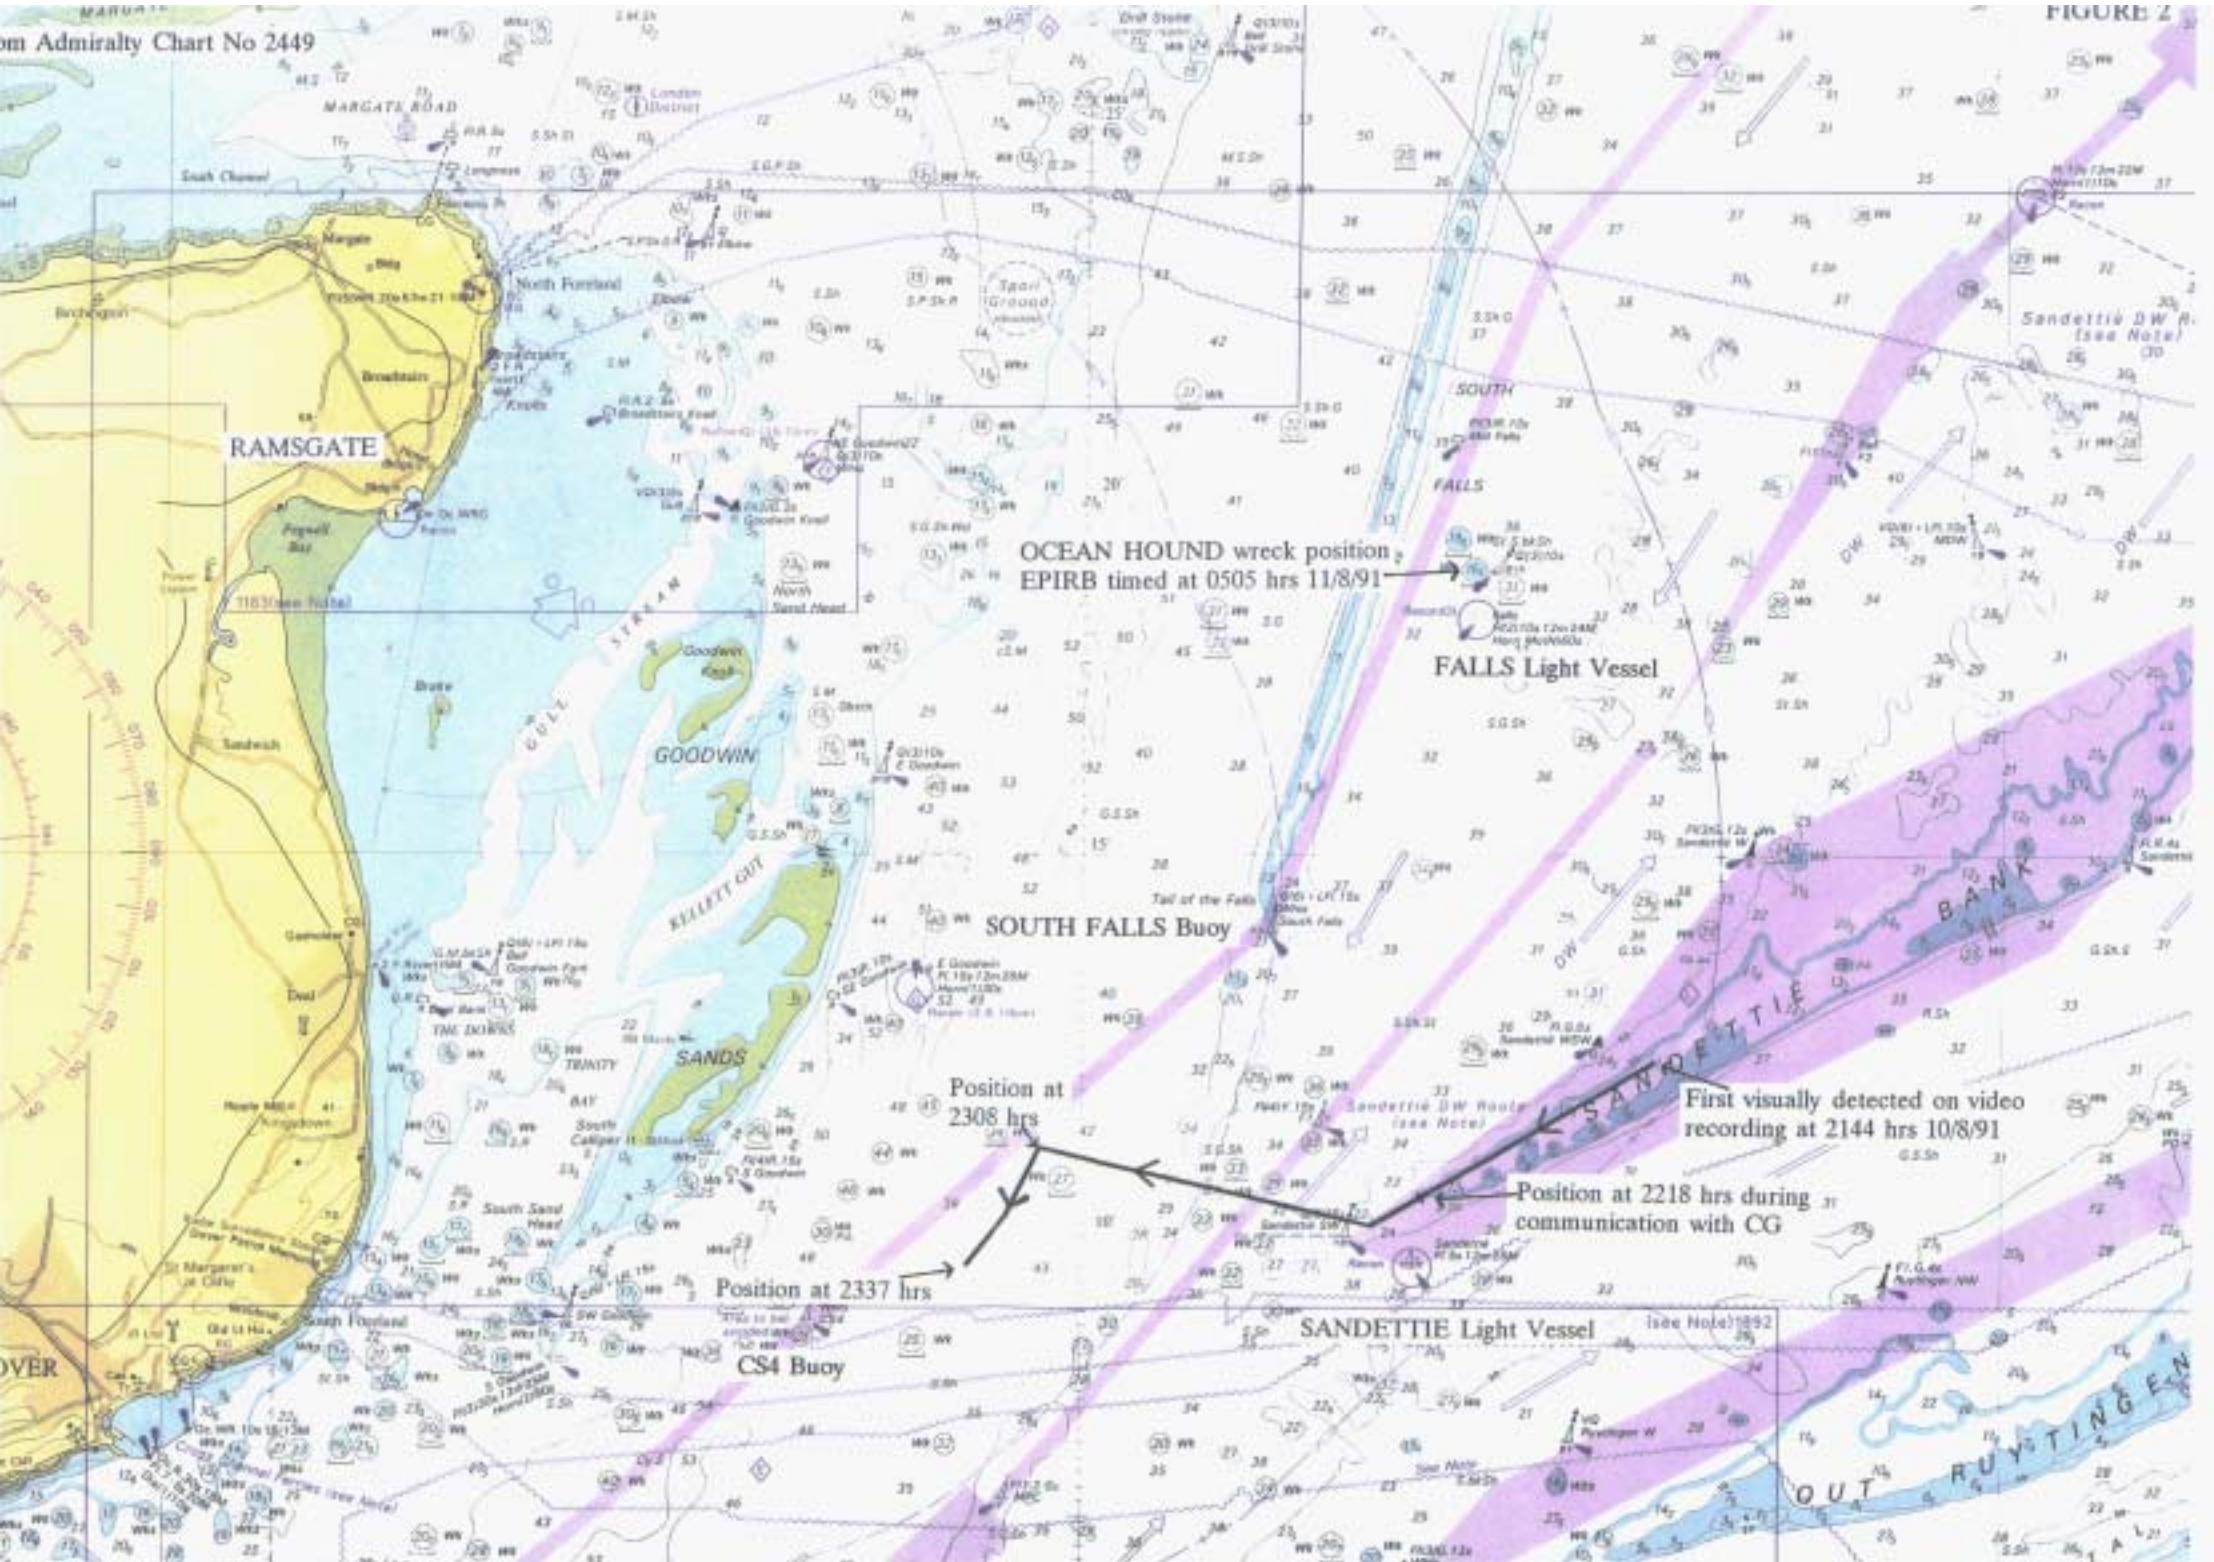
FIGURE 3.1

- 3.9.3 2307 hrs: Radar echo almost across SW lane when vessel appears to alter course towards South and back into the lane. At this time there were three echoes close to the NE of OCEAN HOUND, all heading SW'ly. A fourth echo (D), which later appeared to merge with that of OCEAN HOUND, can be seen just past the South Falls Buoy. (Figure 3.1)

MFV OCEAN HOUND  
2307 hrs 10 August 1991  
Relative positions of radar echoes
