Combined report on the investigations of the  
sinking and abandonment of the DUKW amphibious passenger  
vehicle

## ***Wacker Quacker 1***

fire and abandonment of the DUKW amphibious passenger  
vehicle

## ***Cleopatra***

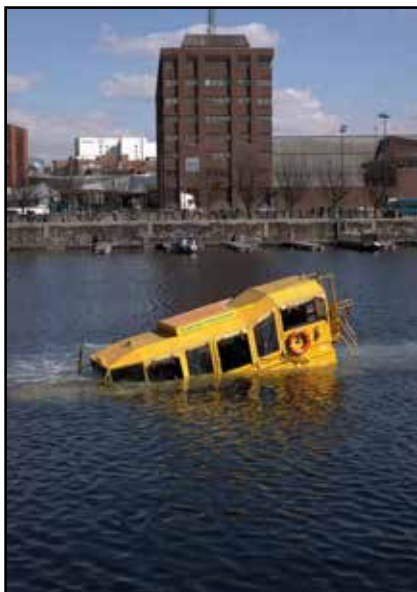
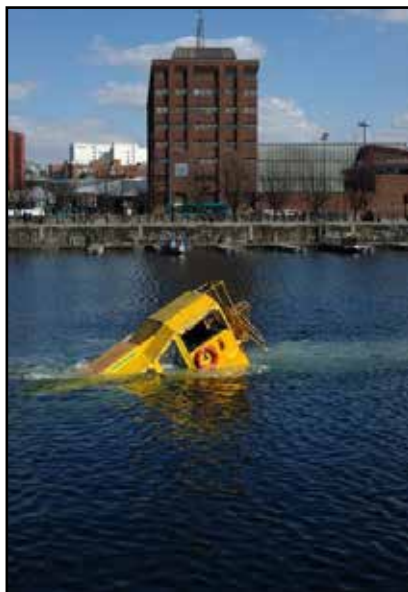
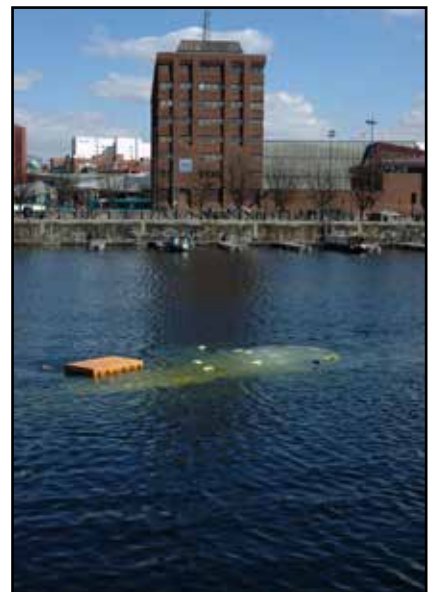
**Figure 2:** *Wacker Quacker 4* sinking in Salthouse Dock, Liverpool, on 30 March 2013

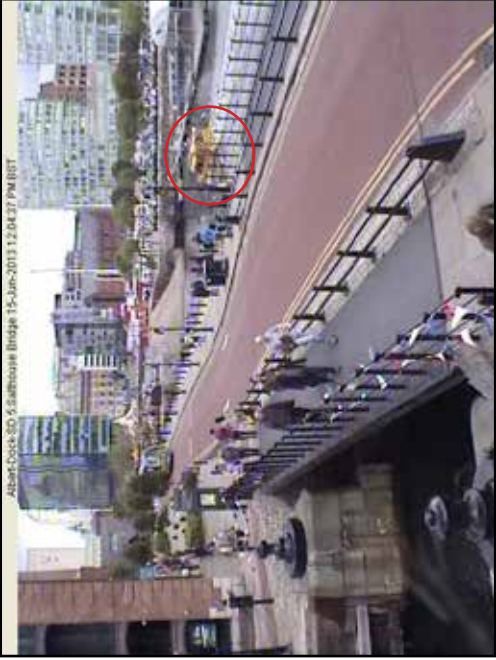
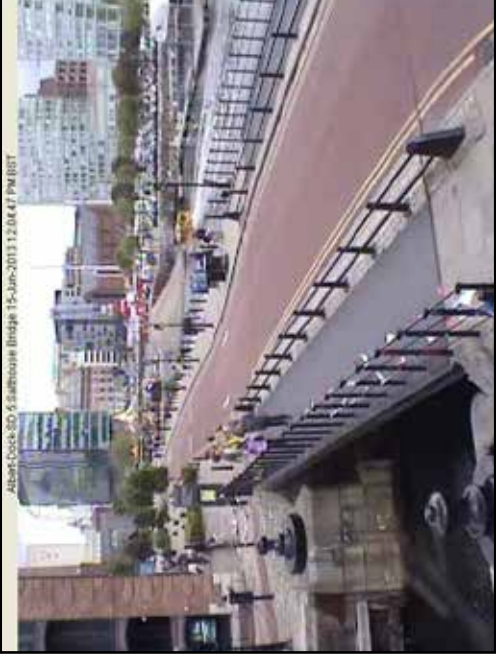
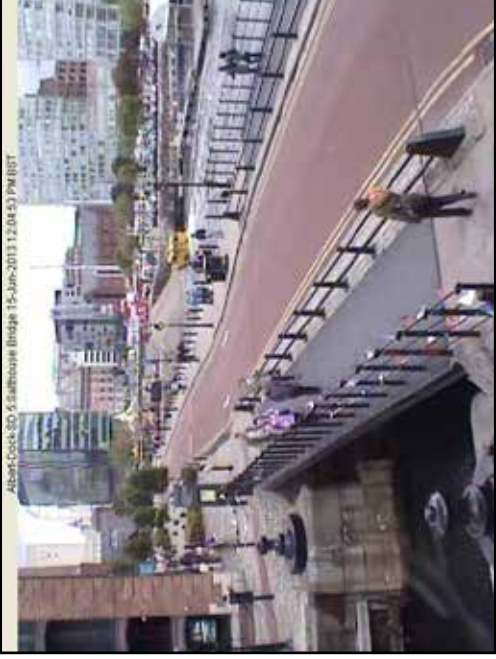
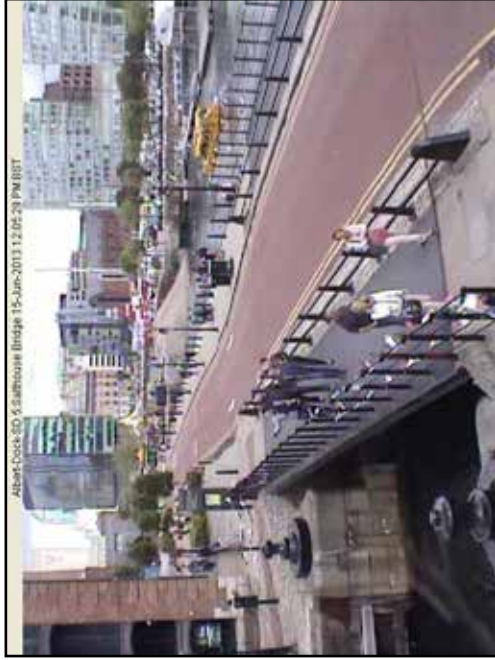
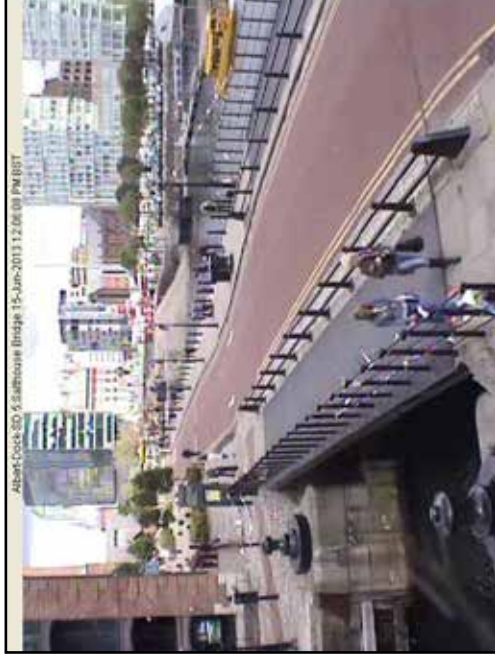
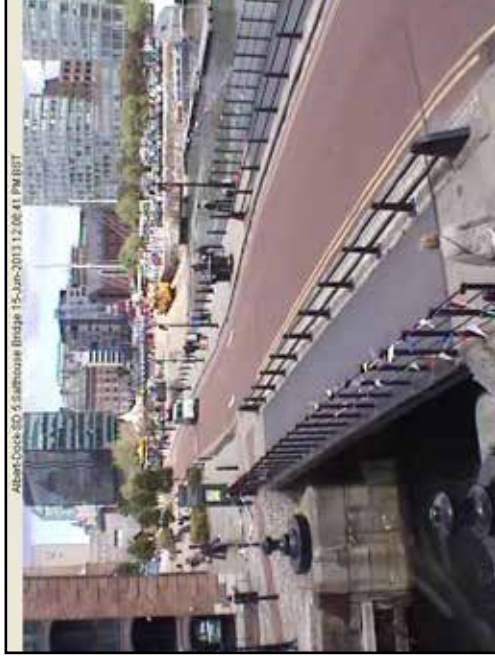
At about 1204, having completed the waterborne section of the third tour of the day, the driver attempted to drive *WQ1* up the Salhouse Dock slipway. During his approach, the driver increased the vehicle's propeller speed and attempted to engage six-wheel drive. When *WQ1*'s wheels made contact with the slipway the vehicle began to climb out of the water. The driver almost immediately realised that the engine was losing power (**Figure 6**). Concerned that the engine might stall, the driver aborted his attempt to exit the dock and allowed *WQ1* to roll back into the water. He put the propeller astern and manoeuvred backwards to make room for a second attempt. The second attempt was successful and the passengers were driven to Gower Street, where they were disembarked.

1204:37 WQ1 approaches slipway

WQ1 frontwheels land on slipway

WQ1 loses power on slipway, driver aborts attempt to exit dock.

1205:29 WQ1 rolls down slipway and manoeuvres astern

**Figure 6:** Wacker Quacker 1's failed attempt to exit Salthouse Dock at 1205 on 15 June 2013

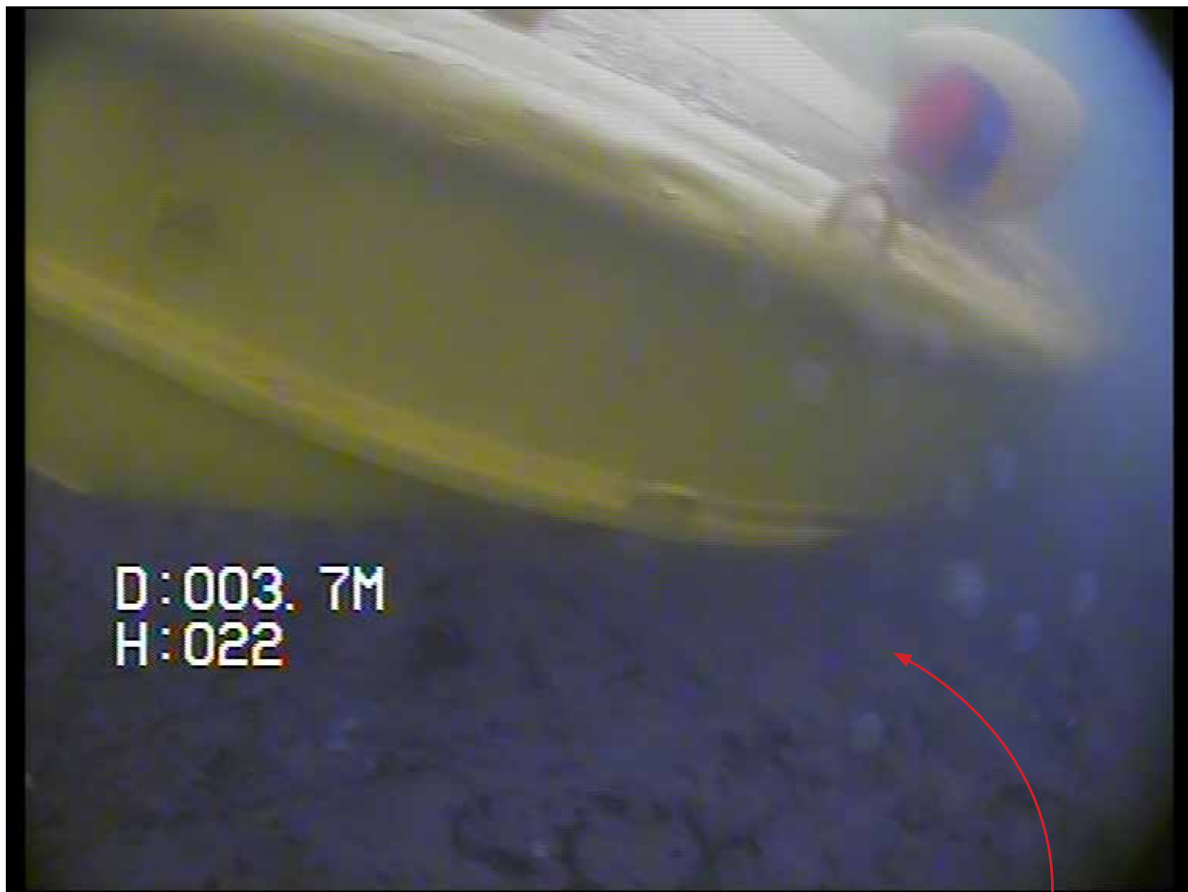
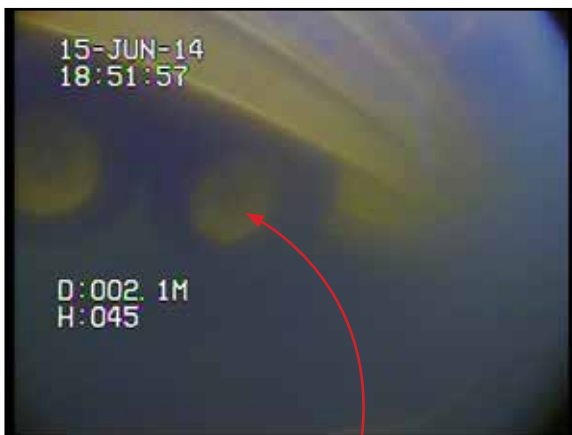
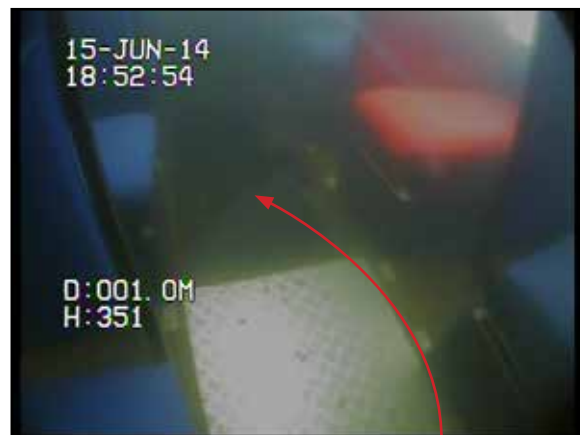
**Figure 10:** Police divers' underwater survey

Later in the evening, police divers carried out an underwater inspection (**Figure 10**) of *WQ1* and then attached recovery slings to the vehicle's rear wheel axle. Once recovered back onto the slipway, *WQ1* was inspected and photographed by a Merseyside Police scene of crime officer. The police discovered a car tyre wrapped around the propeller and found two large holes in the vehicle's propeller shaft tunnel shell plating (**Figure 11**).

WQ1's bow on the dock bed

Starboard aft wheels

Passenger aisle floor plates lifted

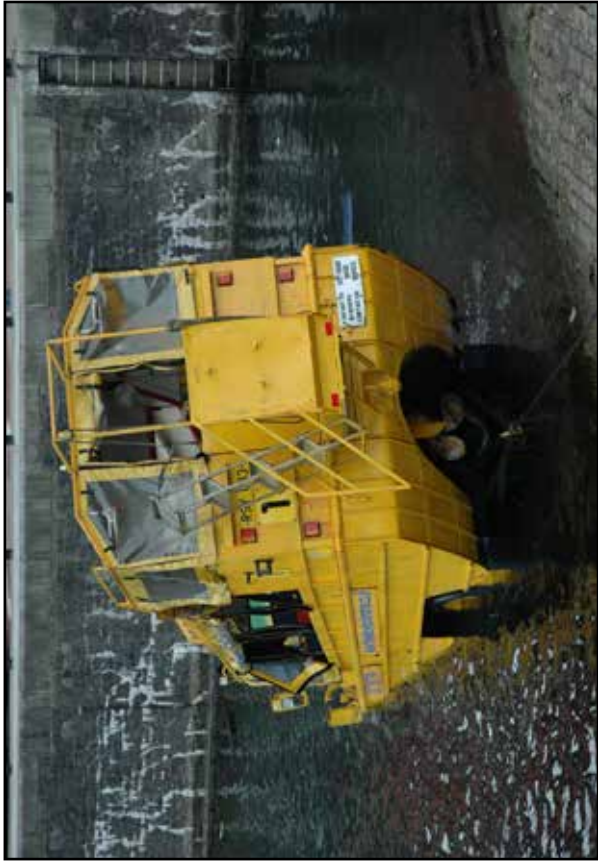
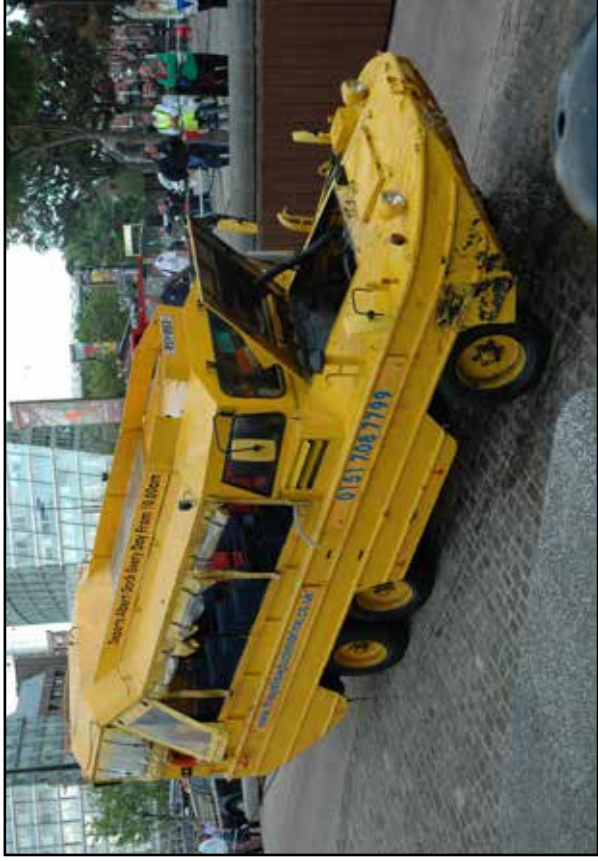
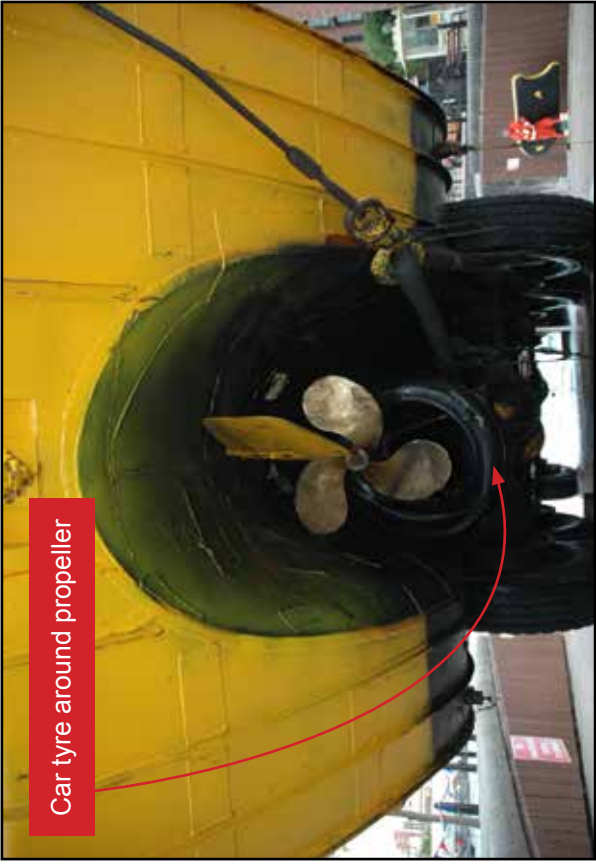
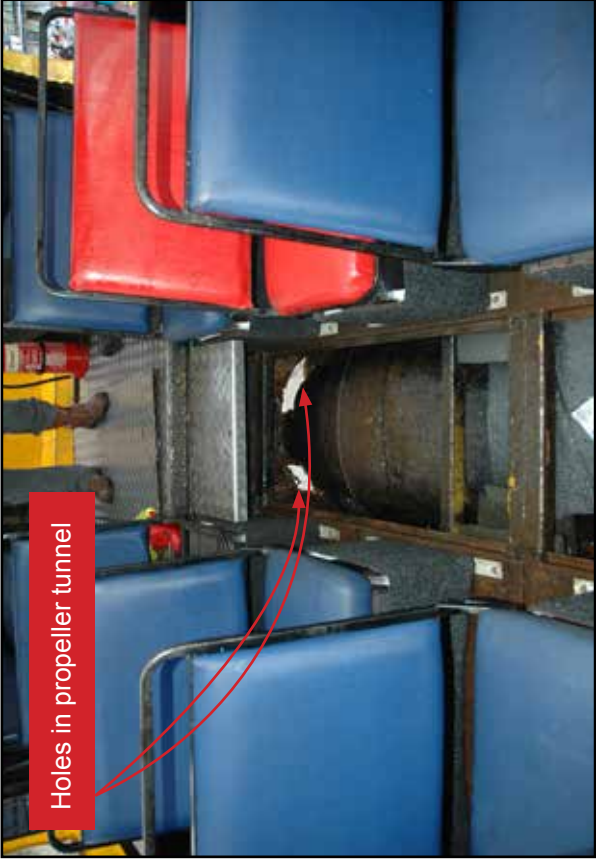
**Figure 11:** Photographs taken by police after the recovery of Wacker Quacker 1

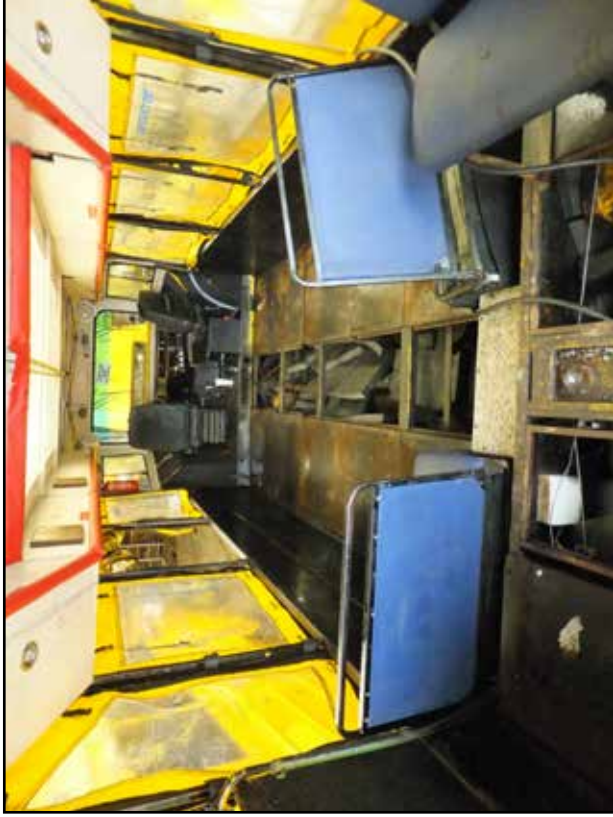
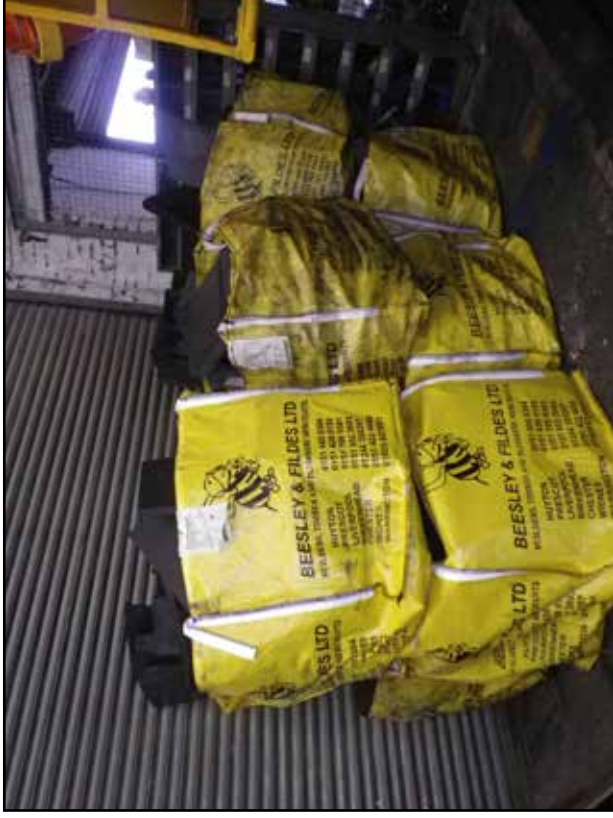
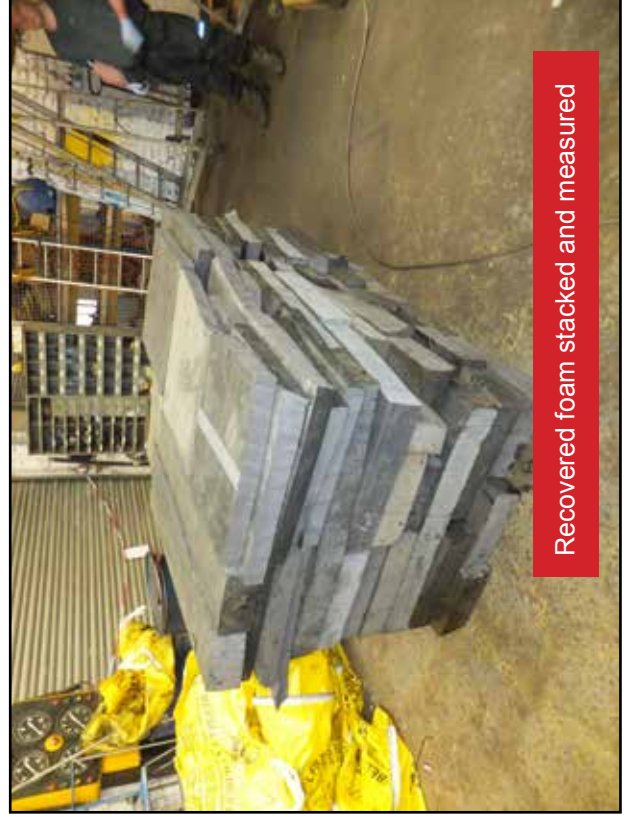
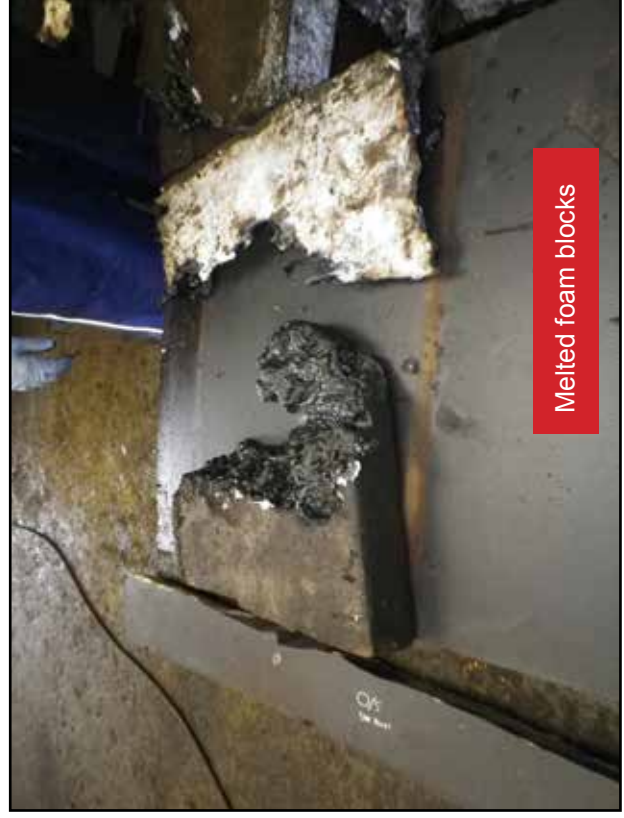
**Figure 19:** Foam removed from Wacker Quacker 1, Wacker Quacker 2 and Wacker Quacker 8

*WQ1*'s hull was found to contain about 6m<sup>3</sup> of buoyancy foam. Similar amounts were found in *WQ2* and *WQ8*. A large proportion of the foam removed was coated in oil and grease and there was evidence that some blocks of foam had melted as a result of contact with moving parts (**Figure 19**).

Recovered foam stacked and measured

Melted foam blocks

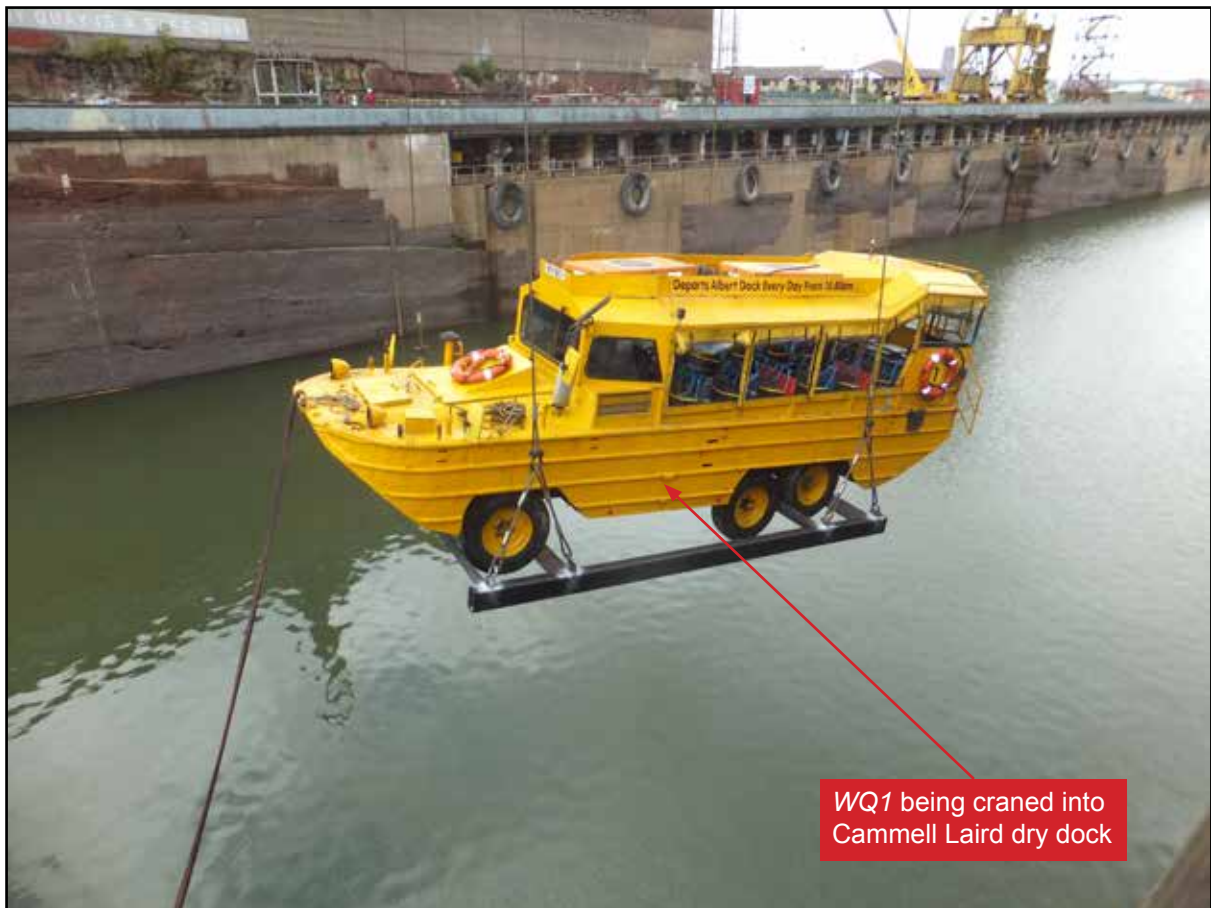
**Figure 25:** MAIB foam insertion trials and flooding reconstruction

On 30 and 31 July 2013, the MAIB used *WQ1* to conduct a series of practical stability tests and flooding trials at the Cammell Laird shipyard, Liverpool (**Figure 25**). In addition to MAIB staff and its shore contractors, the tests and trials were witnessed by representatives from the MCA, TYD, BCTQ and London Duck Tours Ltd (LDT).

With the caps removed from the two 150mm flooding pipes, *WQ1* was craned into the dock. It took about 5 minutes for *WQ1* to fully flood (**Figure 27**). The DUKW assumed a starboard list but remained afloat with the water level settling about 50mm below the forward upper edge of the passenger space side coaming. *WQ1* was observed in this state for 30 minutes before it was craned out of the dock.

Before the trials could take place, MAIB inspectors oversaw the repair of *WQ1*'s propeller tunnel and the insertion of buoyancy foam into the designated void spaces. A steel insert plate was formed and butt welded into the propeller tunnel, in place of the steel that had earlier been removed and sent for metallurgical analysis. Two 150mm diameter holes, designed to replicate those found in the hull after the sinking, were cut into the steel plate (**Figure 26**). A short length of threaded steel pipe, with a blanking cap, was welded to each hole to allow the hull to be made watertight for the initial stability tests.

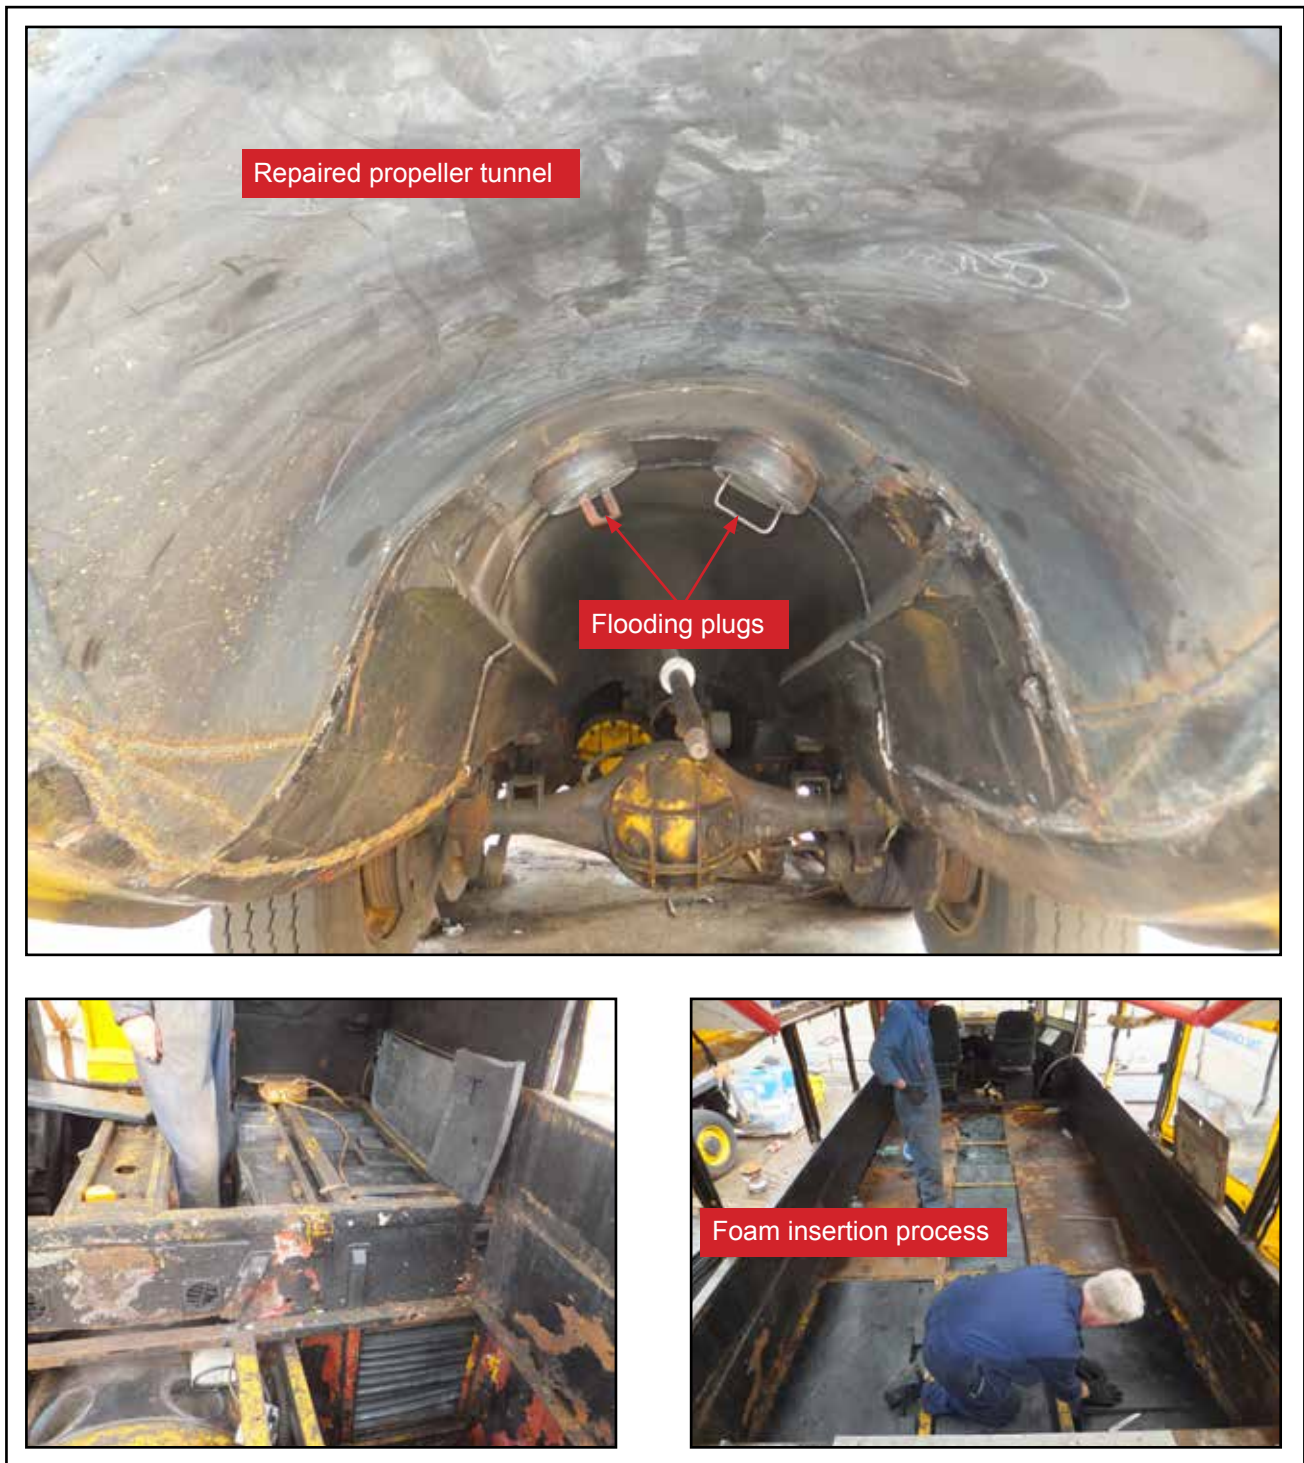
**Figure 26:** Hull preparations and foam insertion process

The buoyancy foam sheets used for the trials were individually measured and weighed before insertion. The foam was found to be about 5% denser, and therefore 5% heavier, than that given in its specification ( $33\text{kg/m}^3$ ). When the high density foam recovered from *WQ1* was weighed, it was found to be 20% denser.

It took teams of 4 men 7 days (approximately 280 man hours) to insert the new buoyancy foam into the hull of the vehicle. The foam sheets were individually cut to size and tightly packed into the spaces identified for the insertion of  $9.7\text{m}^3$  of buoyant material in BCTQ's initial buoyancy assessment report (**Table 1**). Care was taken not to compress the foam (**Figure 26**). In order to ensure the maximum amount of foam was inserted, the operational requirements of the vehicle were not taken into account and foam was deliberately packed up against moving parts. The total quantity of foam fitted was  $7.93\text{m}^3$  (**Table 2**); almost  $2\text{m}^3$  less than the calculated amount required to provide 110% buoyancy and  $4\text{m}^3$  less than that required by the MCA.

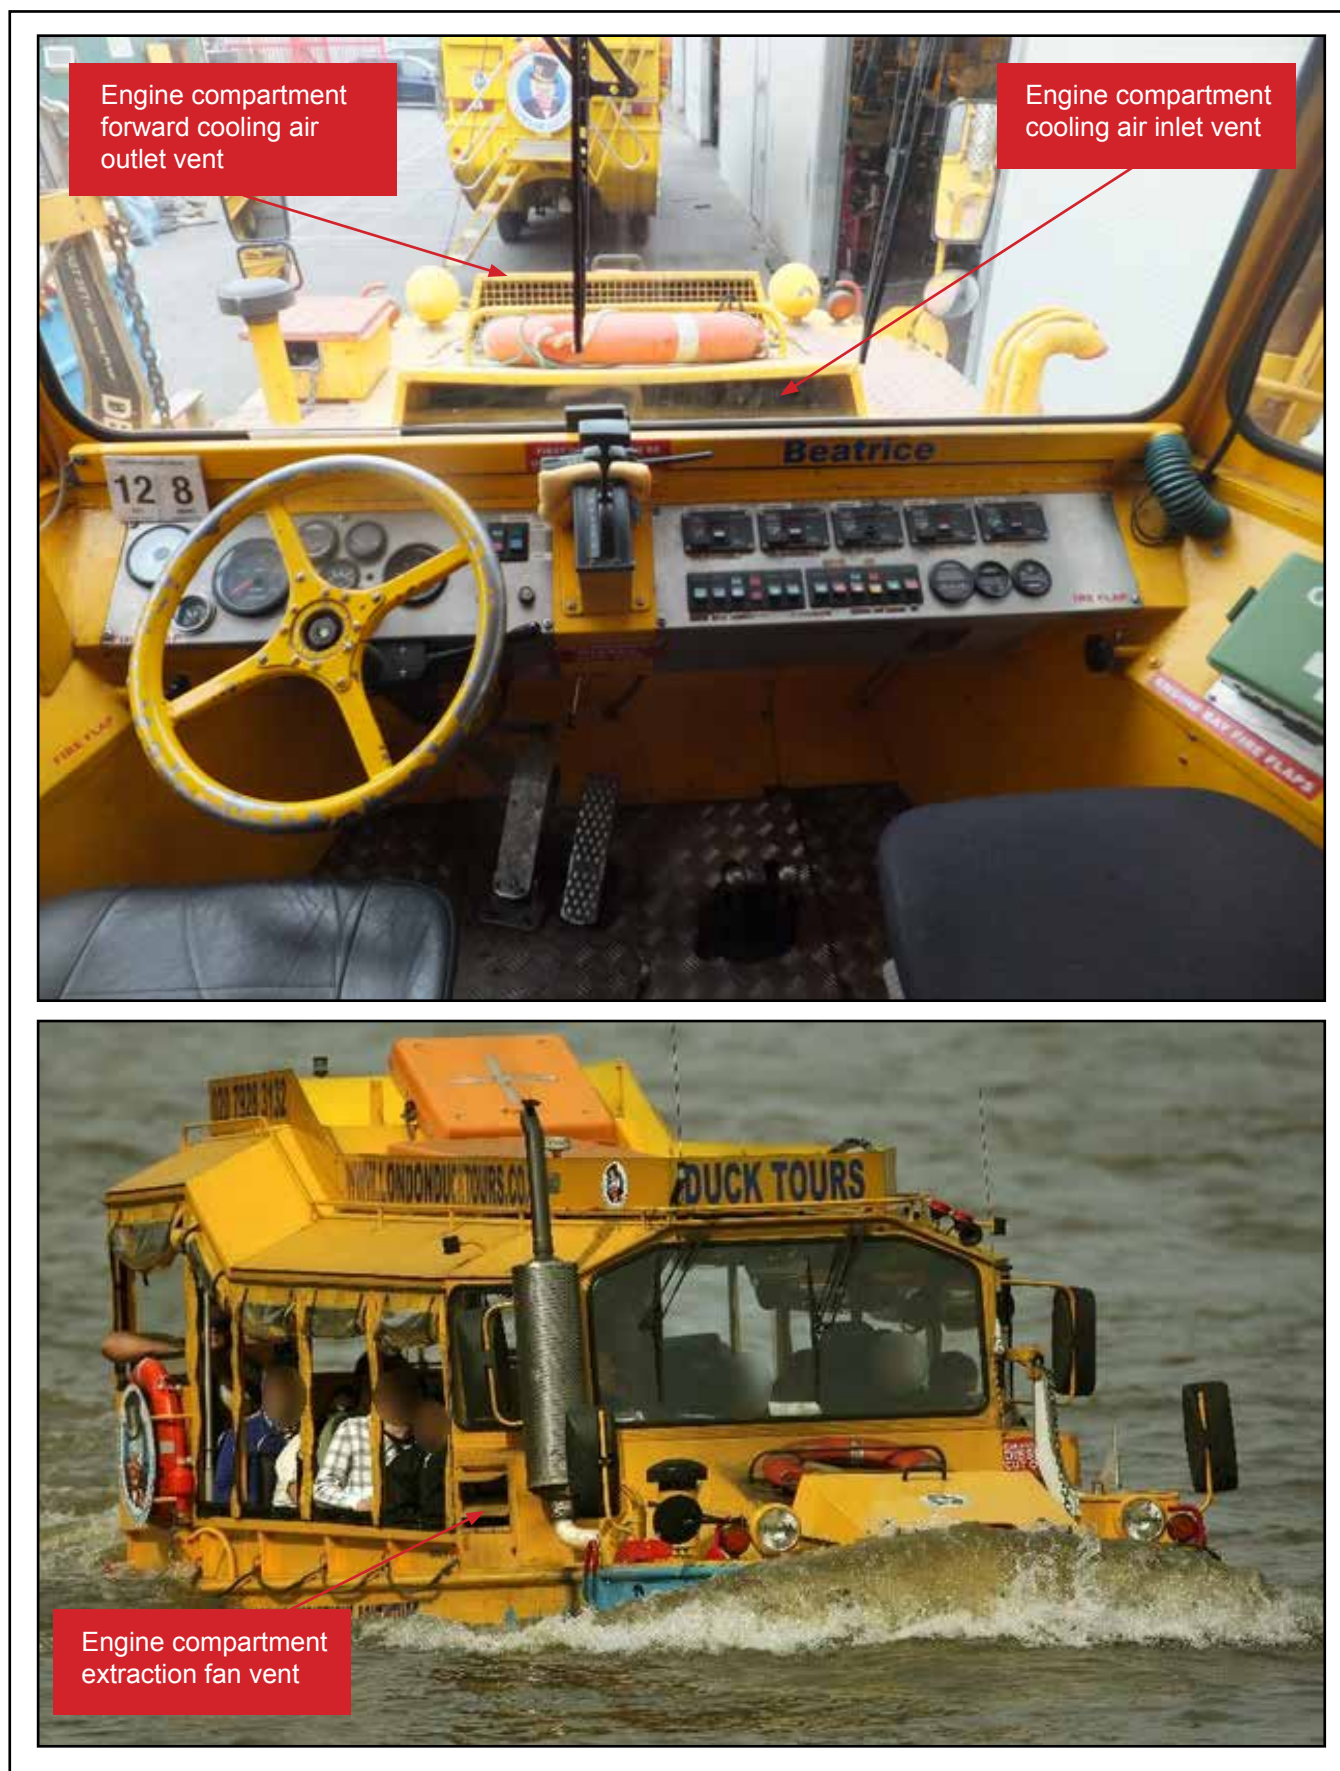
**Figure 36:** Engine compartment cooling air vents on a similar London Duck Tours vehicle

Initially, the master thought that the smoke might have been caused by an engine exhaust problem and, as a precaution, he angled *Cleopatra* towards the shore. The tour guide then made an announcement to the passengers informing them that there was a problem with the vehicle. The smoke increased in thickness, darkened in colour and began to billow out of the engine compartment's starboard extraction fan vent (**Figure 36**). At this point a passenger towards the rear of the vehicle shouted, "Fire! Fire!"

When the cargo compartment was converted into the passenger space the original main cooling air inlet grating was covered up and the engine compartment and bow compartment hatch covers were modified to accommodate aft facing cooling air supply and exhaust vents (**Figure 36**). During their 13 years in operation, the cooling air flows on the LDT DUKWs had been altered several times. At the time of the accident, the original engine compartment cooling air passages had been removed from *Cleopatra*. The cooling air was drawn into the compartment through its aft hatch cover vent and, having passed through the radiator, exhausted to atmosphere through the forward (bow compartment) hatch cover vent.

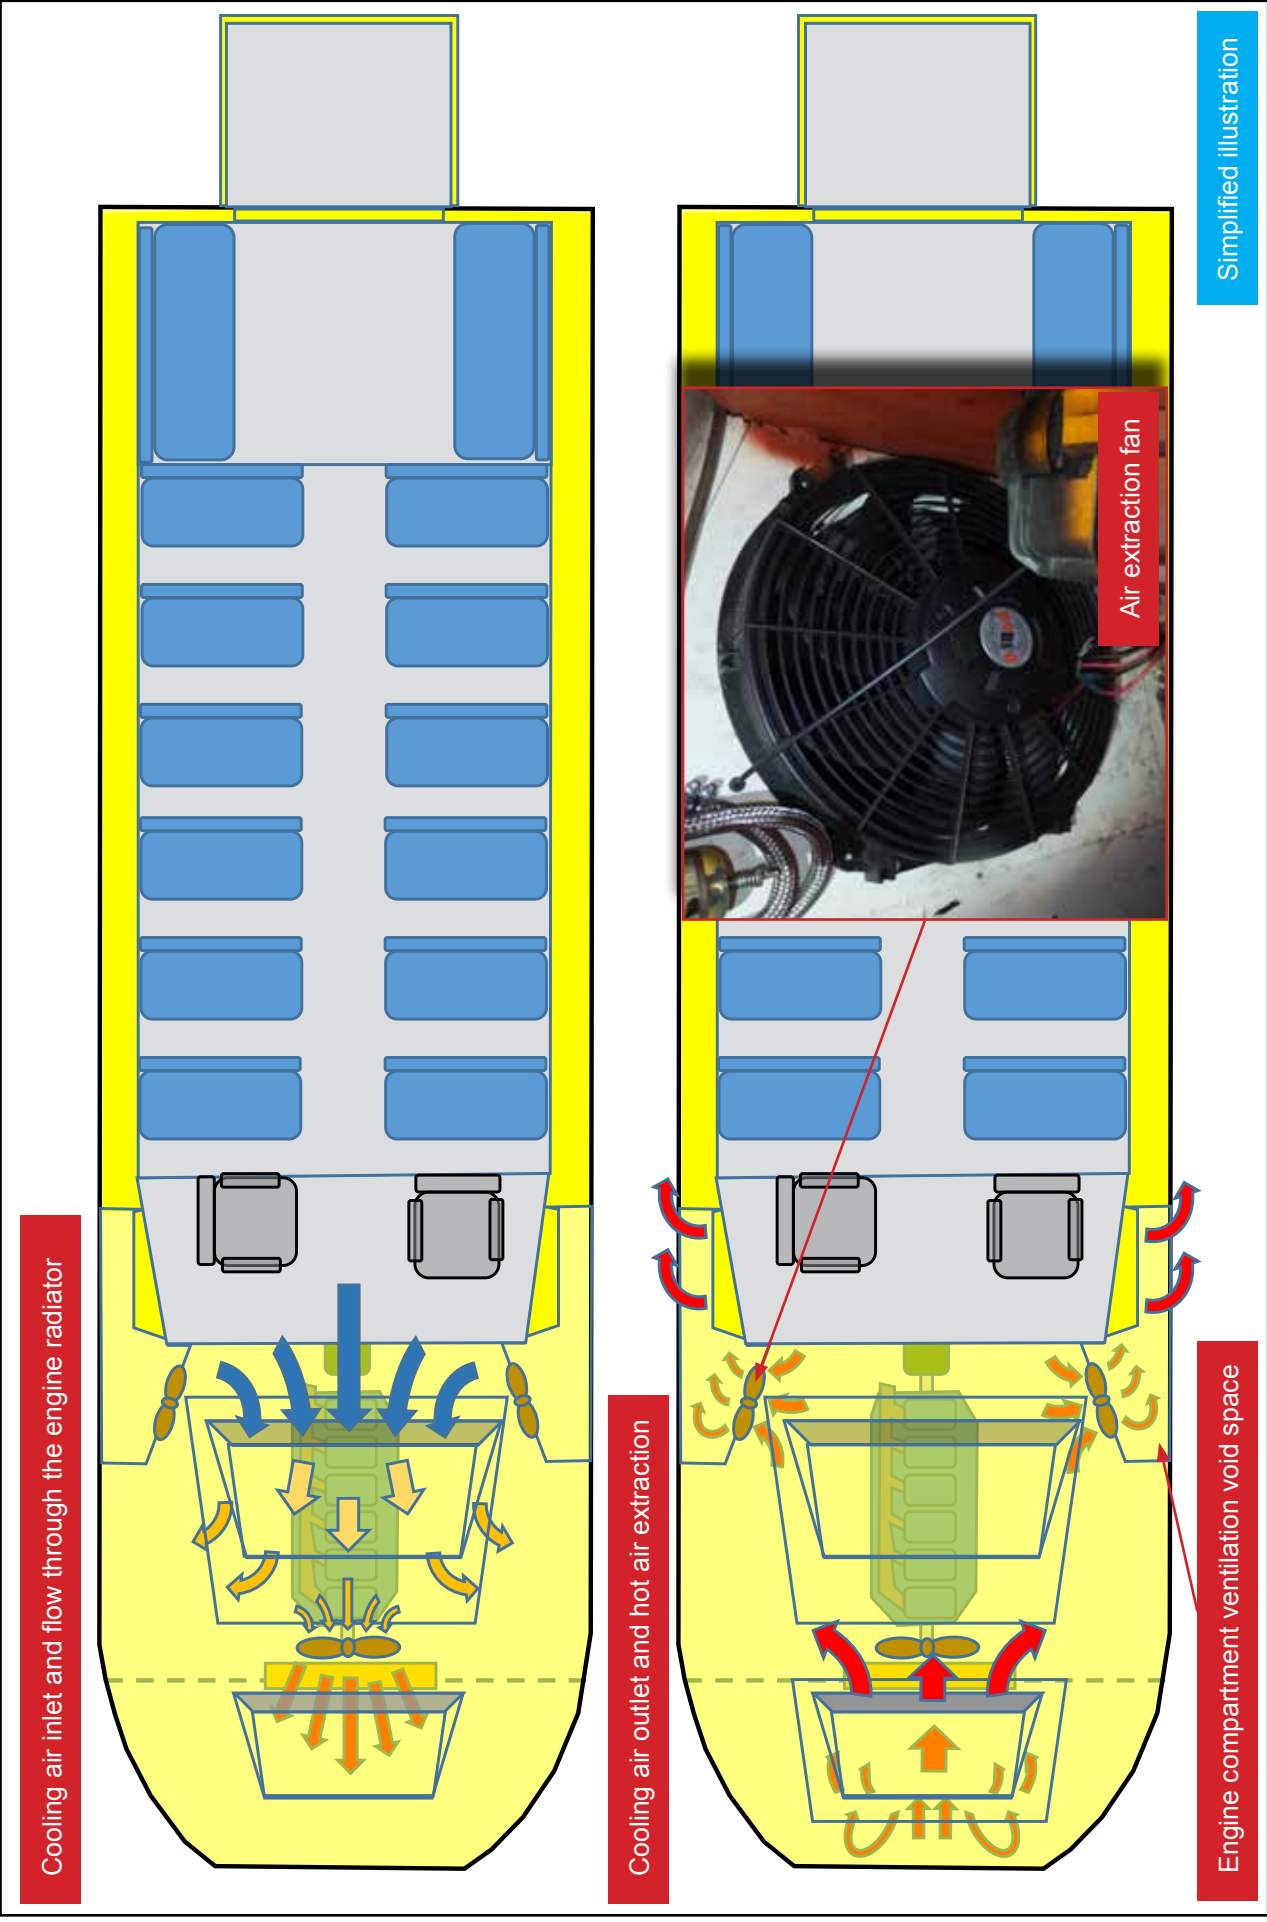
**Figure 42:** Modified engine cooling air flow and engine compartment hot air extraction

In order to prevent the build-up of hot air at the after end of the engine compartment, electrically-driven extraction fans were fitted (**Figure 42**). The hot air was drawn into the port and starboard ventilation void spaces and exhausted to atmosphere through the vehicle's original side vents.

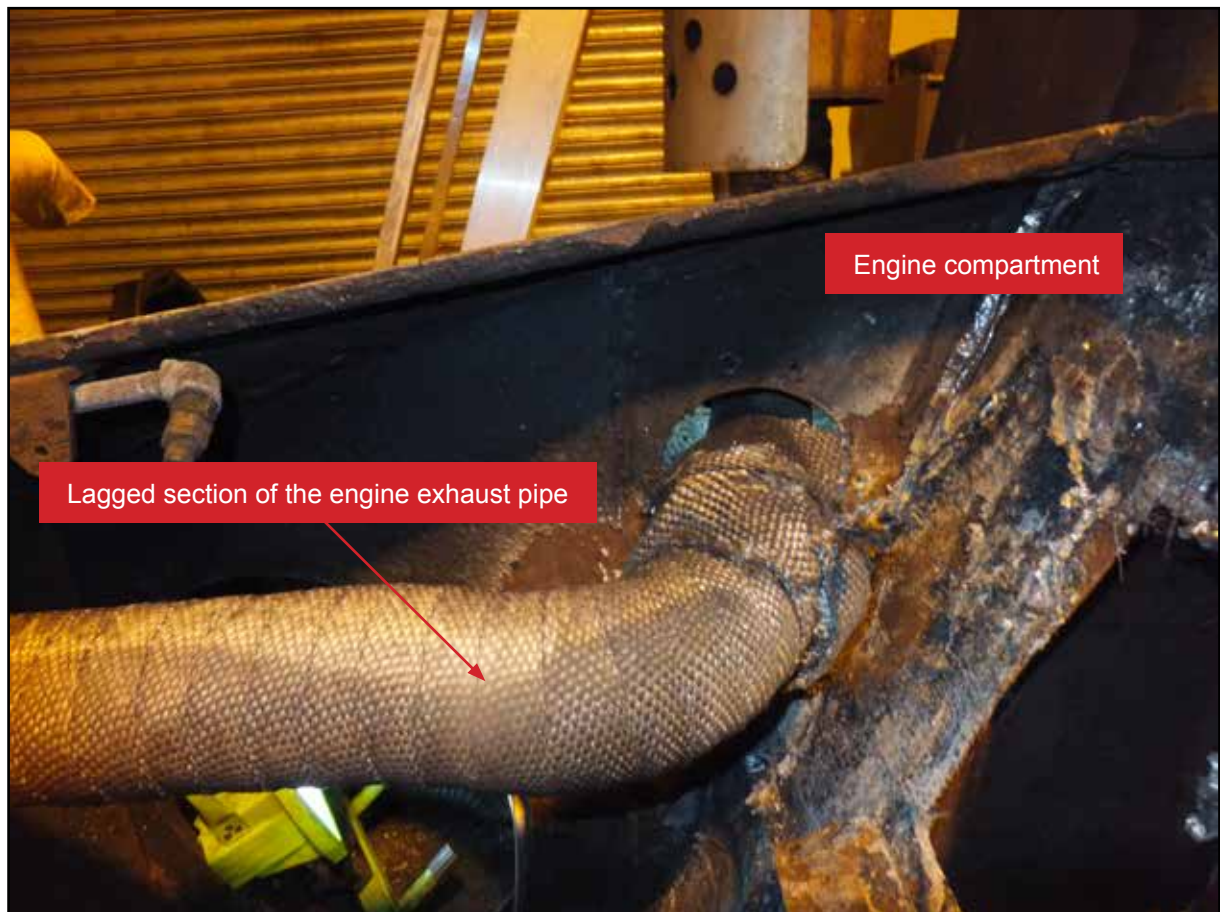
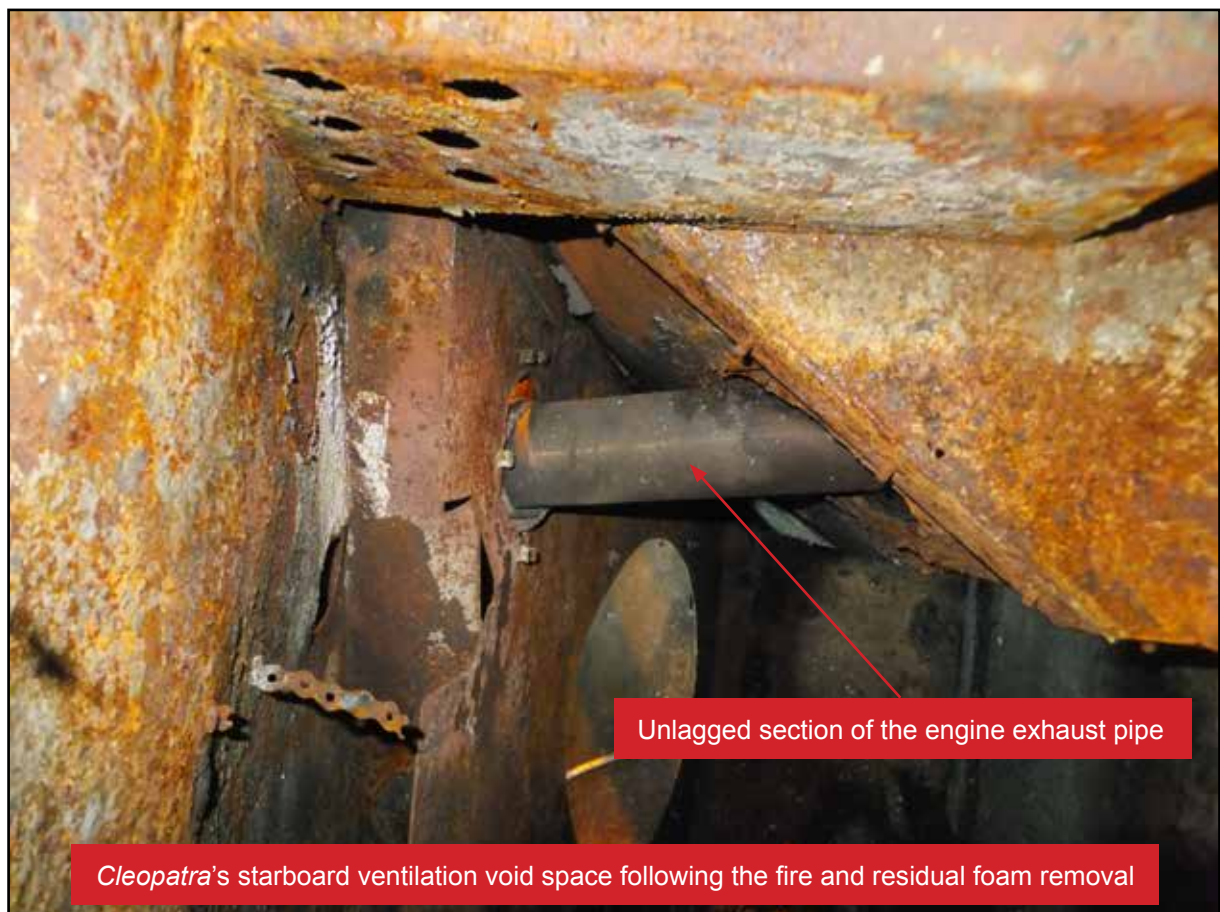
**Figure 43:** *Cleopatra's* engine exhaust pipe

The main engine exhaust pipe was routed down the starboard side of the engine compartment. It passed through the upper part of the starboard ventilation void space and terminated on the deck at the starboard forward corner of the crew cab. The section of the exhaust pipe within the engine compartment was lagged but the section that passed through the void space was not (**Figure 43**).
