Combined report on the investigations of the  
sinking and abandonment of the DUKW amphibious passenger  
vehicle

## ***Wacker Quacker 1***

fire and abandonment of the DUKW amphibious passenger  
vehicle

## ***Cleopatra***

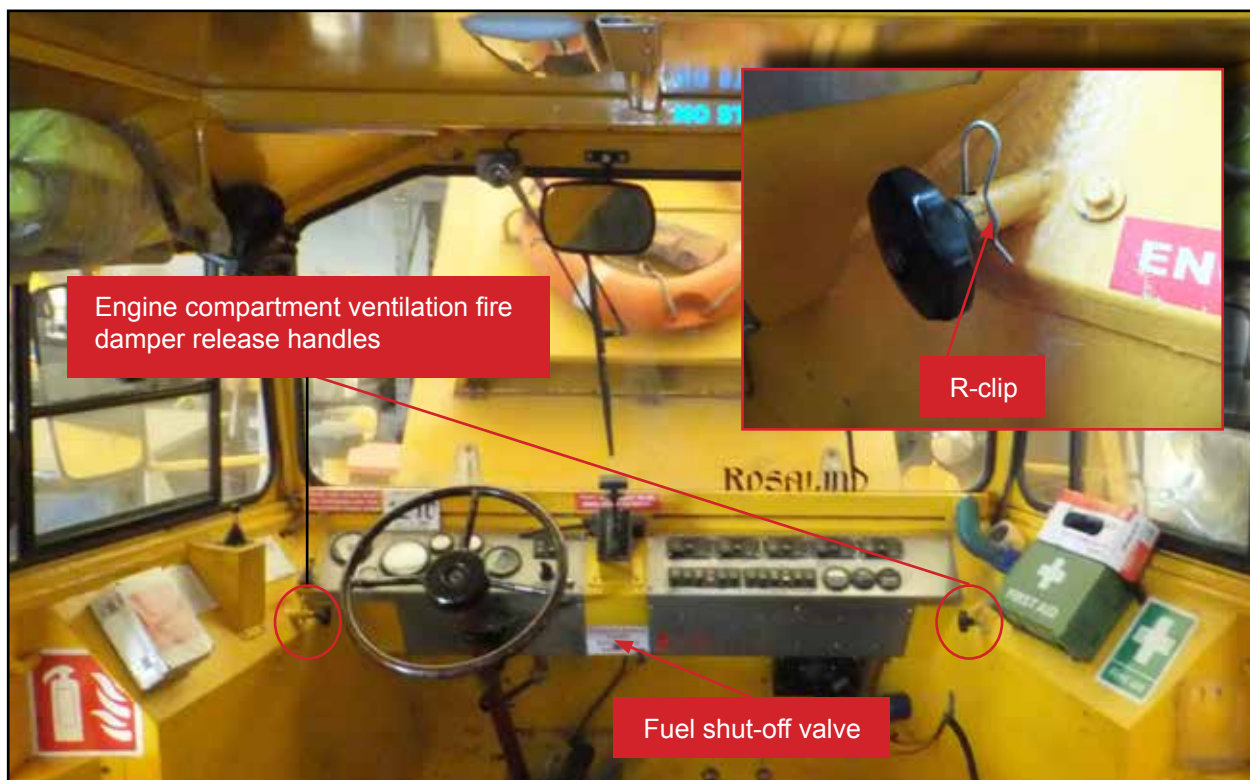
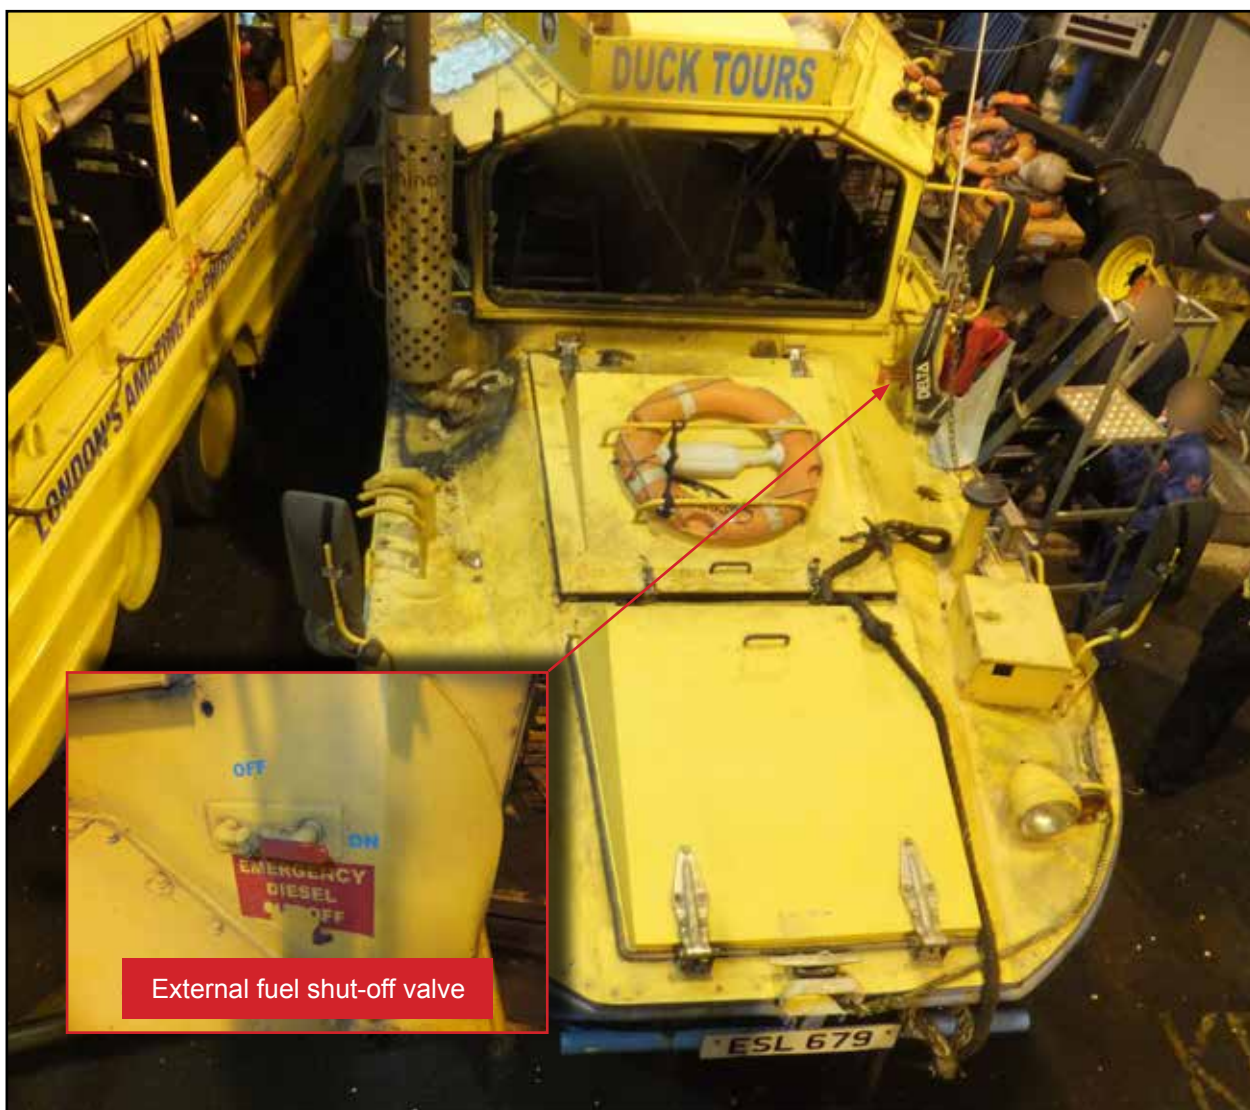
**Figure 48:** Emergency fuel shut-off valves and fire damper release handles in a similar vehicle

In the case of an engine compartment fire, the fuel supply to the compartment could be isolated by closing one of the vehicle's two emergency fuel shut-off valves. One of the emergency shut-off valves was located under the crew cab dashboard and could be closed by the crew from their seated positions. The other was fitted outside the vehicle below the port side of the windscreen (**Figure 48**).

The engine compartment cooling air inlet cowling and the port and starboard ventilation void space vents were fitted with remotely operated fire dampers. The fire dampers could be closed by the crew from their seated positions by pulling individual wire-pull handles (**Figure 48**). The main cooling air outlet on top of the bow compartment hatch cover was not fitted with a fire damper and could not be closed in the event of fire. The Liverpool DUKWs had a similar cooling air inlet arrangement fitted to their engine compartment hatch covers but they did not have fire dampers.

Neither of the fuel shut-off valves were closed before the abandonment. The crew attempted to close the port and starboard ventilation void space fire dampers but they were unable to release the steel "R" clips that secured the wire pull handles because they were too hot. The master was unaware of the cooling air intake fire damper and therefore did not attempt to close it. During the post-accident inspections of the wire pull arrangements on other LDT vehicles, MAIB inspectors found that several of the R clips were difficult to remove under normal conditions.

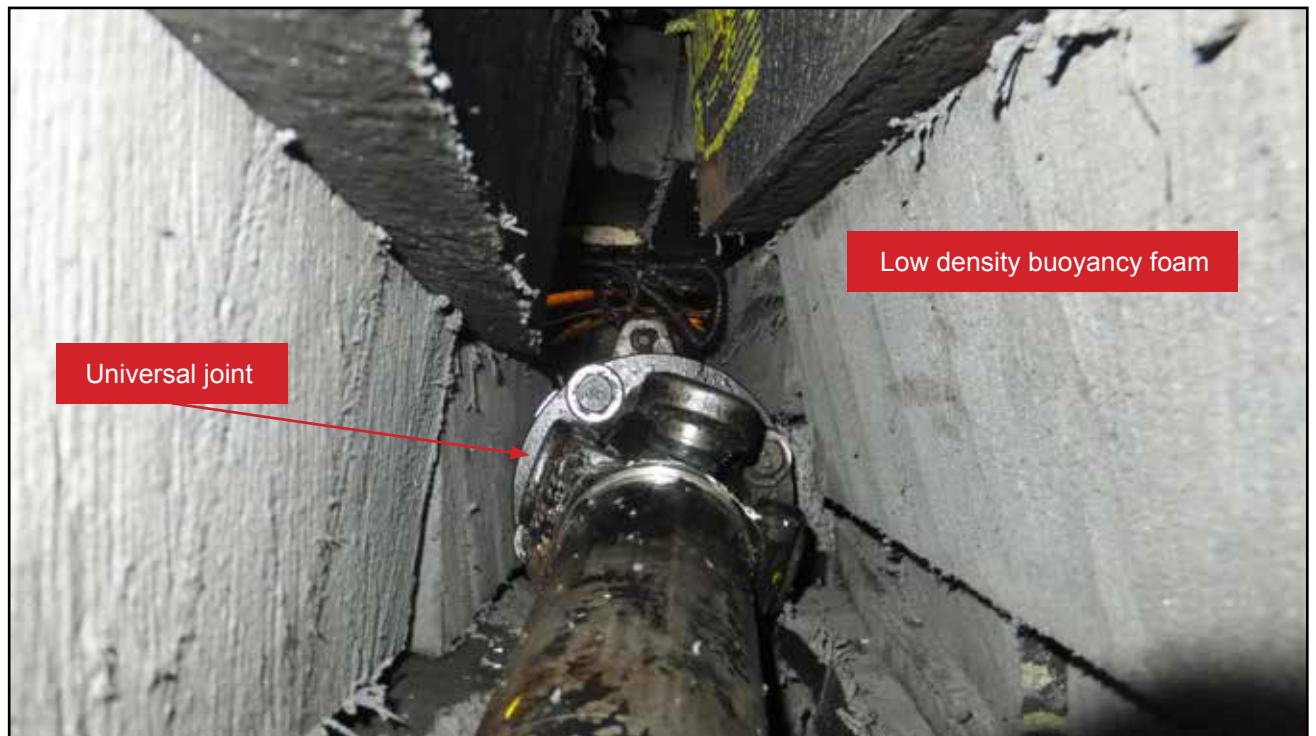
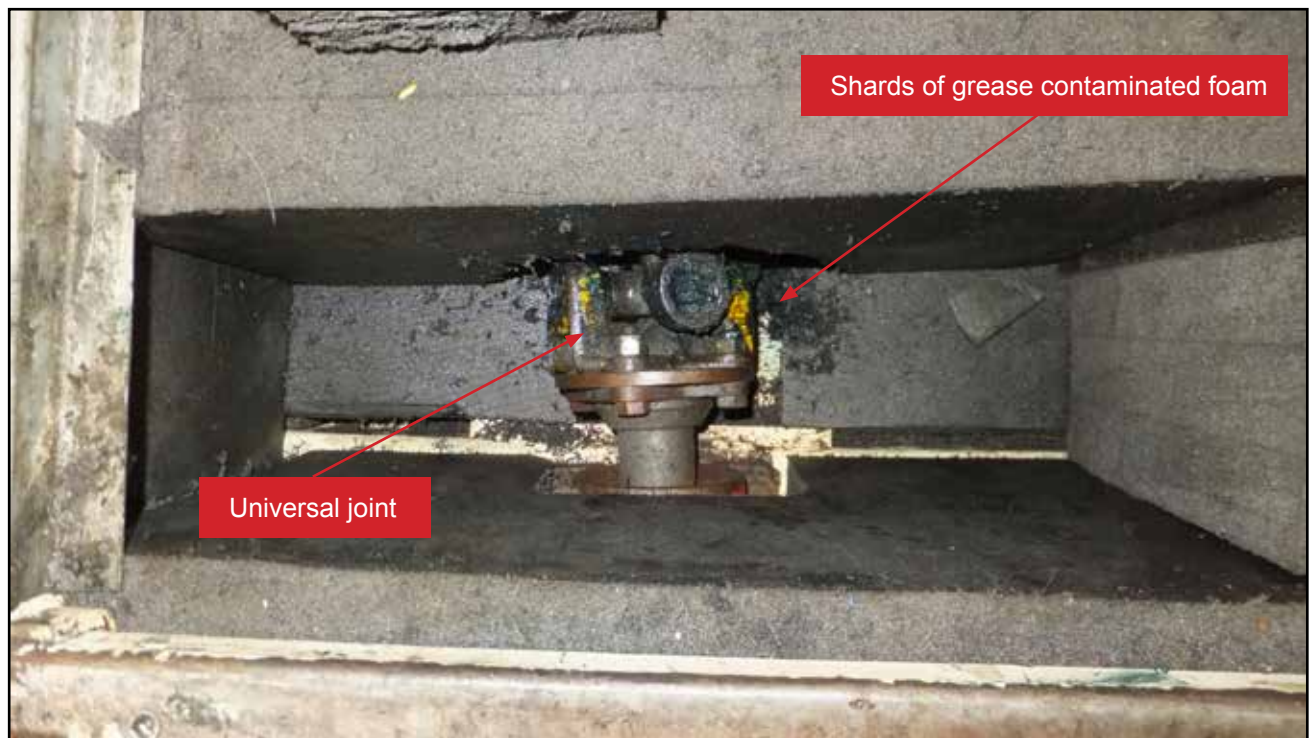
**Figure 50:** Buoyancy foam packed around the drivetrain in the centre void space of a London Duck Tours DUKW

Using the original results from Burness Corlett & Partners Ltd's computer model to help calculate the available space within the vehicle's hull, BCTQ identified 13 separate locations that it estimated, collectively, could hold 10m<sup>3</sup> of foam (**Figure 49**). The BCTQ report re-emphasised the need to ensure that the foam in the central void space was securely fastened to prevent it making contact with the rotating drive shafts.

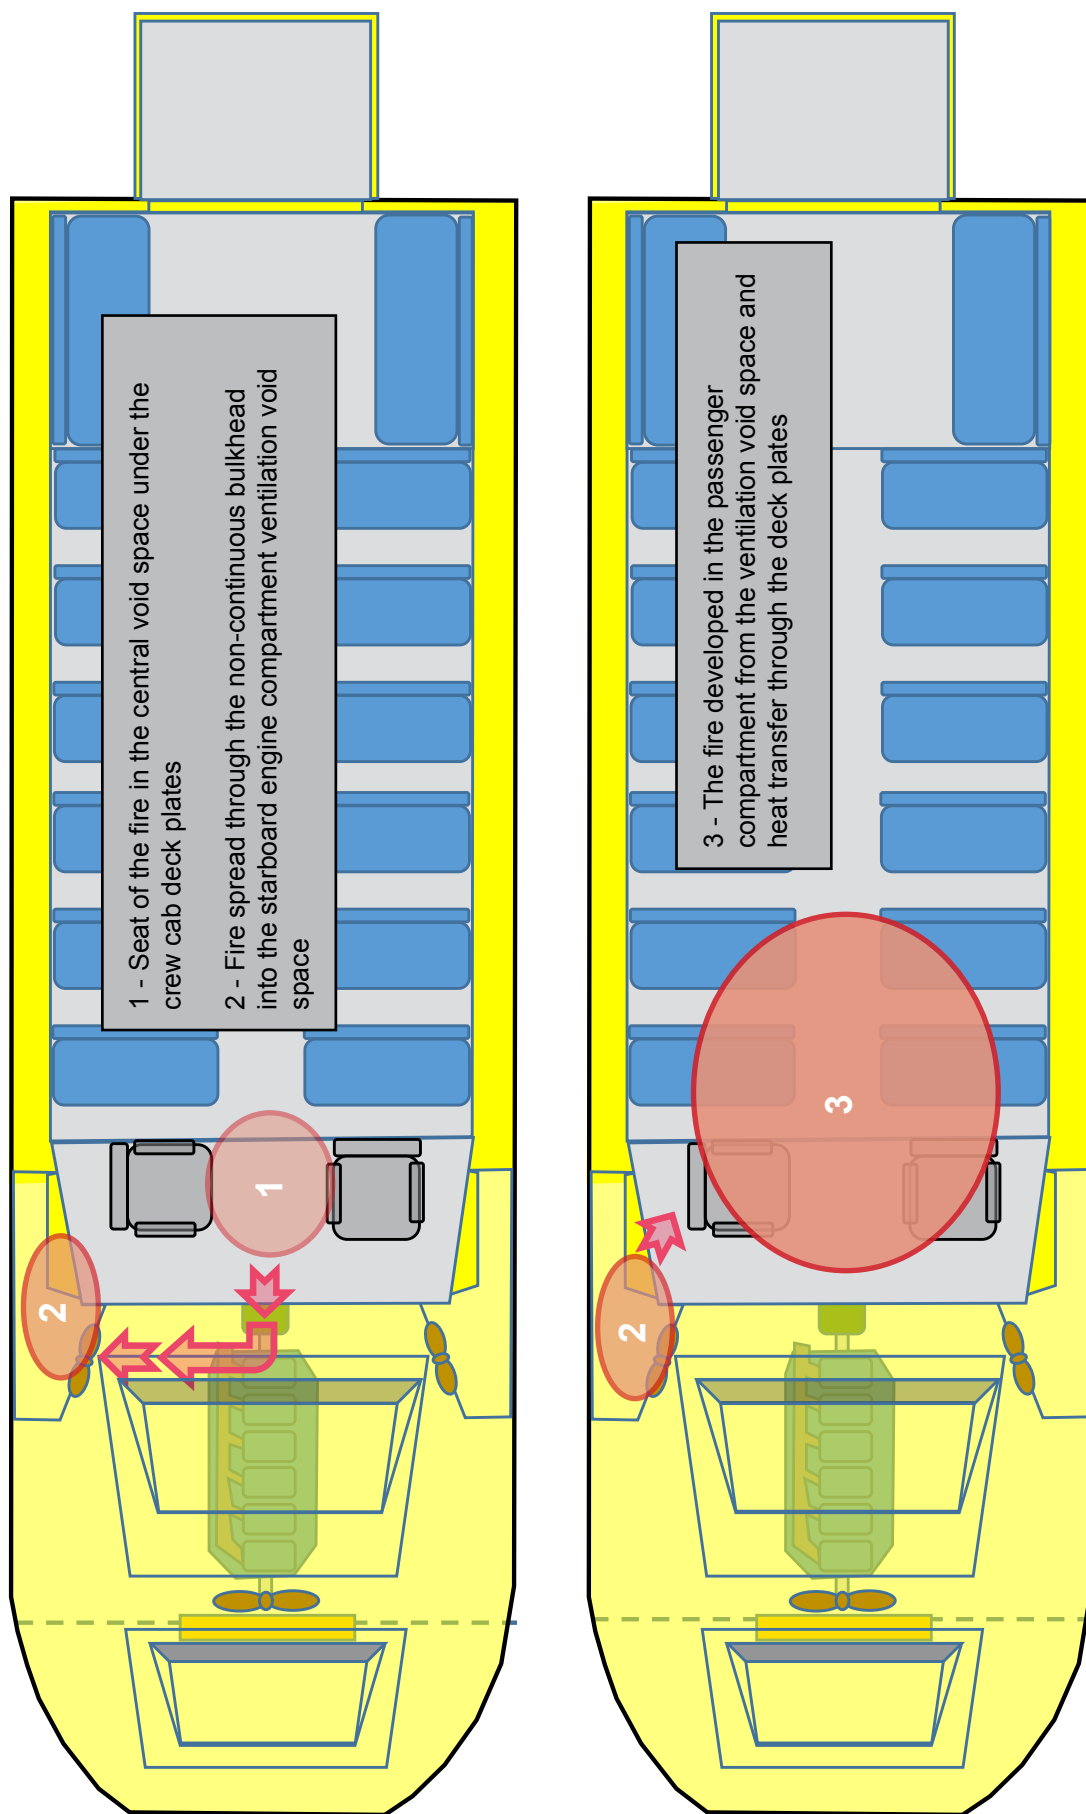
**Figure 61:** Fire development

The engine compartment's starboard extraction fan and the engine radiator fan would have drawn the flames and hot gases into the engine compartment through the holes in the transverse bulkhead (**Figure 61**). From here, the starboard extraction fan forced the smoke and flames through the engine compartment's starboard ventilation void space, pre-heating and subsequently igniting the buoyancy foam contained within it. Again, this is supported by witness accounts that described the smoke as being initially white/grey and then turning black. This is consistent with the fire laboratory's findings that, when burning, the low-density foam (packed in the central void space) and the high-density foam (packed in the engine compartment's ventilation void spaces) produced light grey and black smoke respectively.

Laboratory analysis of the UJs (**Paragraph 2.12.2**) used to connect the splined drive shaft to the automatic gearbox and the MTB determined that both had suffered excessive wear. In particular, the laboratory report identified that the journal cap supporting the needle roller bearings on one of the arms fitted to the forward UJ had fractured circumferentially and that the needle roller bearings had suffered from pre-existing overheating. The report identified that temperatures of between 300 and 400°C would be required to cause the bluing that was evident on the needle rollers. These temperatures would have been sufficient to ignite the foam, particularly the fine shards of grease contaminated foam that were present at the time.

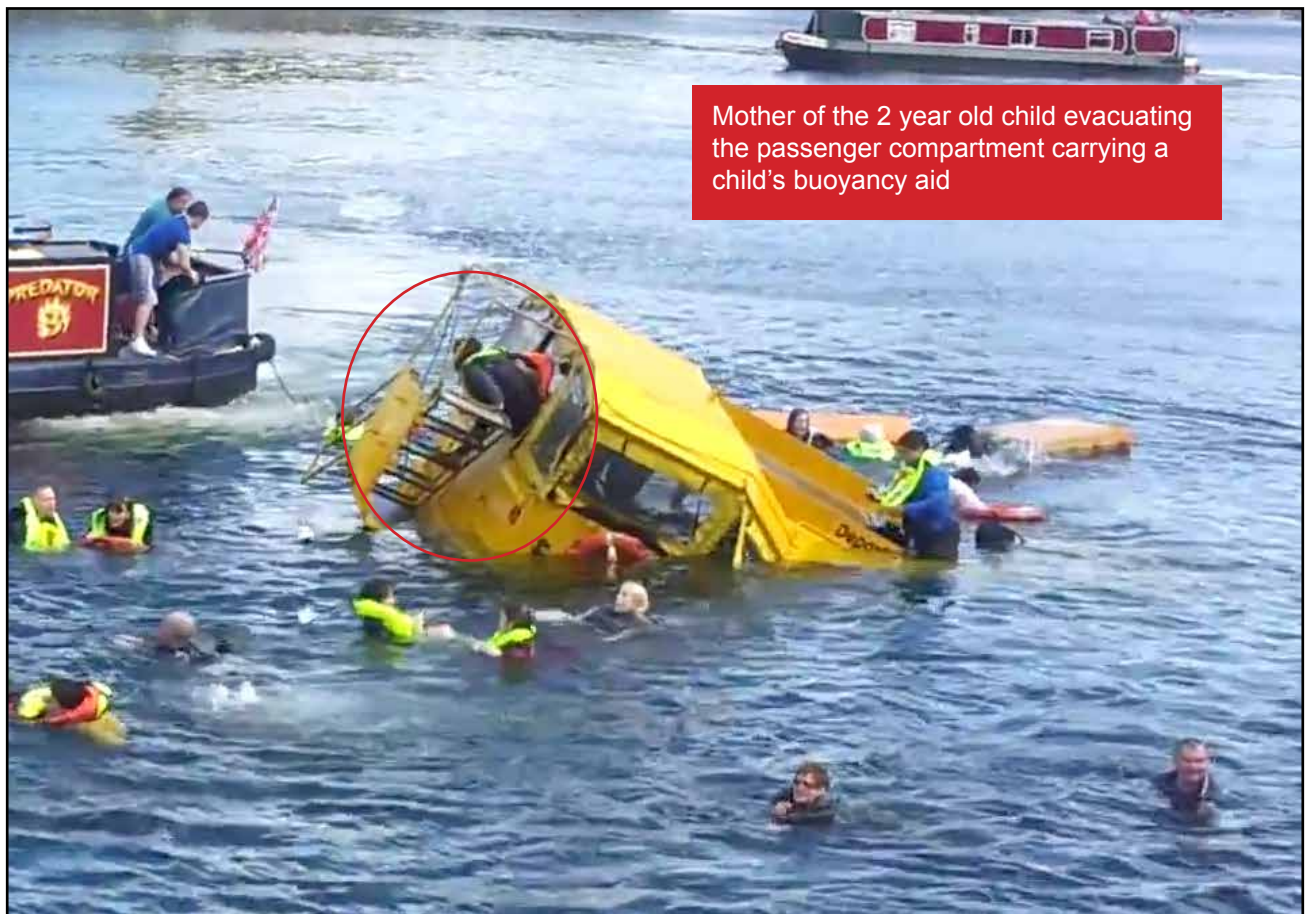
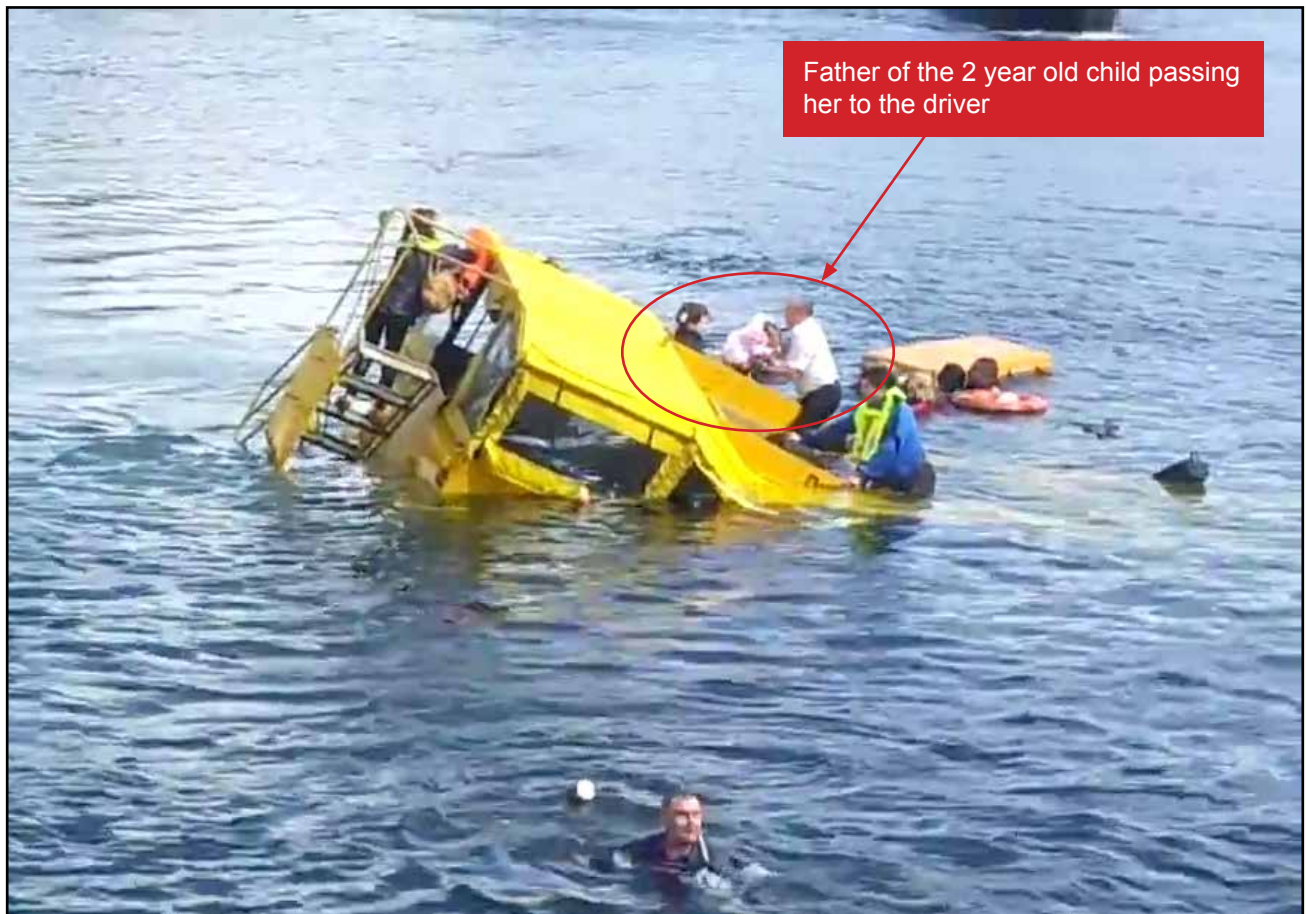
**Figure 62:** The last of the passengers to escape from *Wacker Quacker 1's* passenger compartment

When *WQ1* sank, the driver and several of the passengers were still inside the vehicle. Fortunately, when the bow of the vehicle touched bottom, the stern remained above water and they were able to escape through the side and stern windows. The last passenger to escape, the mother of the 2 year old child, climbed over the passenger compartment access door onto the boarding platform (**Figure 62**).

Although the MCA's intervention did not achieve its aim of keeping a flooded vehicle afloat and upright, fitting more foam into the vehicles did slow the sinking process and helped keep the stern section of *WQ1*'s canopy above water. This gave the passengers and crew vital extra seconds to abandon the vehicle and provided a platform to keep the 2 year old child out of the water (**Figure 62**). Those two positive outcomes almost certainly helped to save lives.

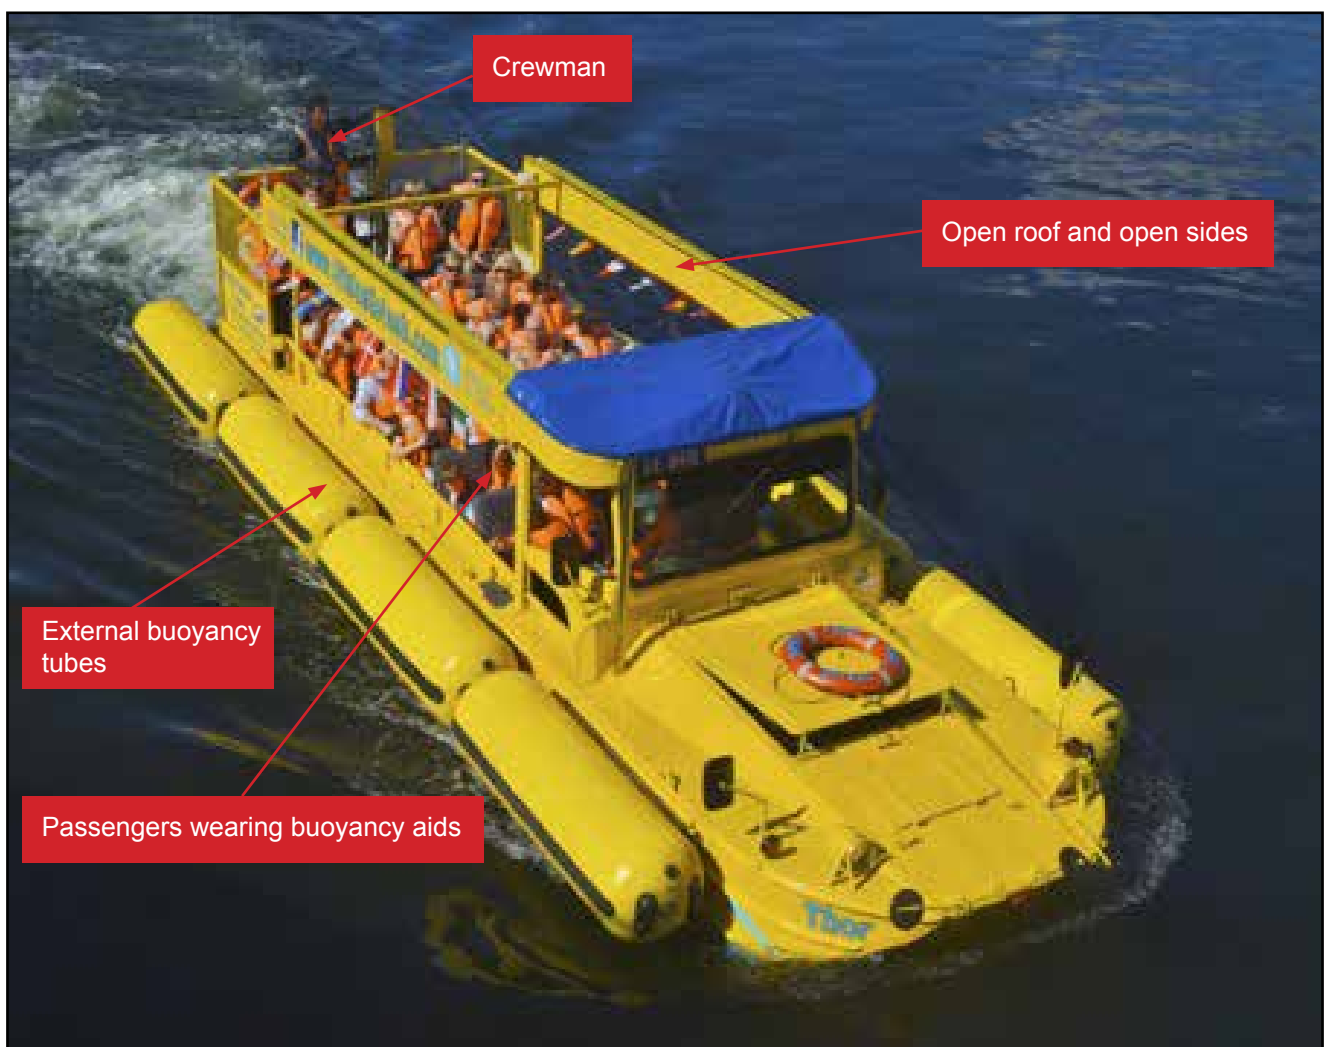
**Figure 63:** Dublin DUKWs operating with external buoyancy tubes and open canopy

- Fit external buoyancy tubes (**Figure 63**) designed to slow the sinking process and make the vehicle sink bodily.

- Retract the canopy roof and open the side curtains prior to entering the water.
- Require passengers and crew to wear PFDs while on the water.

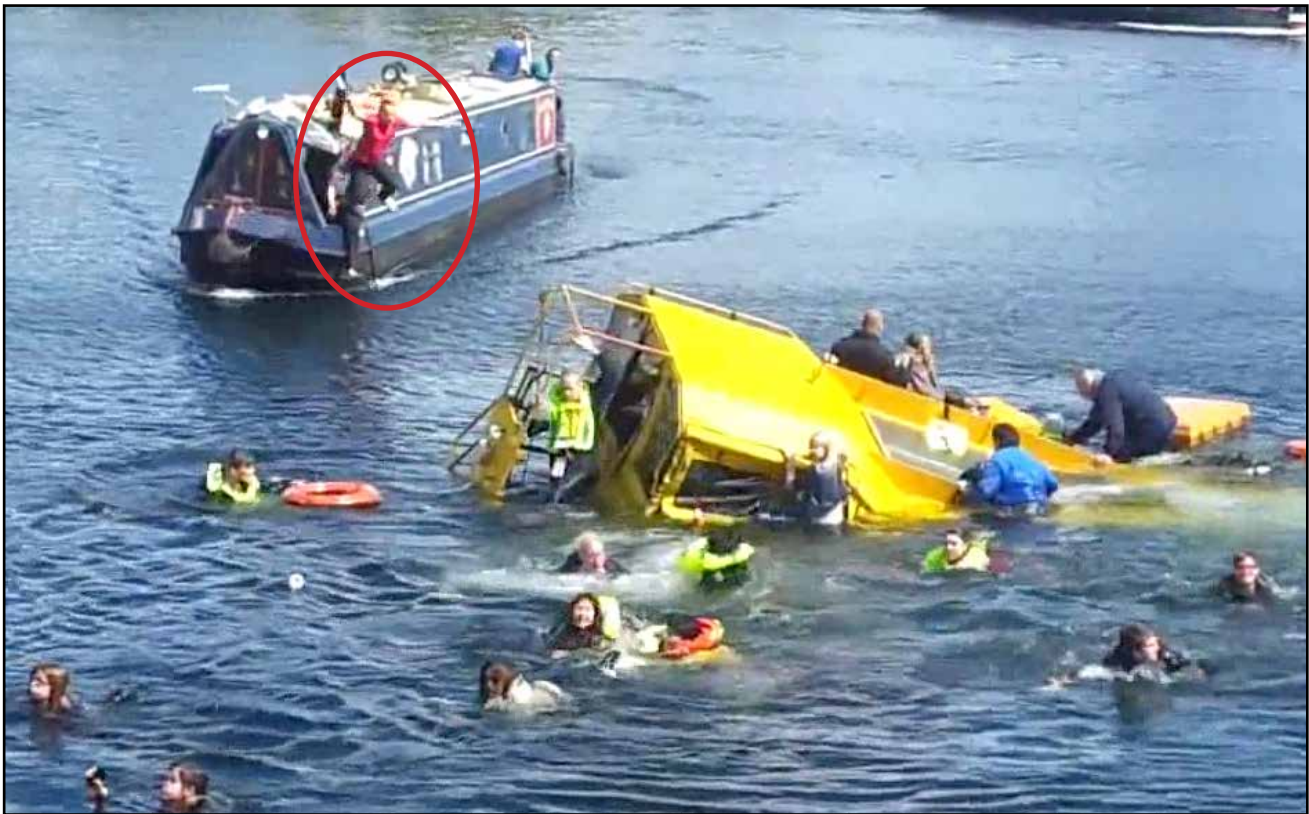
**Figure 64:** Member of the public jumping from *Predator 3* to help passengers in the water

The efforts of the narrowboat crews were instrumental in the safe recovery of many of those in the water, particularly as some were struggling to, or could not swim. The young man who jumped into the water from the bow of *Predator 3* (**Figure 64**) to assist those struggling in the water was fully aware of the risk he was taking, and should be commended for his bravery.
