**Foundering of the fishing vessel**

***Diamond***

**resulting in the death of a crew member**

**25 March 2014**

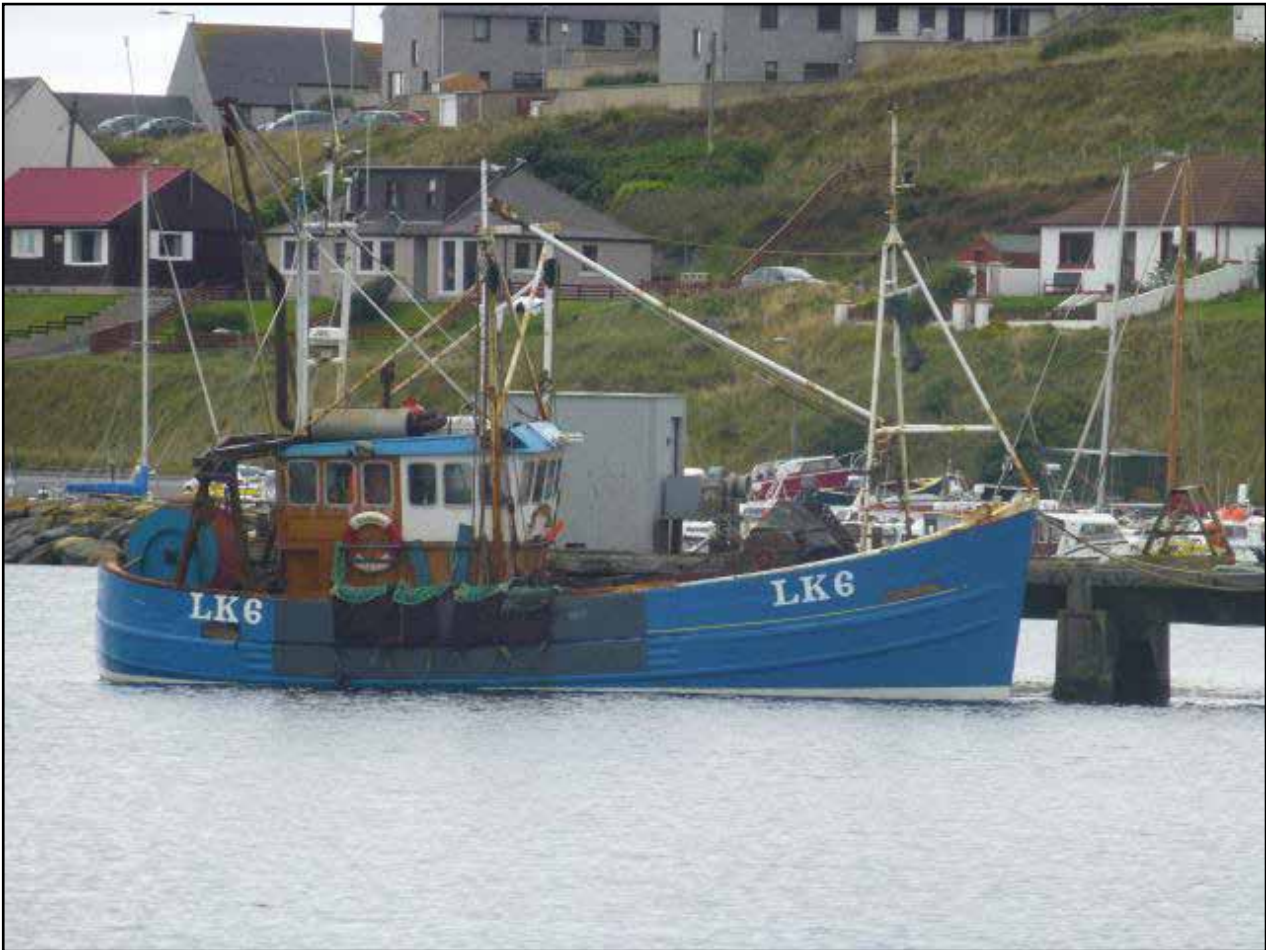
**Figure 1:** *Diamond* (LK 6)

The 12.2 metre long fishing vessel *Diamond* (**Figure 1**) was built in 1962 as a stern rigged trawler and was later modified for scallop dredging. The vessel was of wooden construction and registered in Lerwick, Shetland. The internal transverse bulkheads separating its forward space, hold, engine space and lower accommodation space were not watertight. The draught of the vessel was 2 metres.
