Rail Accident Report

**Fatal accident involving a track worker near
Newark North Gate station
22 January 2014**

Report 01/2015
February 2015

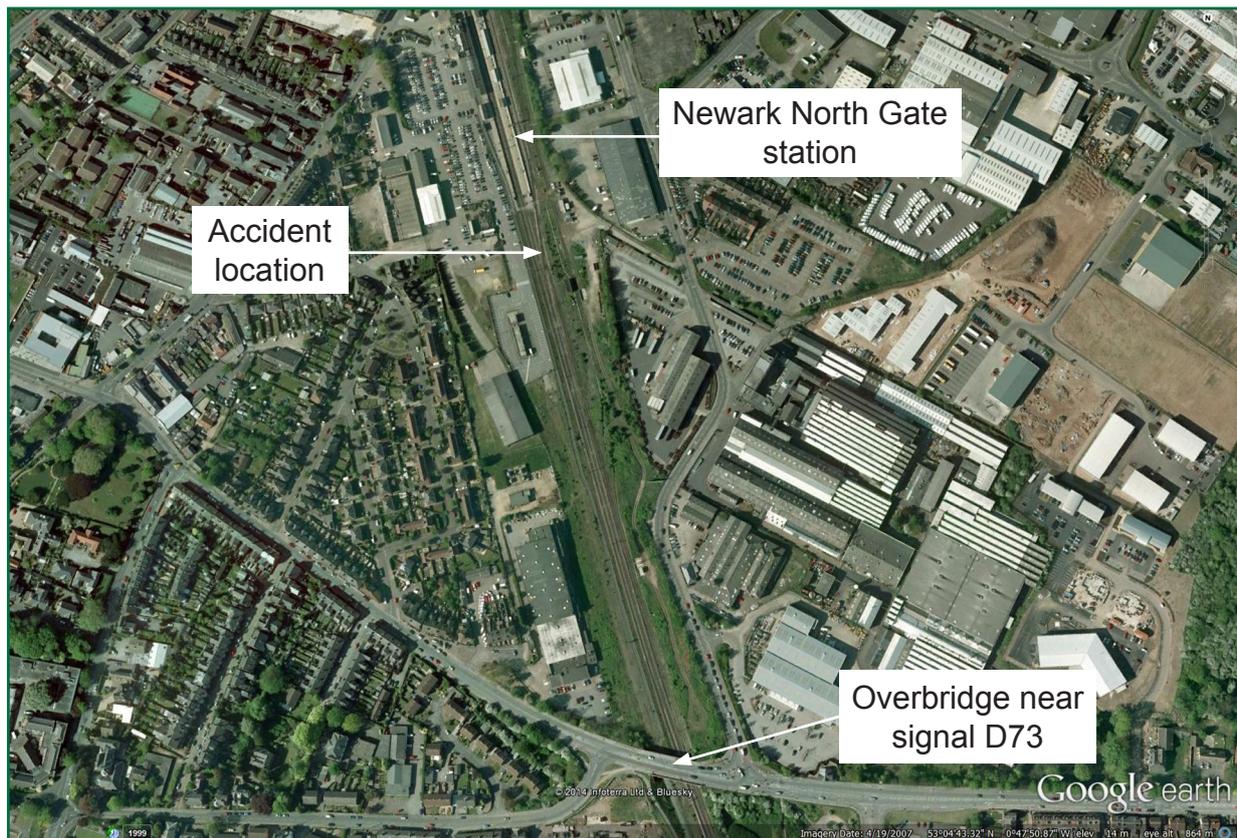
Figure 2: Google earth image of the accident site

- 8 Before the accident, there were two track inspection staff at the site on the *up* main line, the lookout and the operator of the ultrasonic test equipment (hereafter called the tester). As the train approached, it sounded its horn as a warning. The lookout and tester each acknowledged the horn by raising one arm above their heads (as required by the railway *rule book*) and moved to an adjacent siding which the *controller of site safety* (COSS) had reportedly nominated as the *position of safety*. Around 12 seconds later, as the train was crossing over from the up main line to the up/down Passenger Loop, the lookout moved from the position of safety and onto the second crossover where he was struck by the train. He suffered serious injuries and subsequently died in hospital on 31 January 2014.

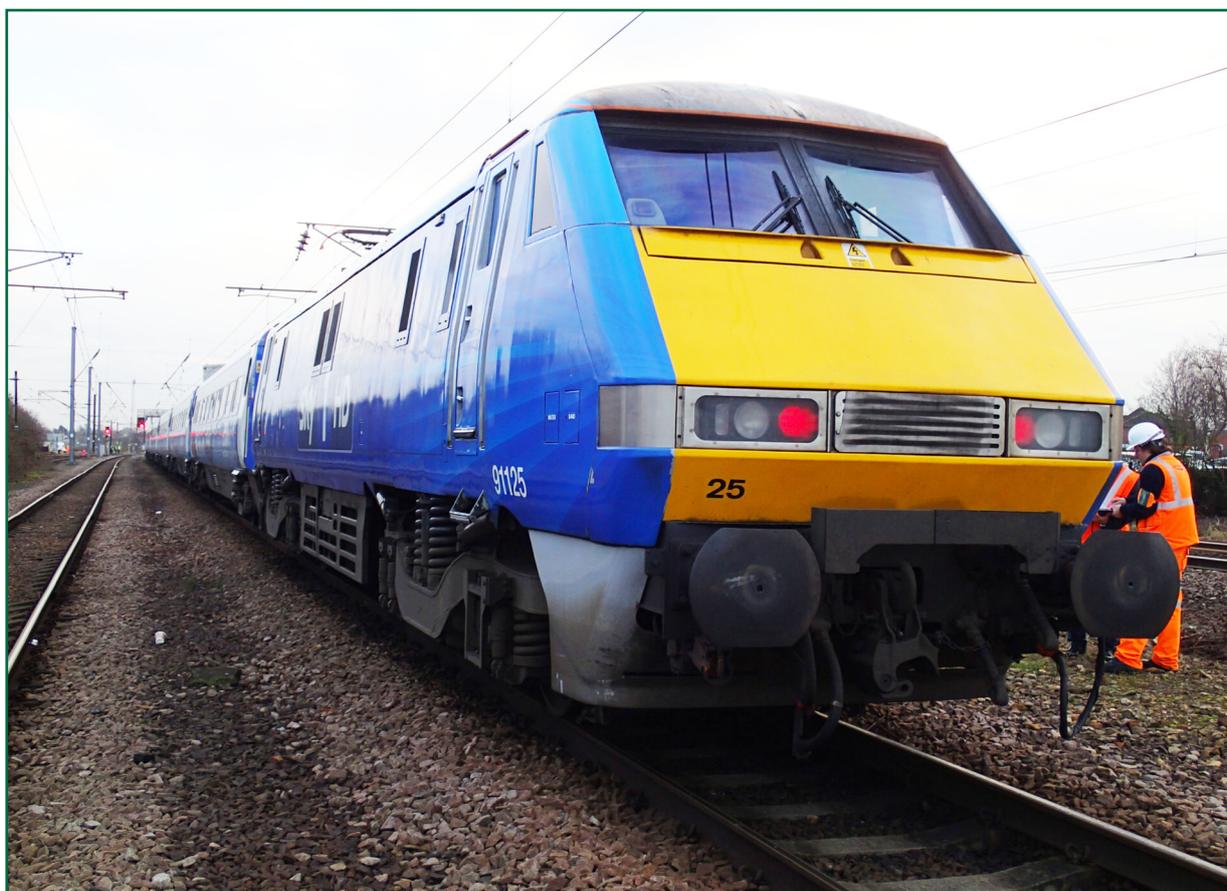
Figure 4: Train 1B82

- 16 Train 1B82 comprised a class 91 locomotive at the leading end (figure 4), nine coaches and a *driving van trailer* at the rear. It was the first of four off-peak services from London Kings Cross to Newark North Gate that day and was scheduled to arrive at Newark North Gate at 11:33 hrs.
