# Rail Accident Report

**Derailment of a freight train at Stoke Lane Level  
Crossing, near Nottingham  
27 August 2013**

Report 02/2015  
April 2015

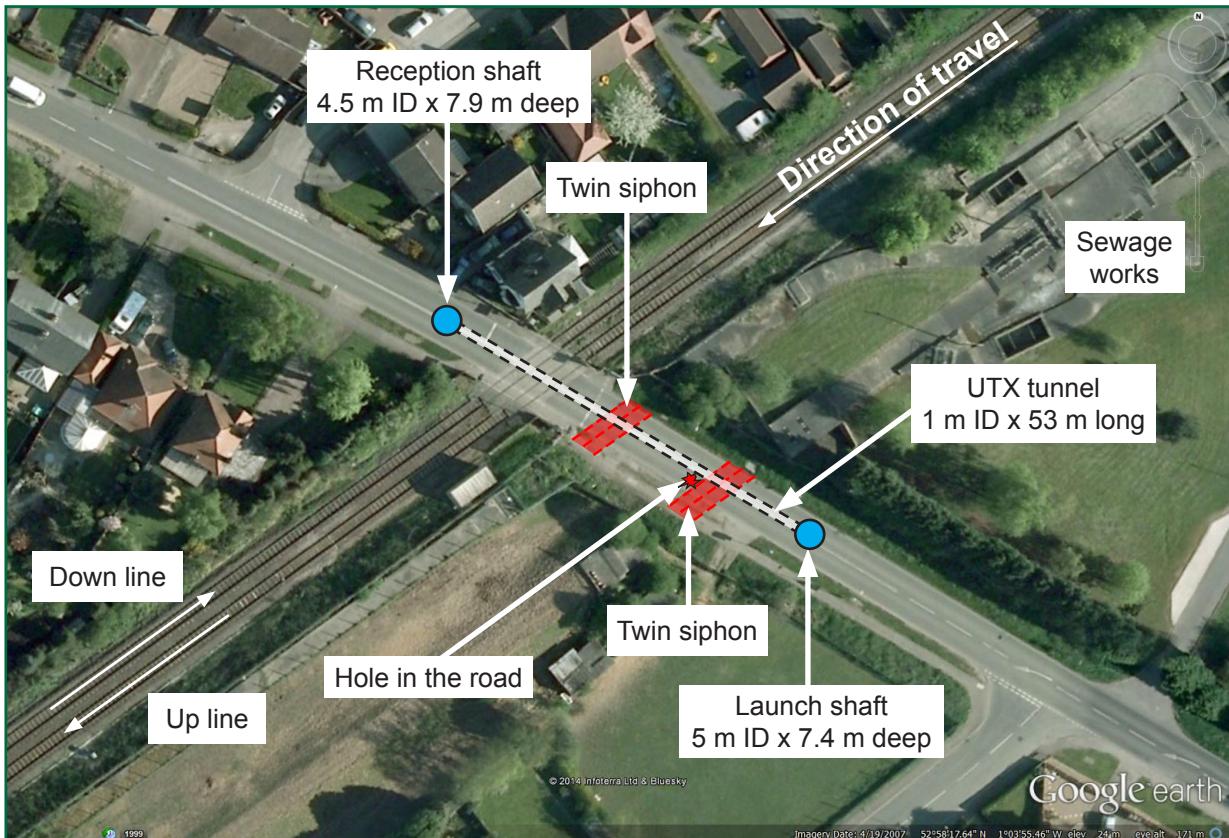
Figure 5: Google image of the level crossing, with microtunnel and construction shafts marked

- 11 At this location there is an *under track crossing* (UTX) which had been built under the road and railway, seven weeks prior to the derailment (figure 5). The UTX was built to carry six 132 kV electrical cables along Stoke Lane as part of a larger project to build and connect a new substation on the east side of Nottingham at Stoke Bardolph. The UTX comprises a *microtunnel* around 53 metres long with an internal diameter of 1 metre and an external diameter of 1.2 metres. The crown of the tunnel lies at a depth of around 5.7 metres below ground level.

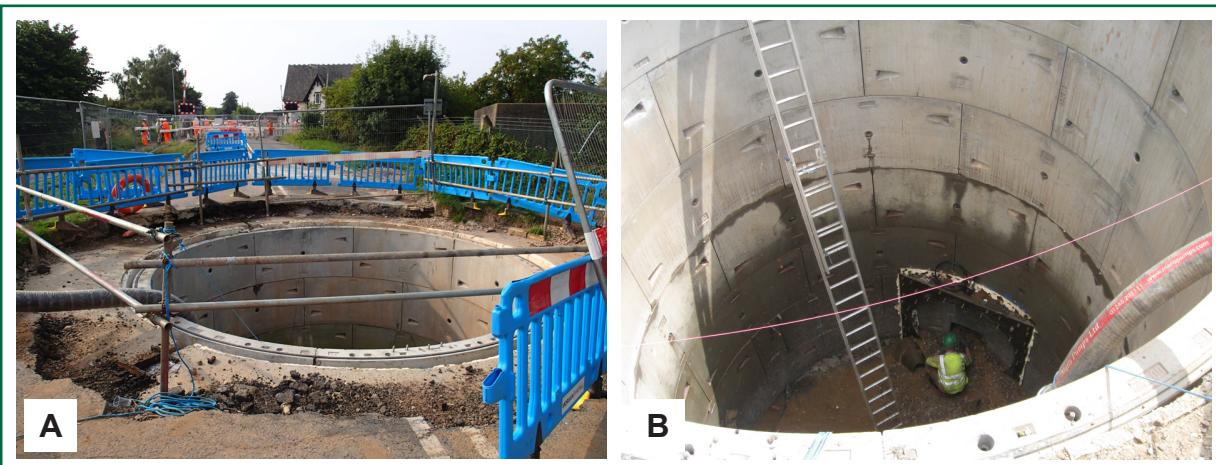
Figure 6: Launch shaft (a) and reception shaft (b) during the works (image courtesy of Morgan Sindall)

- 12 The microtunnel was bored by a *slurry shield tunnel boring machine* (TBM) (appendix D) and lined with 2.5 metre long concrete pipes (called *jacking pipes*), locked together end to end. In order to bore the microtunnel, two vertical shafts had to be built first. The launch shaft was built at the south eastern end of the tunnel and used to insert the TBM into position and then drive it and the jacking pipes forwards, along the path of the tunnel. At the north western end, the reception shaft was used to retrieve the TBM. These shafts (figure 6) are also the entry and exit points for the 132 kV electrical cables. A cross section along the centre line of the road showing the position of the microtunnel and shafts in relation to the railway is shown in figure 7.

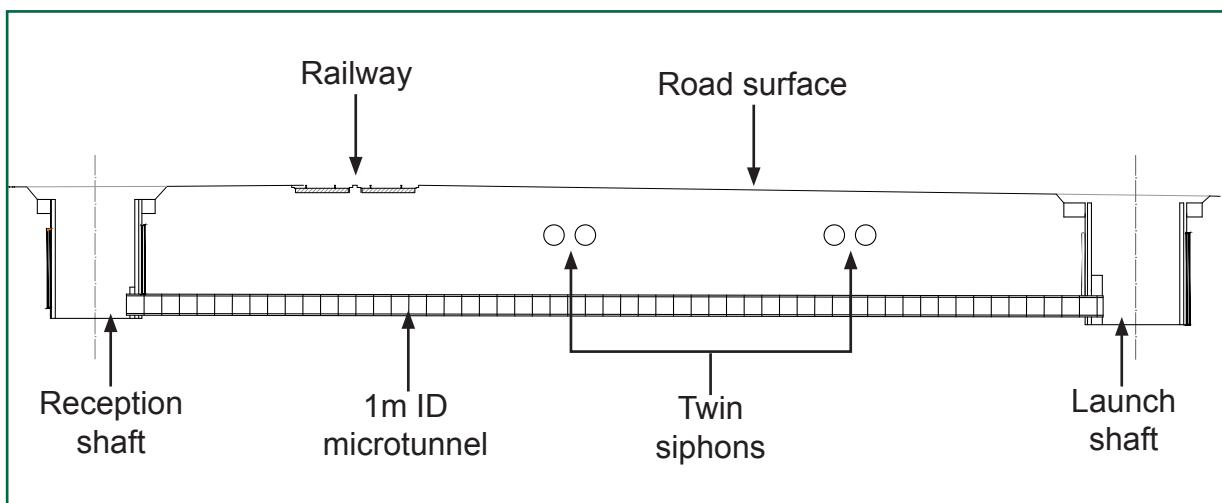
Figure 7: Schematic cross-section through microtunnel and construction shafts

13 Between the launch shaft and railway, two twin sewer siphons (figures 5 and 7) run across the road and parallel to the railway and carry sewerage from Nottingham into the Stoke Bardolph sewage works (figure 5). The twin siphons nearest the railway comprise two 1.2 metre diameter cast iron pipes located around 3 metres below ground level and date back to circa 1880. The twin siphons nearest the launch shaft are believed to be cast iron pipes of about 1.3 metres diameter each and encased in concrete. The two twin siphons have a combined flow capacity of around 6 m<sup>3</sup>/sec and their location was a factor in deciding the depth of the microtunnel.

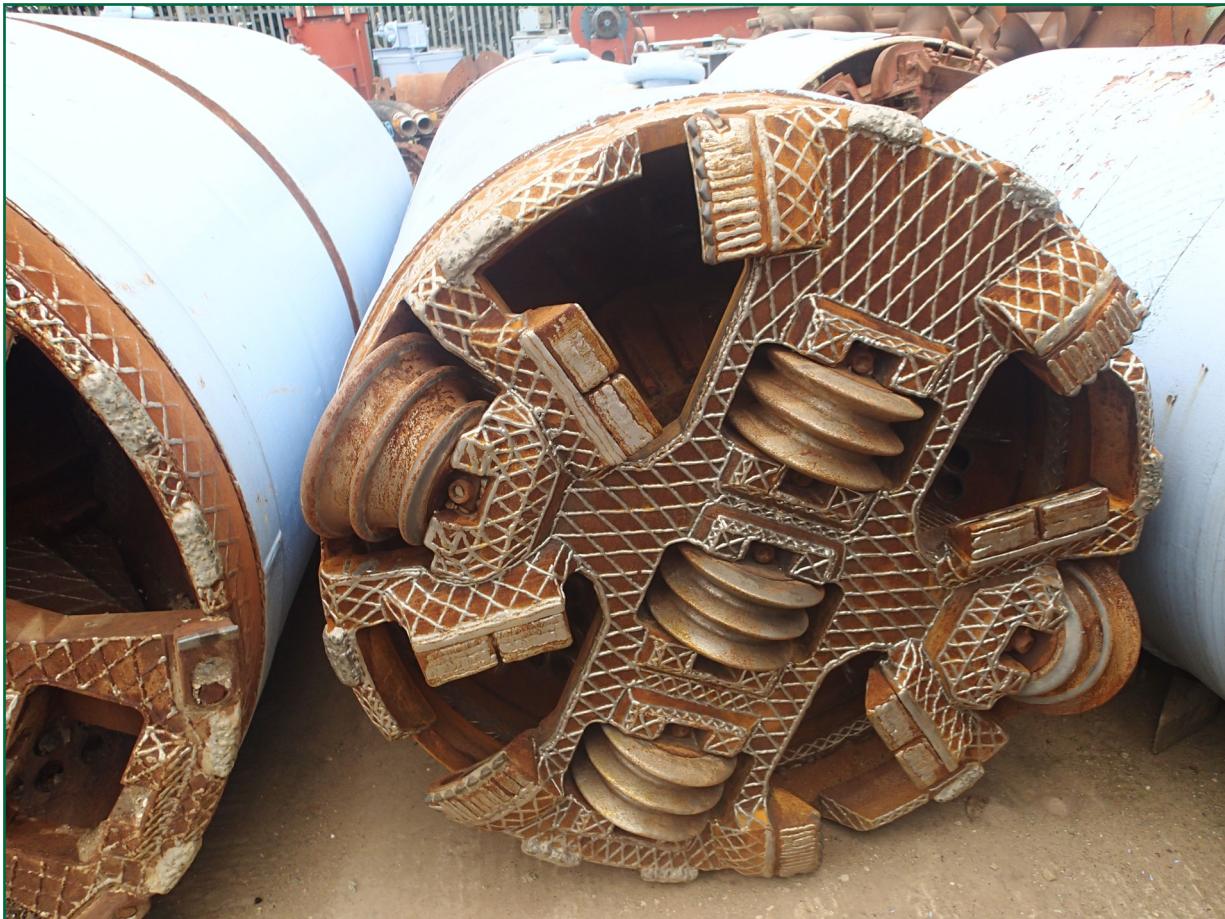
Figure 10: TBM cutter head

- 54 The UTX at Stoke Lane was bored using a slurry shield tunnel boring machine (TBM), described in appendix D. The minimum amount of material that must have been removed by the 1.25 metre diameter TBM cutter head (figure 10) to bore out a 53 metre long tunnel, is around  $65 \text{ m}^3$ . The combined volume of the near surface and deep voids (shown in red and green in figure 9) was around  $54 \text{ m}^3$ , which indicates there had been additional ground loss<sup>4</sup> of around 80%. The RAIB was advised by its consultant that a typical upper bound value of ground loss for a tunnel of this type and size would be around 5%.

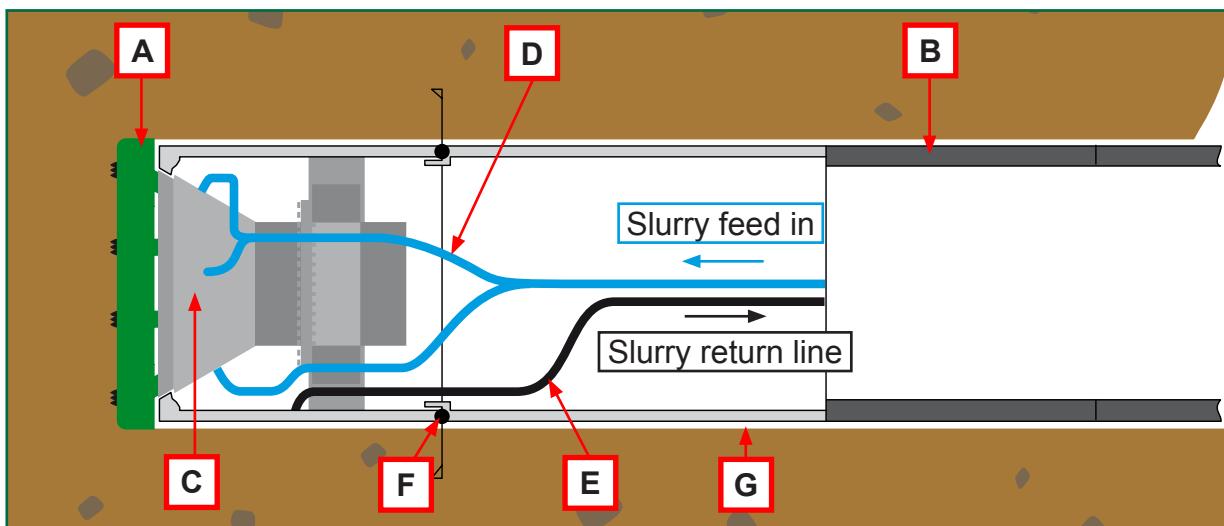
Figure D1: Schematic of a slurry shield TBM

The machine is remotely operated from a control cubicle at the surface. It works by cutting the ground with a rotating cutter head (A), which has rollers, scrapers and teeth, and which is pushed from behind by a series of concrete pipe sections (B). The pipes are pushed along the microtunnel by hydraulic jacks installed in the launch shaft. The process has to be paused periodically to insert a new pipe; at Stoke Lane this was every 2.5 metres. The cut ground falls into the excavation chamber (C) of the TBM. A crushing device (called a 'cone crusher') in the excavation chamber breaks up any large lumps as the cutter head rotates.

If the machine is being used in unstable ground such as wet sands and gravel below the water table, the excavated face must be supported while the TBM is operating, to prevent uncontrolled collapse of the ground into the excavation chamber, potentially leading to overmining. According to industry best practice this is achieved by feeding in a pressurised slurry (D), comprising water mixed with bentonite (or a polymer), into the excavation chamber. The pressure in the excavation chamber (called the face pressure) forces the slurry into the tunnel face in front of the cutter head, where it permeates into the ground, leaving a thin layer of bentonite (called a filter cake) on the surface of the ground. This layer of bentonite impregnated ground supports the areas of the tunnel face which are exposed as the cutter head (figure 10) rotates, while the slurry pressure counterbalances the ground water pressure. For excavation in some types of soil, such as clays, bentonite may not be required. In such cases the slurry may simply comprise water and a proportion of suspended clay material from the excavation face.

The plant separates the cut ground from the slurry, which is then recycled back to the TBM. The TBM has an articulation joint (F) which allows it to be steered by means of hydraulic jacks within the TBM (not shown) to maintain horizontal and vertical alignment as the TBM is driven forwards, using lasers and targets.

The cutter head diameter is slightly larger than the diameter of the main body of the TBM and the pipes and this results in an annular void space around the pipes (G) which, in accordance with industry best practice, should be filled with bentonite to prevent the ground closing in on the pipes.
