Report on the investigation of
the loss of the yacht
Cheeki Rafiki
and its four crew
in the Atlantic Ocean,
approximately 720 miles east-south-east of
Nova Scotia, Canada
on 16 May 2014

SYNOPSIS

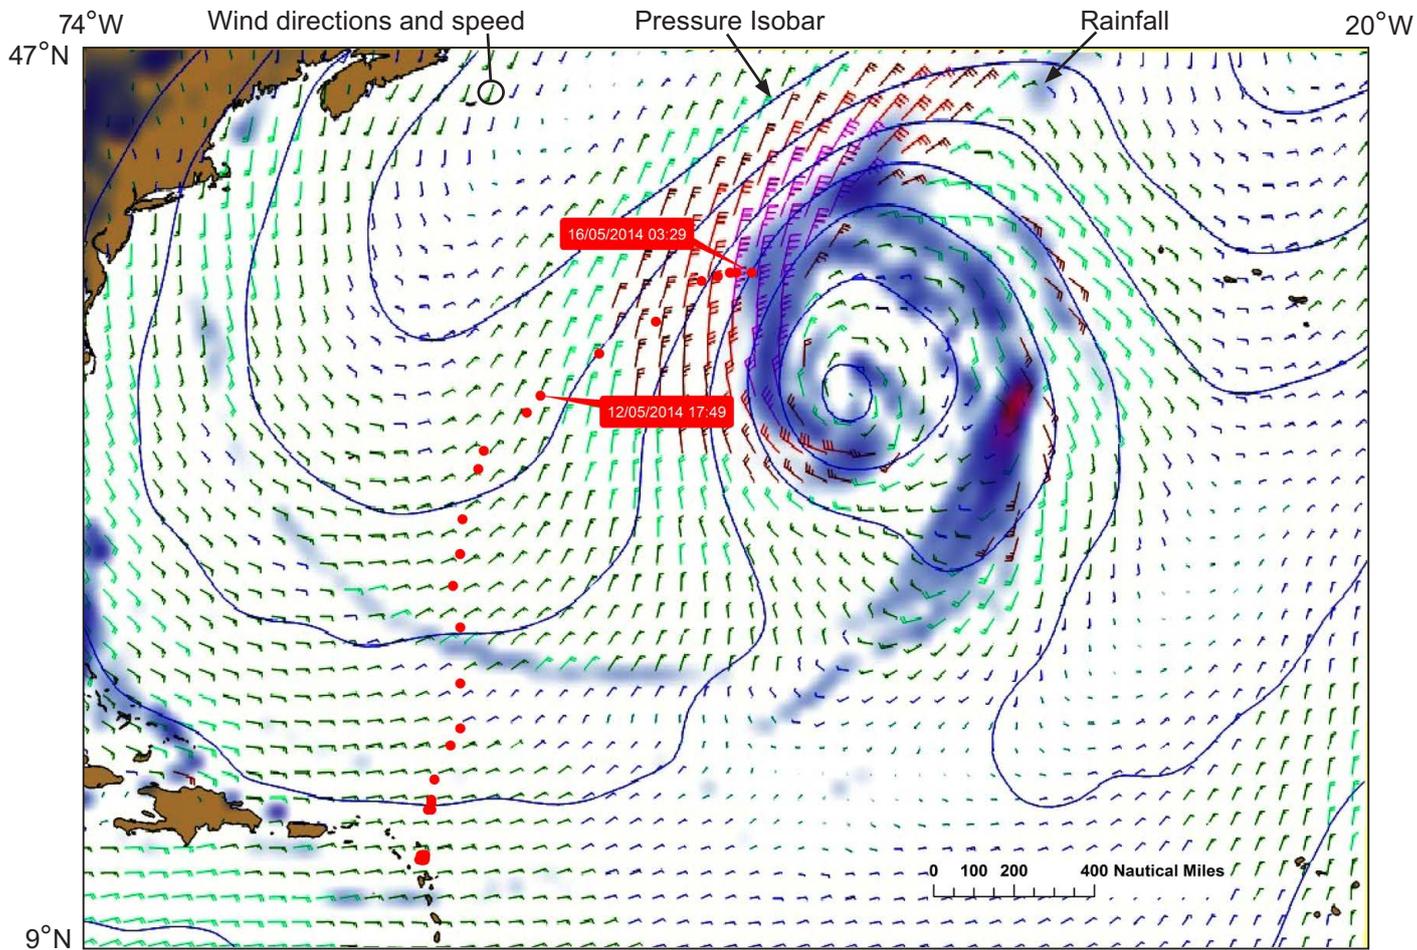
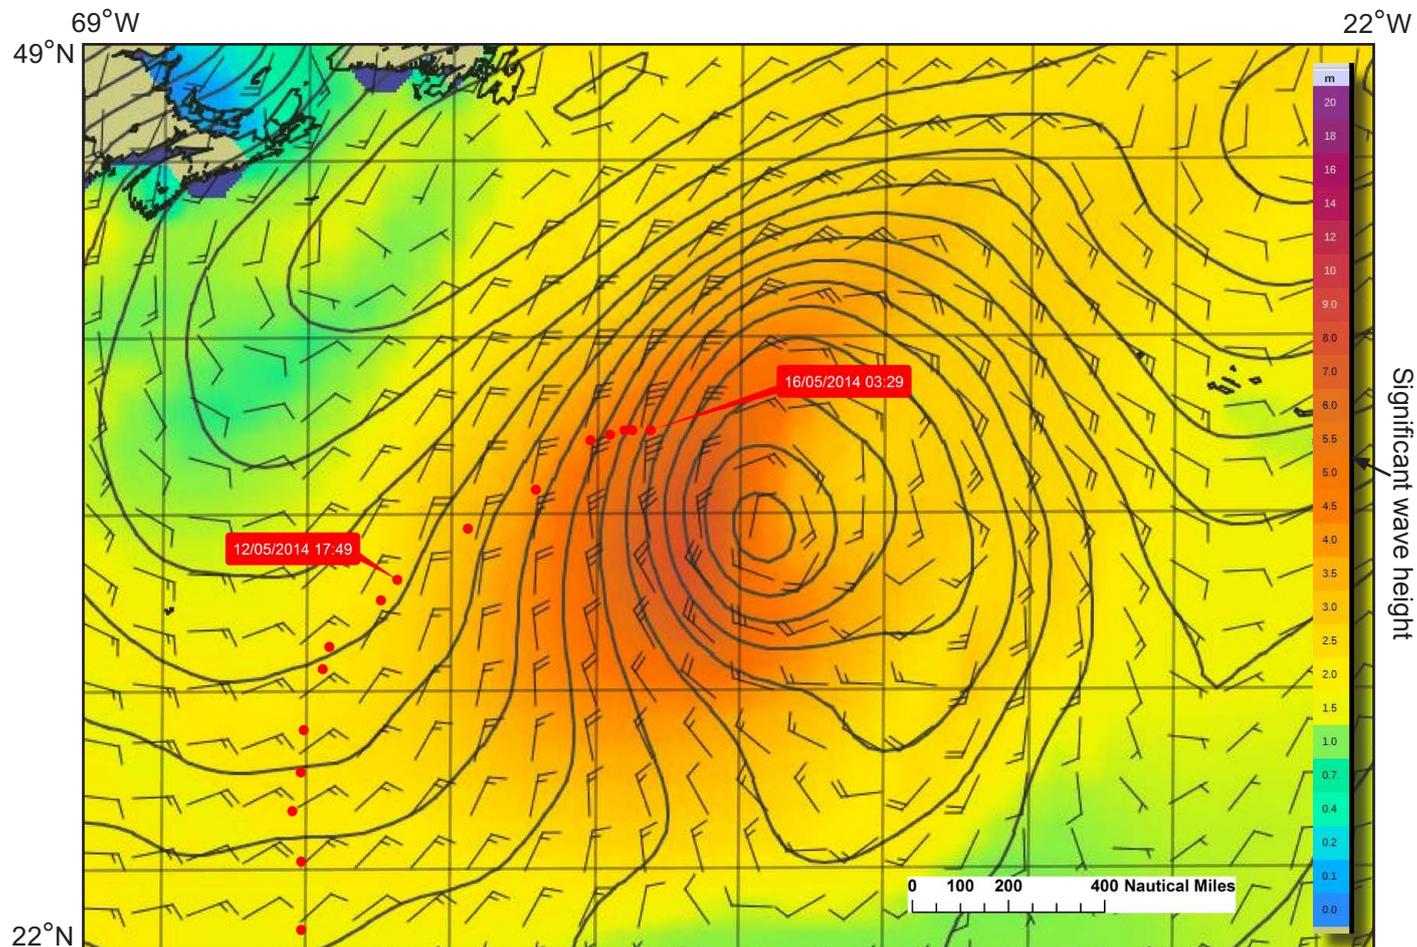
Figure 4: Ugrib forecast conditions for 0300 16 May 2014, as predicted at 0600 on 12 May 2014

Figure 5: zyGrib forecast conditions for 0300 16 May 2014, as predicted on 12 May 2014

In his email of Saturday 10 May the skipper reported having to use the engine the previous night due to light winds, and when the principal/director replied to that email on Monday 12 May he advised the skipper to '*perhaps steer NE*'. The principal/director's email mentioned that there would be lightish winds until Wednesday, but did not warn of the worsening conditions thereafter (see **Figures 4** and **5**) that were predicted in the Ugrib 12 May 0600 forecast.

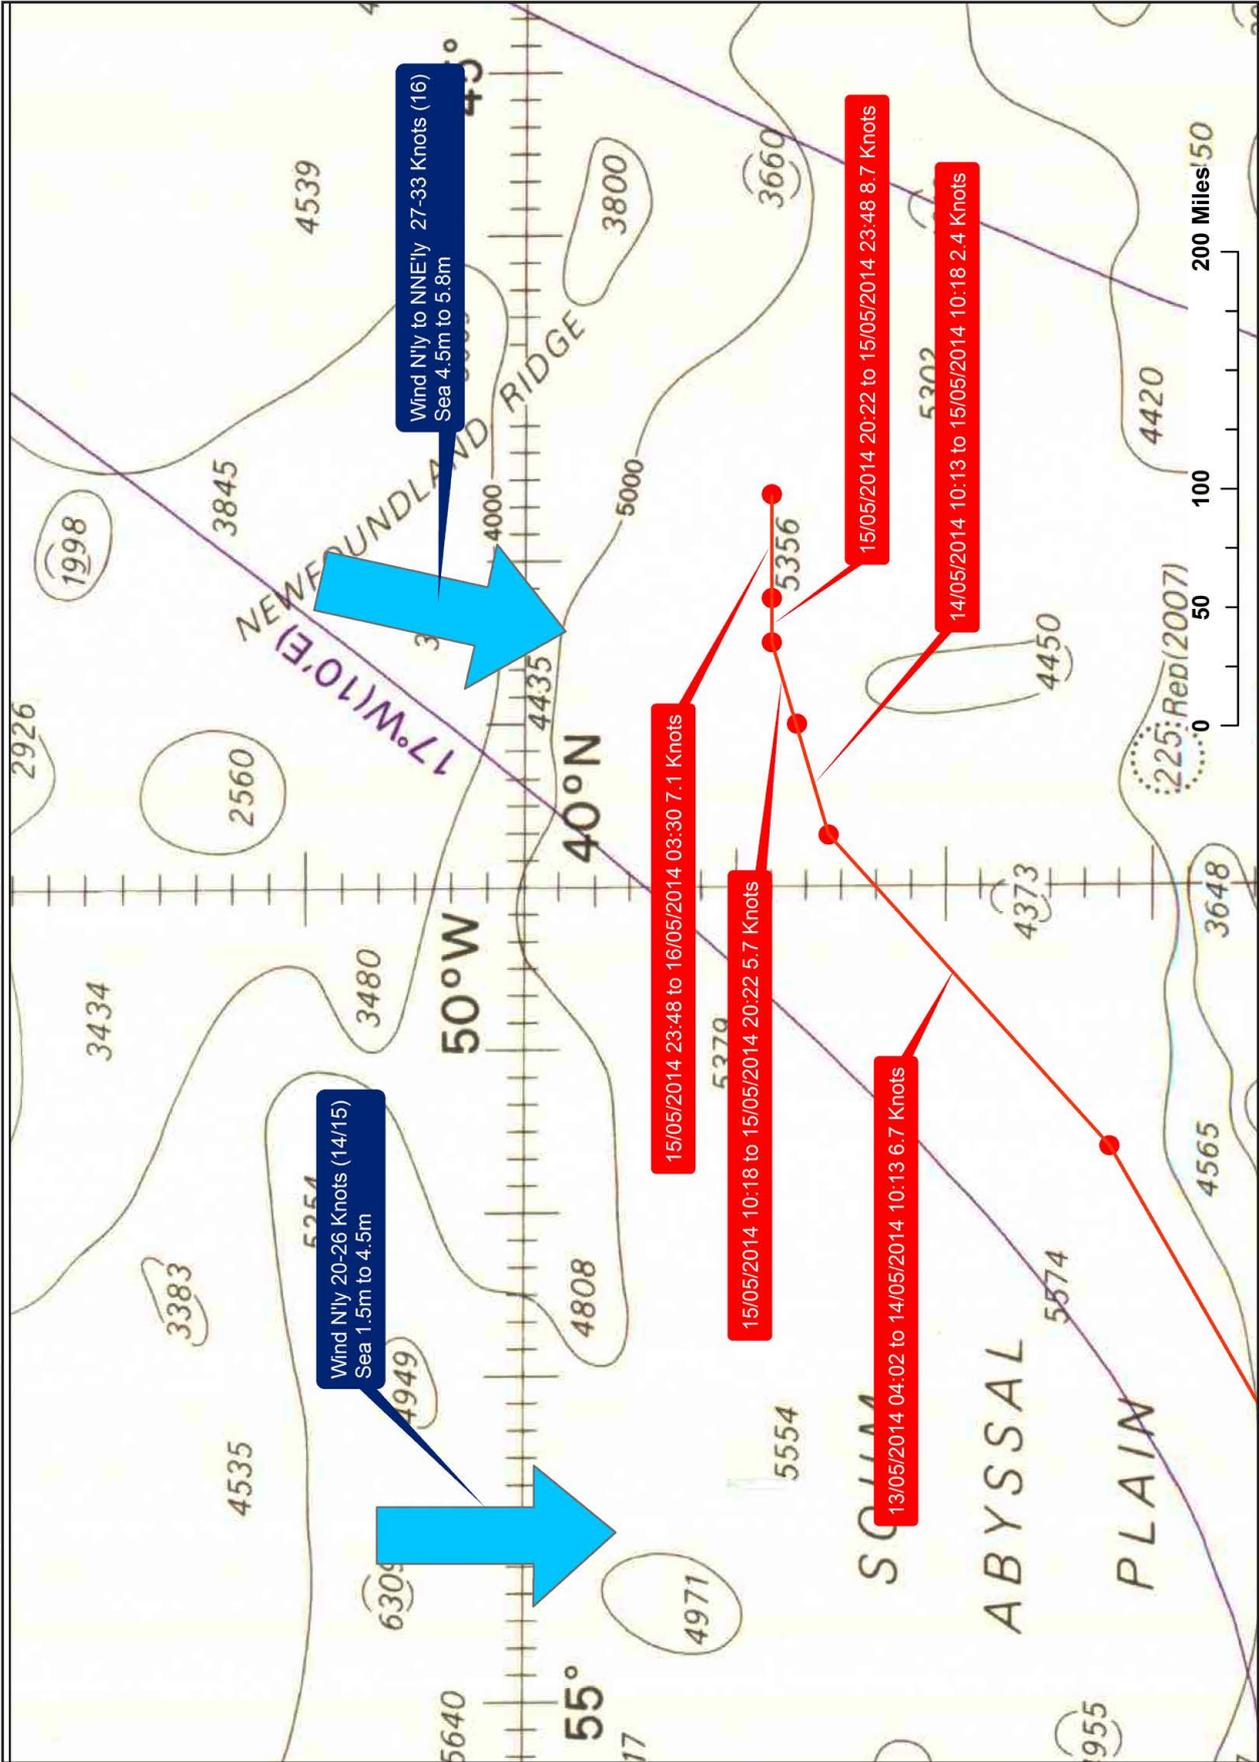
Figure 20: Cheeki Rafiki's indicative courses and speeds made good obtained from its Iridium satellite telephone recorded positional data between 14 May and 16 May 2014

Without the benefit of the principal/director's advice, it is possible that the skipper had neither identified nor considered that the source of water ingress was in the keel area. Consequently, it is probable that he had neither recognised the increasing risk of the keel becoming detached nor the danger of continuing on the same approximate course without reducing speed (**Figure 20**), producing high lateral keel load; a point not included in the principal/director's advice.
