## ACCIDENT

<b>Aircraft Type and Registration:</b>	CZAW SportCruiser, G-EWZZ	
<b>No &amp; Type of Engines:</b>	1 Rotax 912 ULS piston engine	
<b>Year of Manufacture:</b>	2010 (Serial no: LAA 338-14815)	
<b>Date &amp; Time (UTC):</b>	9 August 2014 at 1440 hrs	
<b>Location:</b>	Kingarth, Isle of Bute, Scotland	
<b>Type of Flight:</b>	Private	
<b>Persons on Board:</b>	Crew - 1	Passengers - 1
<b>Injuries:</b>	Crew - 1 (Serious)	Passengers - 1 (Fatal)
<b>Nature of Damage:</b>	Aircraft destroyed	
<b>Commander's Licence:</b>	National Private Pilot Licence	
<b>Commander's Age:</b>	53 years	
<b>Commander's Flying Experience:</b>	555 hours (of which 100 were on type) Last 90 days - 29 hours Last 28 days - 1 hour	
<b>Information Source:</b>	AAIB Field Investigation

## Synopsis

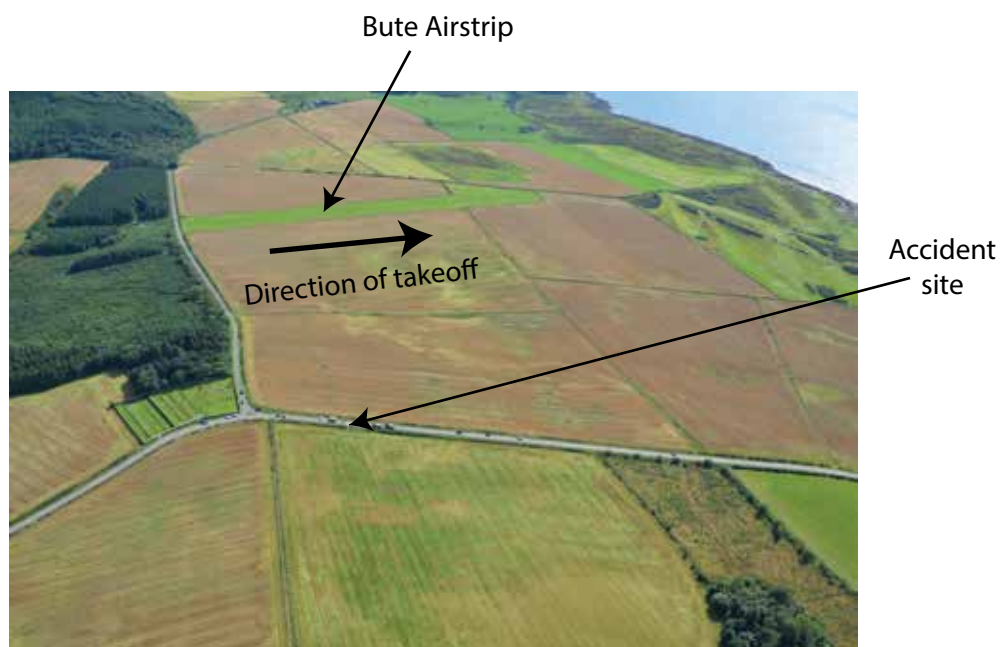
**Figure 1**

Bute airstrip is an unlicensed grass airfield located 850 m south-west of the village of Kingarth on the Isle of Bute, Figure 1. It has a single runway orientated 27/09 with a declared length of 480 m. The approach to Runway 27 is through a gap cut in a large area of trees which border the eastern end of the airfield. The sea is 600 m west of the end of Runway 27. Between the runway and the sea is an area of small rectangular fields orientated north-south and the edge of a links golf course.

The terrain surrounding the airfield has a pronounced slope up to the north from the runway. The surface of the fields on the lower slopes was very soft though the ridge just north of the A844 road was relatively firm. There are various power and communication wires crossing the fields parallel to the runway.

Bute airstrip (Photo courtesy of Police Scotland)
