Report on the investigation of  
a fatal accident to the skipper of fishing vessel

***Ronan Orla***

3 miles north-east of Porth Dinllaen

on 30 March 2014

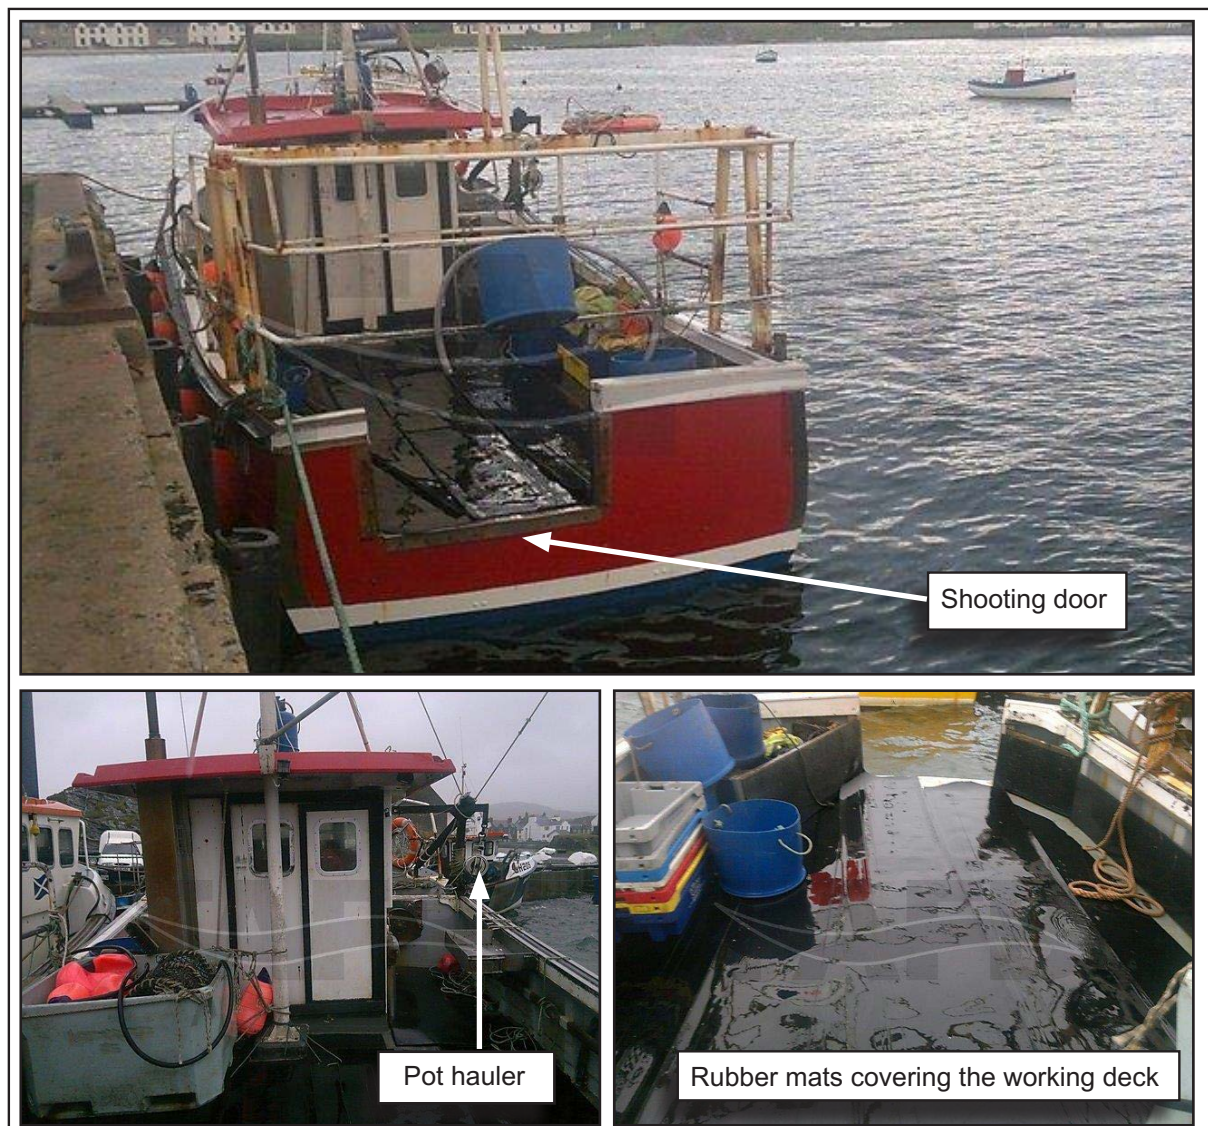
Previously based in the Isle of Islay, Scotland, *Ronan Orla* had been used as a potting vessel (**Figure 4**) and operated with a Category A<sup>2</sup> under 10m shellfish licence. The skipper purchased *Ronan Orla* and its licence with the help of a bank loan in March 2012 and sailed it to Porth Dinllaen. Initially, the skipper used *Ronan Orla* as a potter to fish for whelks, but was commercially unsuccessful.

**Figure 4:** *Ronan Orla* rigged as a stern shooting potter

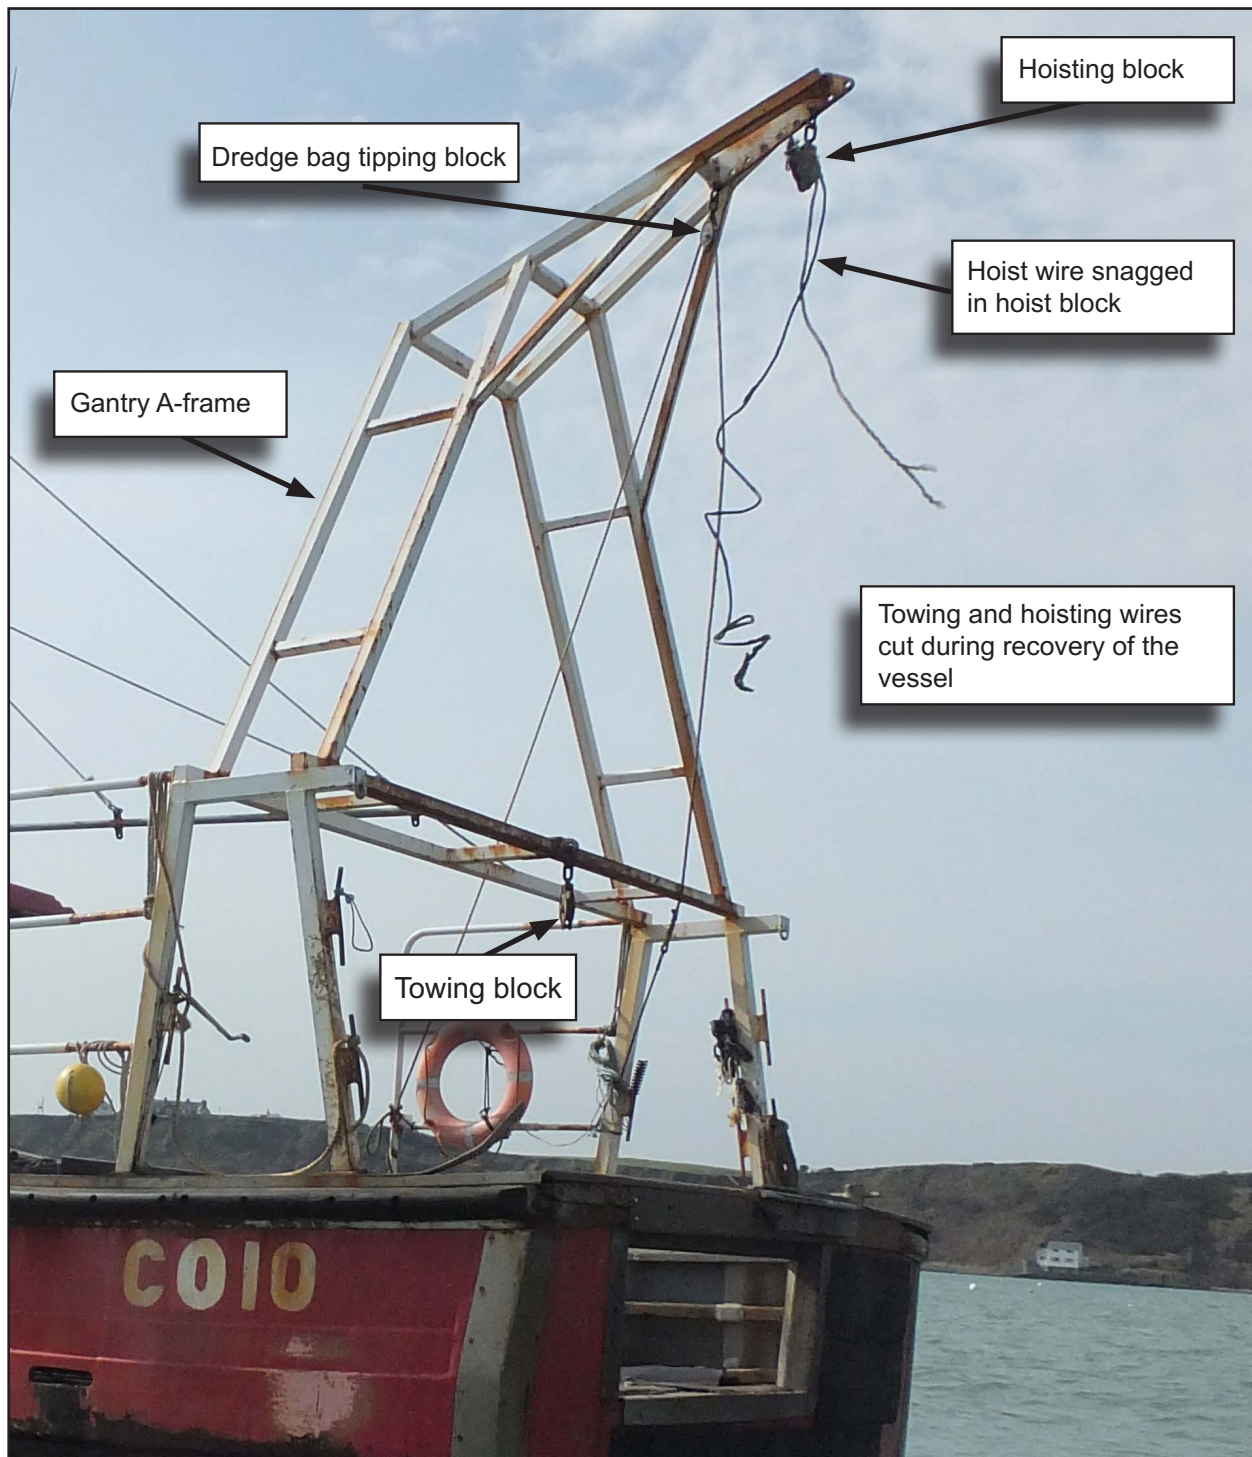
The modifications carried out for scallop dredging included the fitting of a mild steel A-frame (Figure 5) on top of the vessel's aft gantry and the installation of a dredge gear hauling winch. The A-frame, fabricated by a local mechanic, significantly increased the gantry height. This allowed the skipper to rig a high-level dredge gear

Figure 5: *Ronan Orla*'s modified gantry

There was no evidence found to suggest that the modifications were assessed against any recognised construction standards, or that any potential adverse effects on the vessel's stability or its safe operation were formally considered. The Sea Fish Industry Authority<sup>4</sup> (Seafish) provided a set of construction and outfit standards for small fishing vessels but there was no requirement for existing vessels undergoing modification to meet those standards.

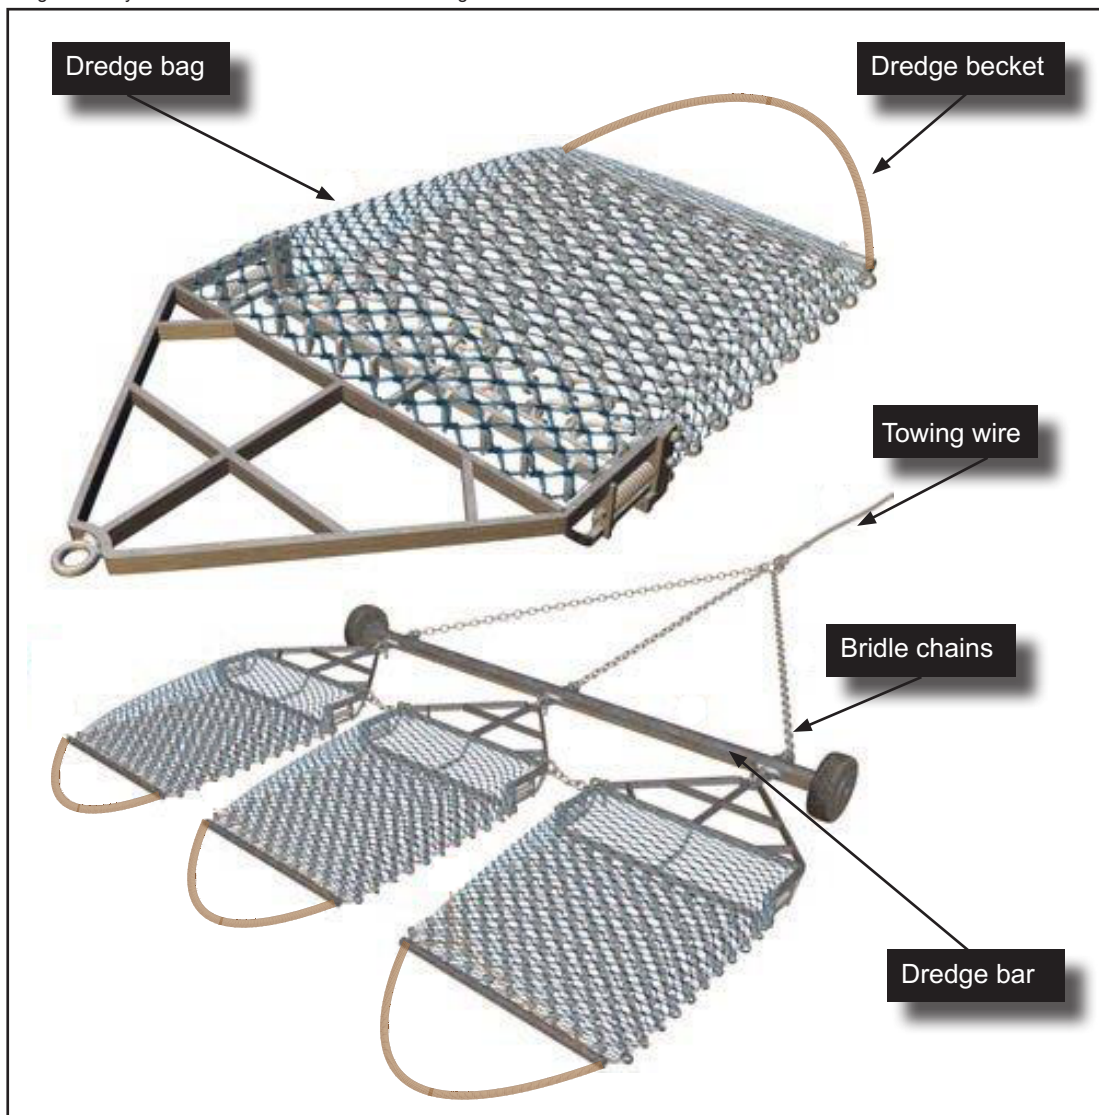
The dredge gear (**Figure 6**) comprised a 2.5m long dredge bar with wheels at each end, a chain bridle, and three steel mesh dredge bags. The dredge gear was connected to a 10mm diameter towing wire, and was shot and recovered over the stern using the winch. The gear was recovered on board with the aid of a 16mm diameter hoisting wire and a pull-down rope.

**Figure 6:** Example of the type of dredge gear carried on board *Ronan Orla*

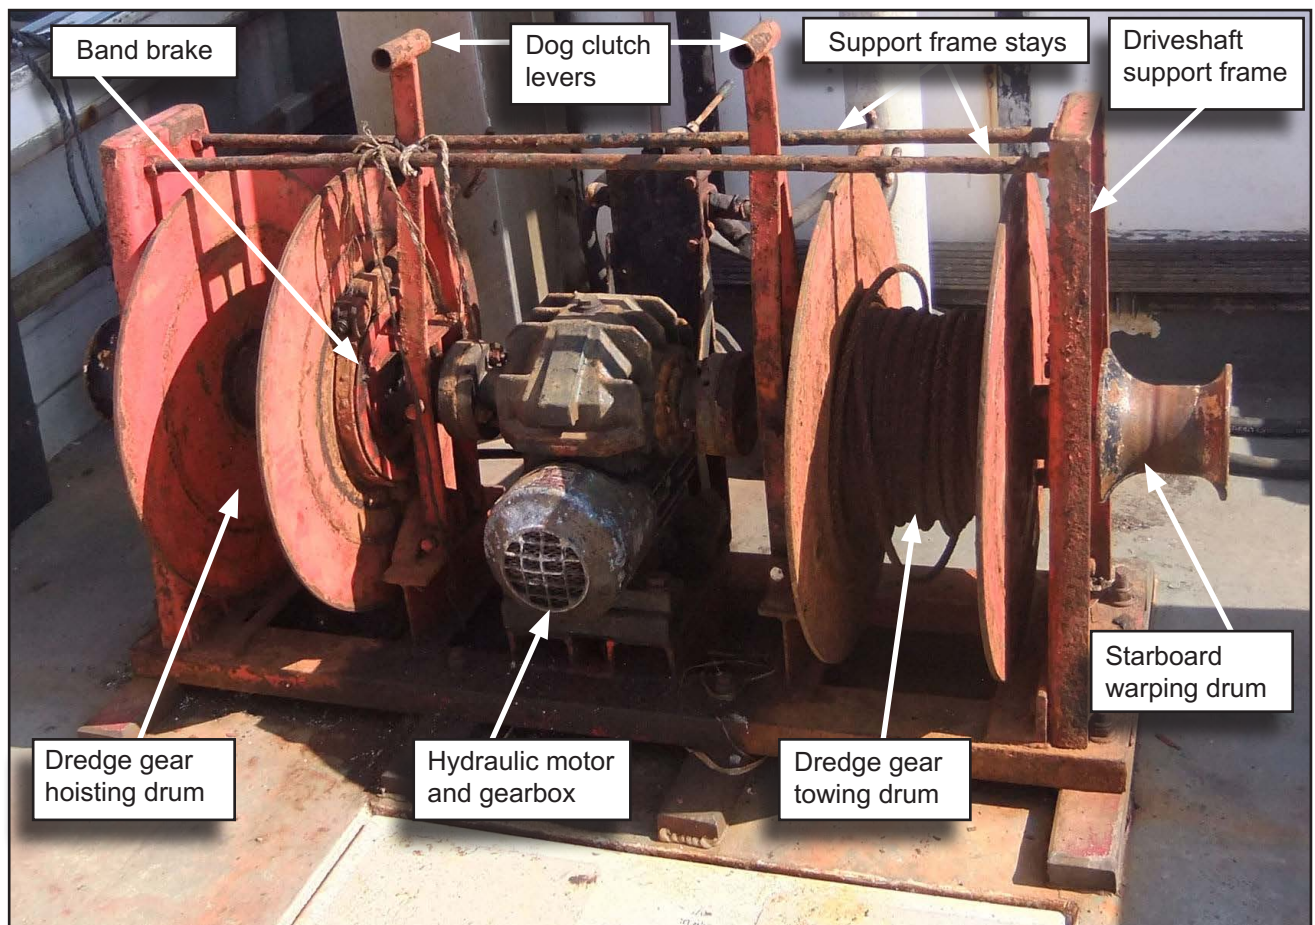
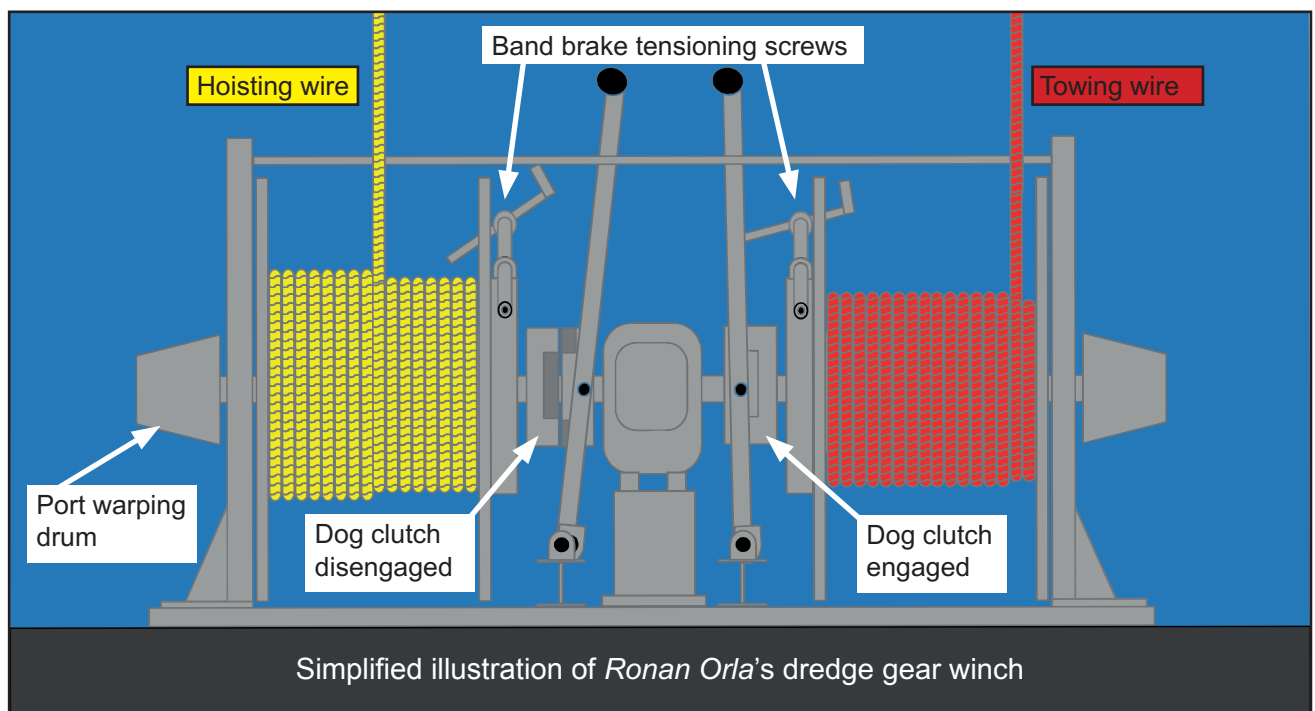
The winch (**Figure 7**) was positioned towards the forward end of the working deck, slightly to port of the vessel's centreline. It was powered by an engine- driven hydraulic pump, which could be clutched-in and clutched-out from the wheelhouse. The winch had two main hauling drums and two warping drums. The hauling drums

**Figure 7:** Ronan Orla's hydraulic powered dredge gear hauling winch

could be independently engaged and disengaged using manually operated dog clutches. When declutched, the drums could be held in position by the application of independent hand tensioned band brakes. The warping drums could not be declutched, and rotated constantly whenever the winch was running.

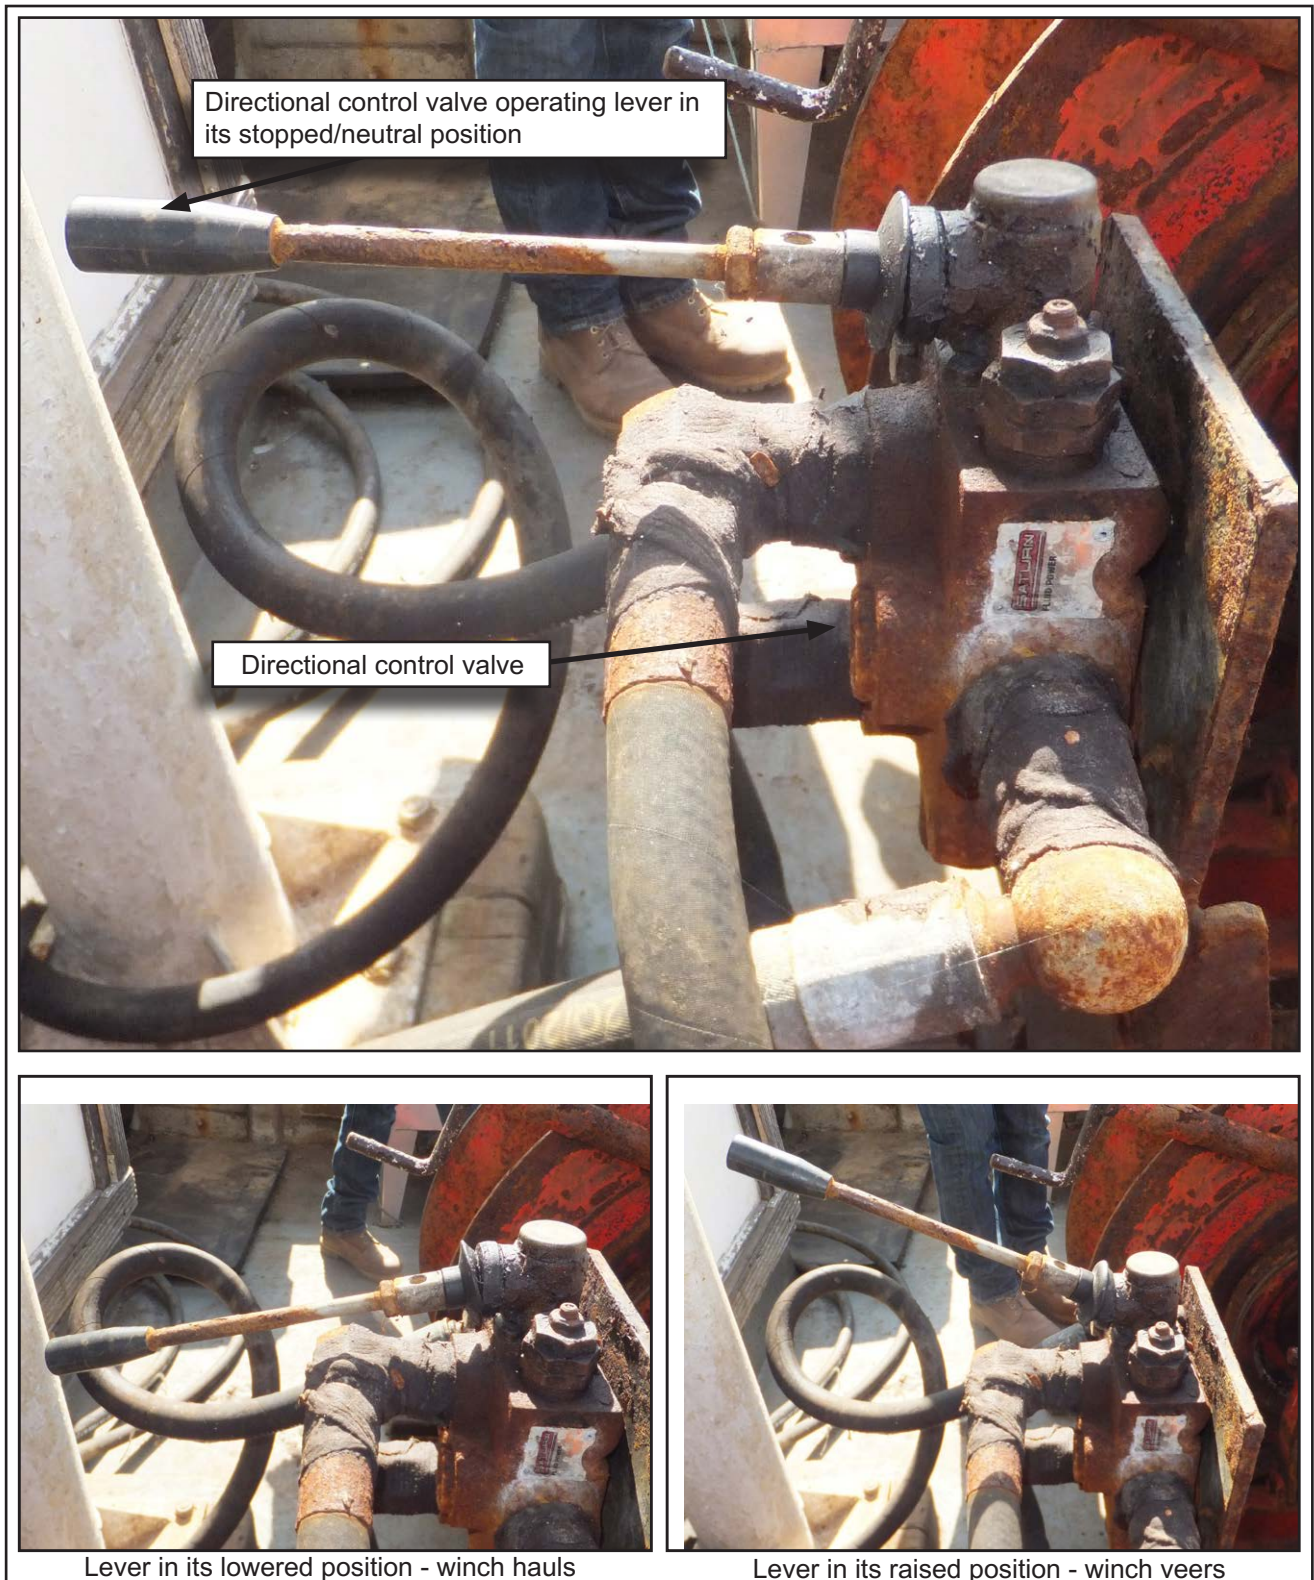
The winch was operated using a directional control valve (**Figure 8**) that was positioned centrally at the forward end of the winch. To haul in the wires on the winch hauling drums, the manually-operated control valve lever had to be lowered

**Figure 8:** Winch directional control valve and its operating lever

from its horizontal stopped/neutral position. To veer<sup>5</sup> the wires, the control lever had to be lifted. The control lever was fitted with a detent that held the valve in either of its fully open positions to allow hands-free operation.

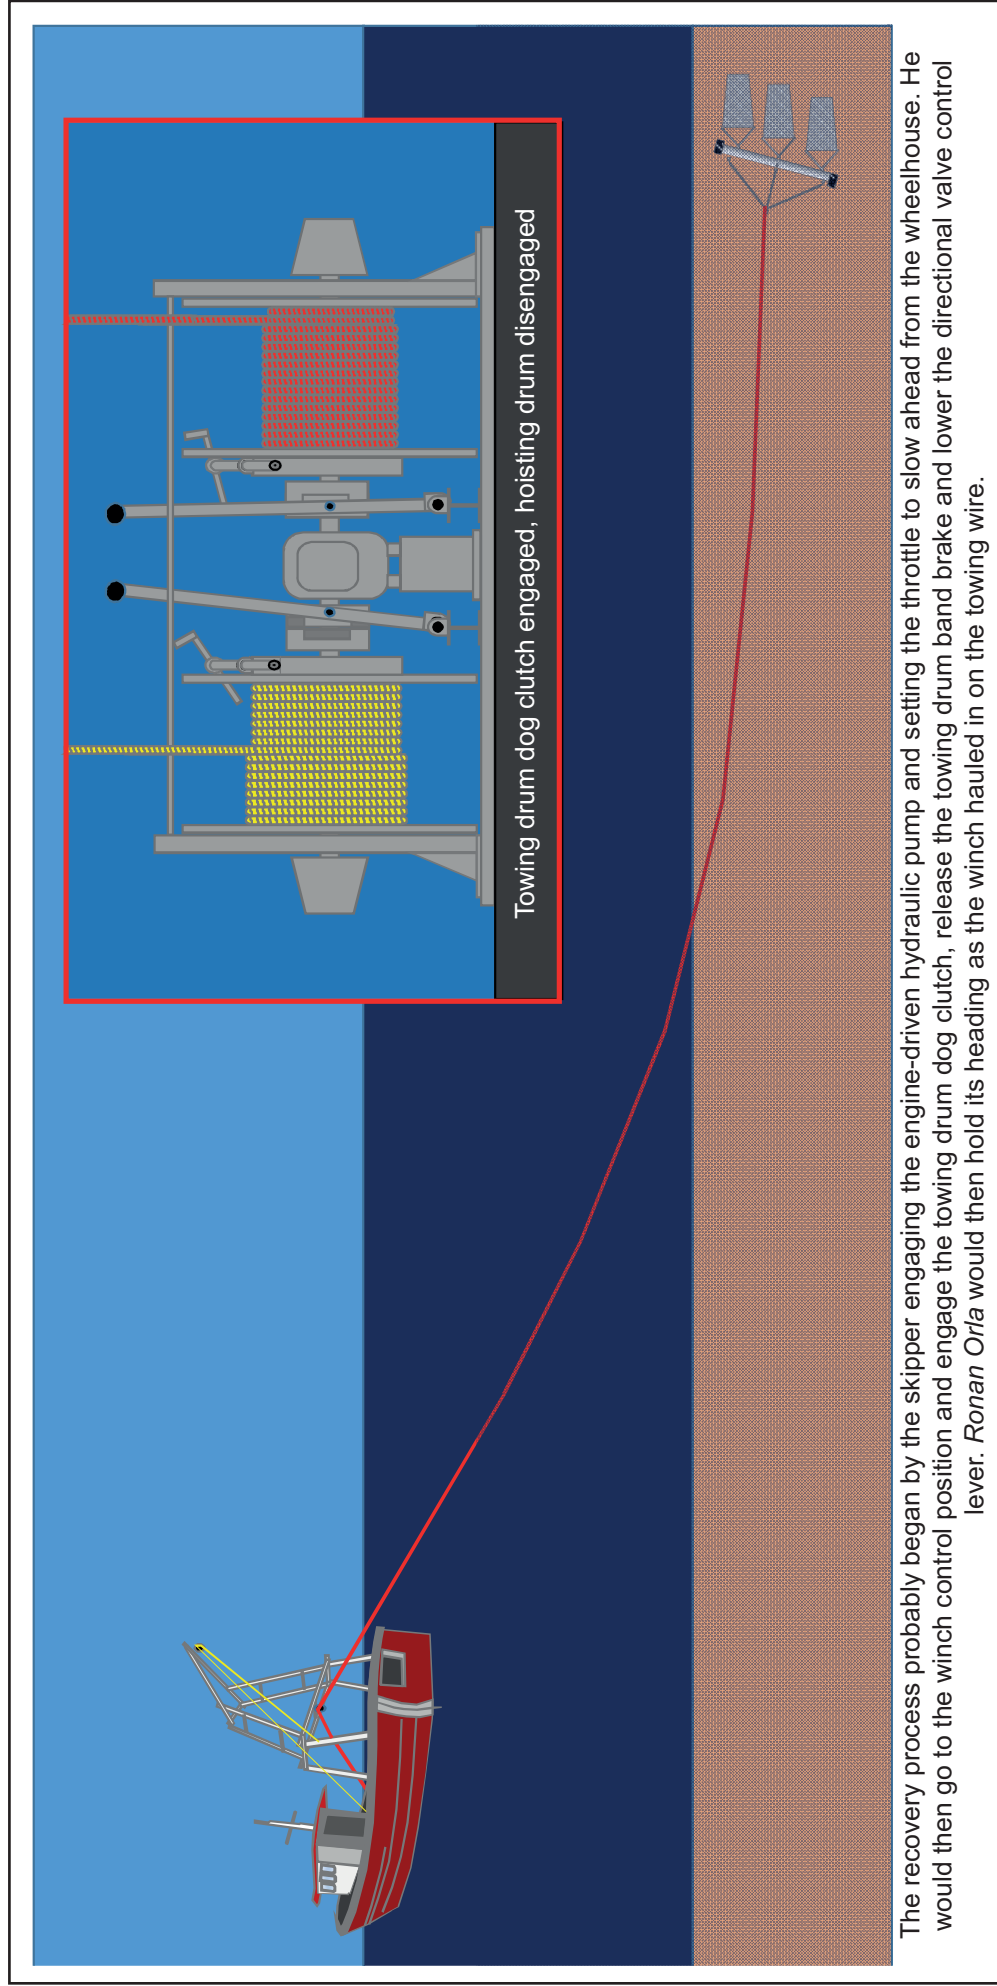
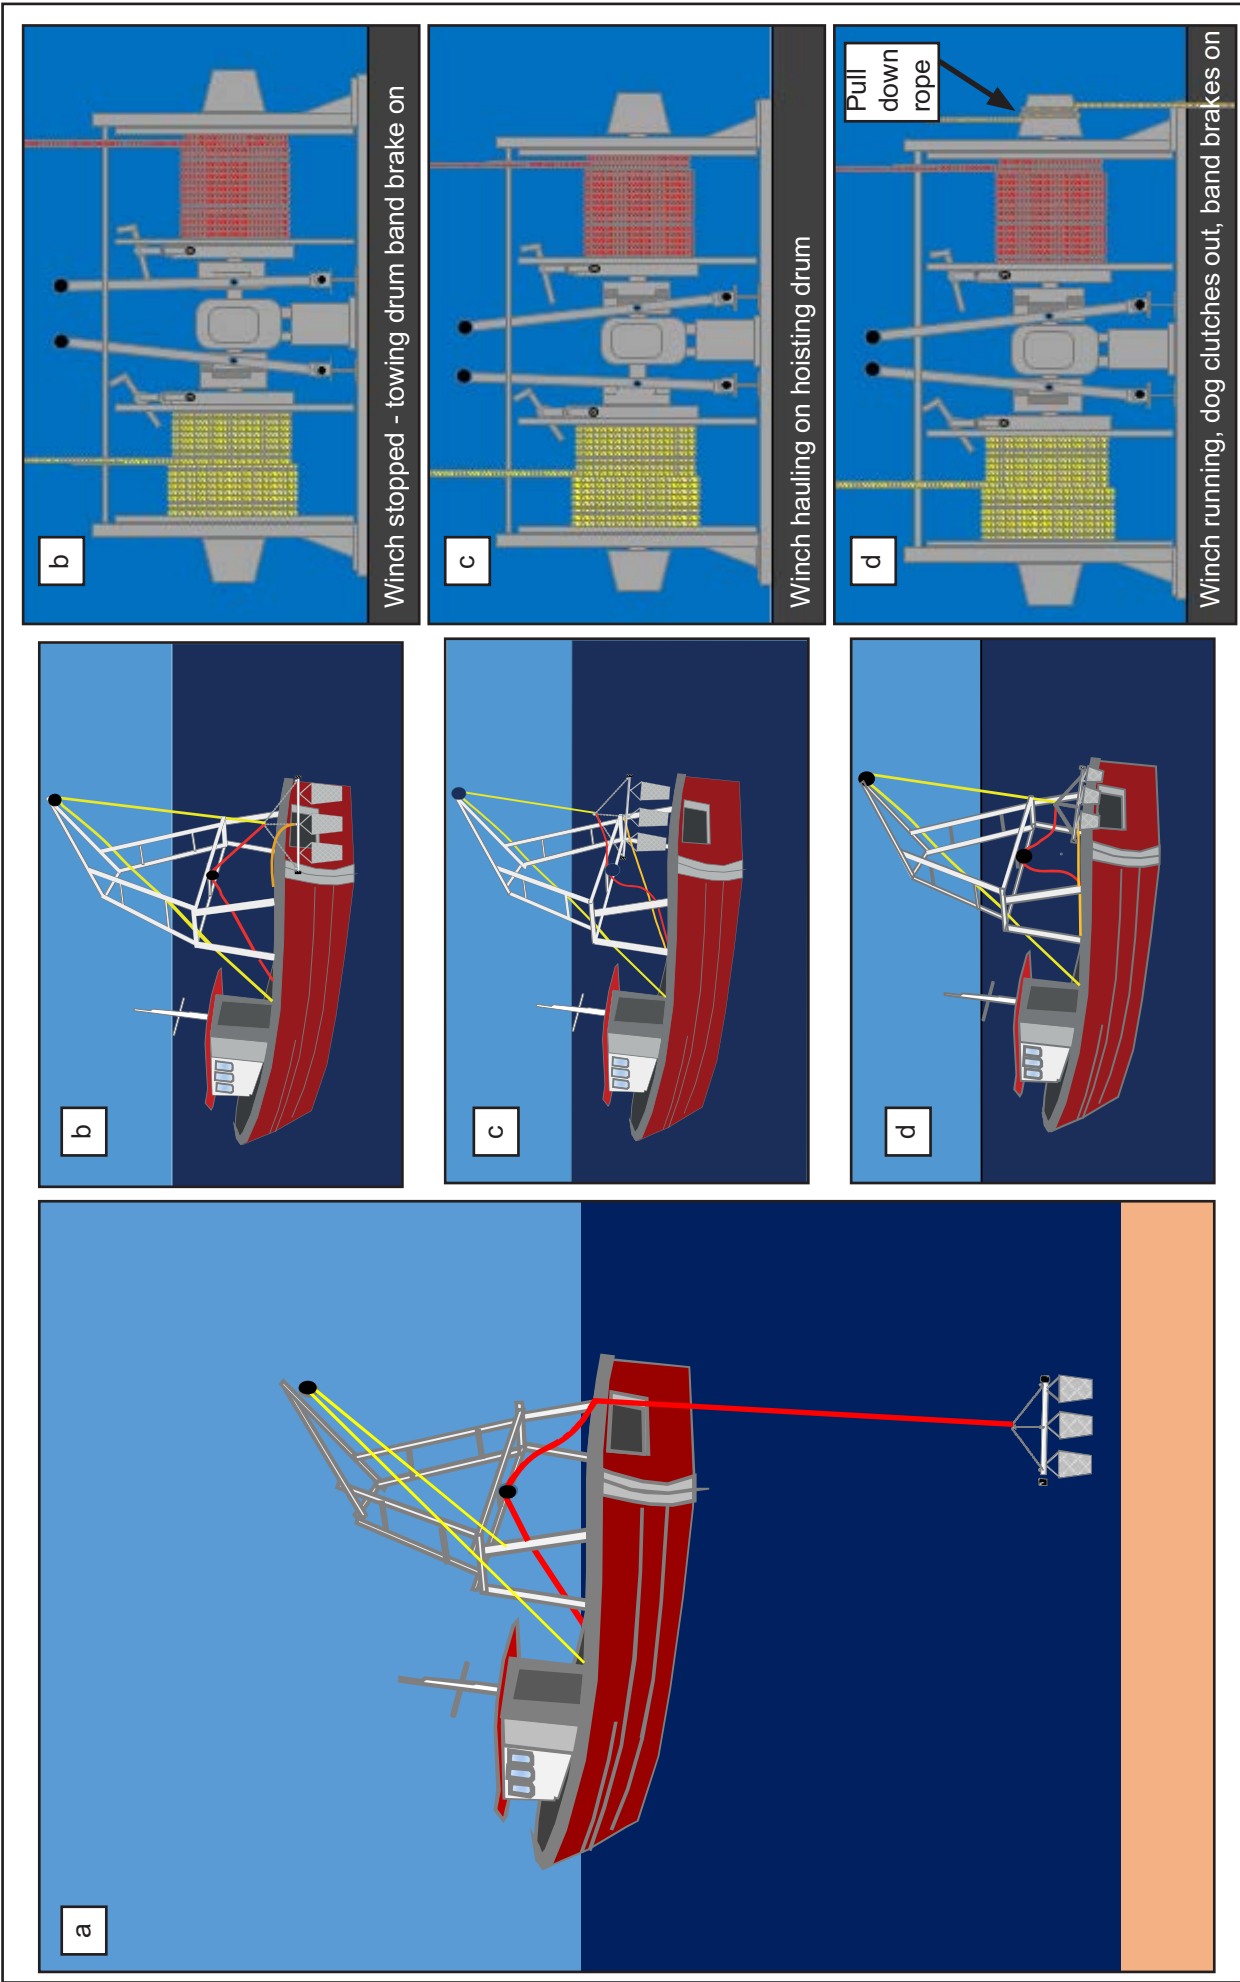
5. When the dredge gear reached the transom, stopped hauling and applied the towing drum band brake (**Figure 10b**).
6. Walked aft and connected the hoisting wire hook to the dredge gear bridle and the pull-down rope to the dredge gear bar (**Figure 10b**).

10. Stopped hauling and slackened off the starboard band brake to allow the towing wire to pay out.
11. Hauled in on the hoist wire until the dredge bags reached the transom gunwale (**Figure 10c**).

**Figure 10:** Dredge gear recovery procedure - lift dredges inboard

14. Put two or three turns of the pull-down rope on the starboard warping drum.
15. Started the winch and began to apply tension on the pull-down rope.
16. As the dredge gear bar began to swing inboard, slackened off the port band brake to pull the dredge bar onto the deck (**Figure 10d**).
17. Stopped the winch.
18. Went aft and, with the help of a tipping rope, emptied the contents of the dredge bags onto the deck.

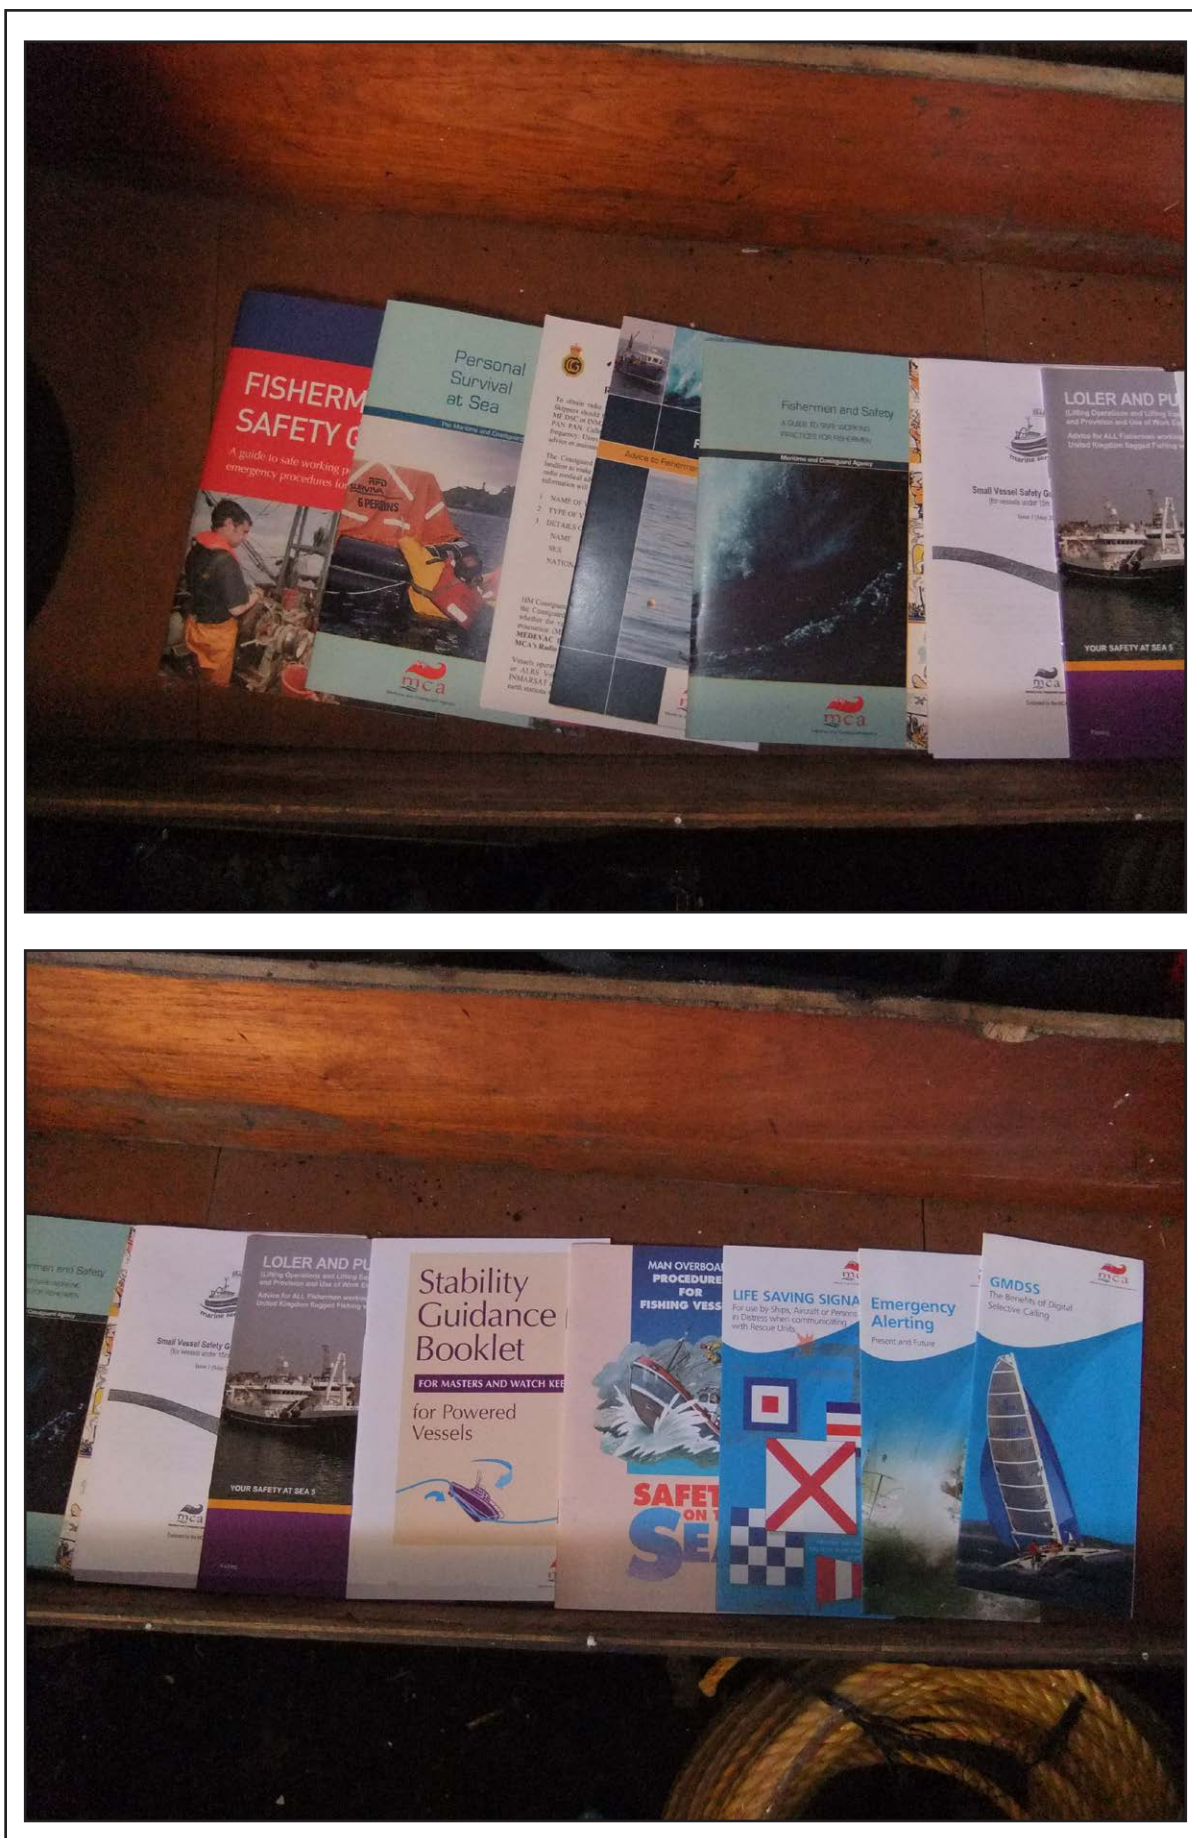
A range of safety publications and guidance on various regulations applicable to the vessel was found on board *Ronan Orla* (**Figure 18**), but no documented risk assessments were found.

**Figure 18:** Safety publications and regulatory guidance booklets held on board *Ronan Orla*
