AIRCRAFT ACCIDENT REPORT 1/2015

Air Accidents Investigation Branch

**Report on the accident to
Airbus A319-131, G-EUOE
London Heathrow Airport
on 24 May 2013**

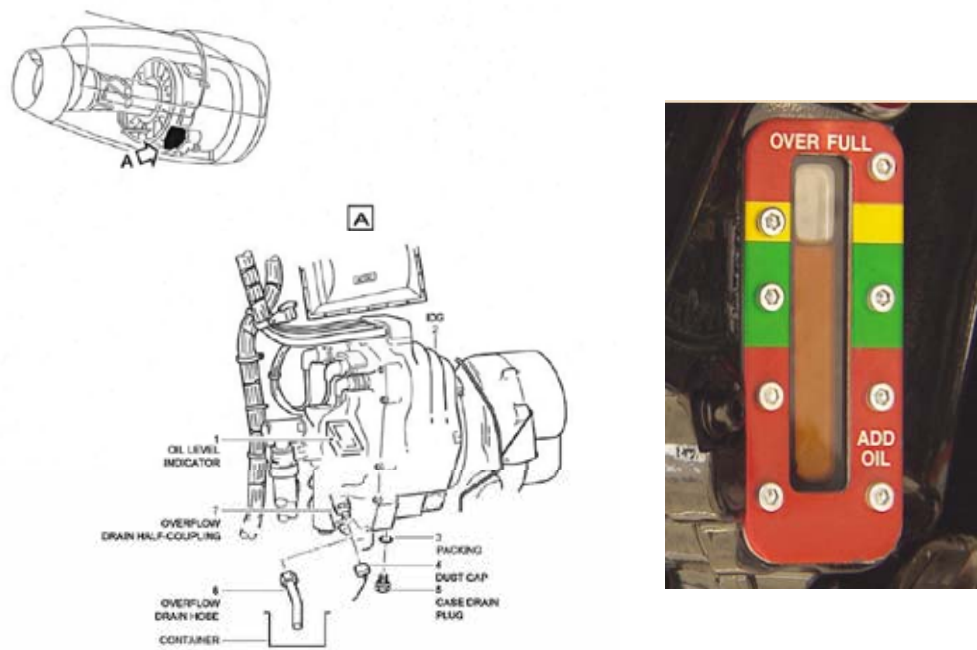
Figure 12

Due to its location on the engine, the IDG cannot be viewed or accessed unless the fan cowl doors are opened and AMM task 24-21-51-200-010 requires, as an initial step, the fan cowls to be opened.

Location of the IDG on the V2500 engine

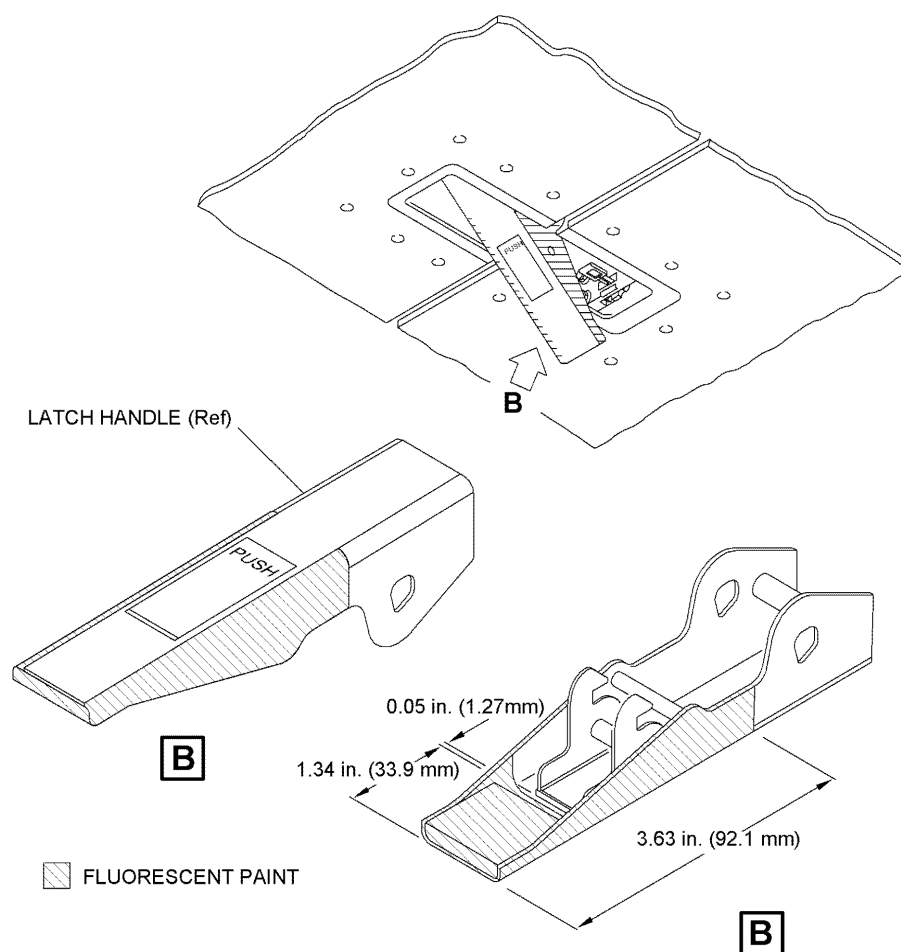
**Figure 28**

The area of the latch to repaint identified above was different from the painted area as defined in the engine manufacturer's August 2008 Revision 1 of Service Bulletin SB V2500-NAC-71-0227, which included the following diagram (Figure 28):

Latch painted area as defined by SB V2500-NAC-71-0227 Revision 1

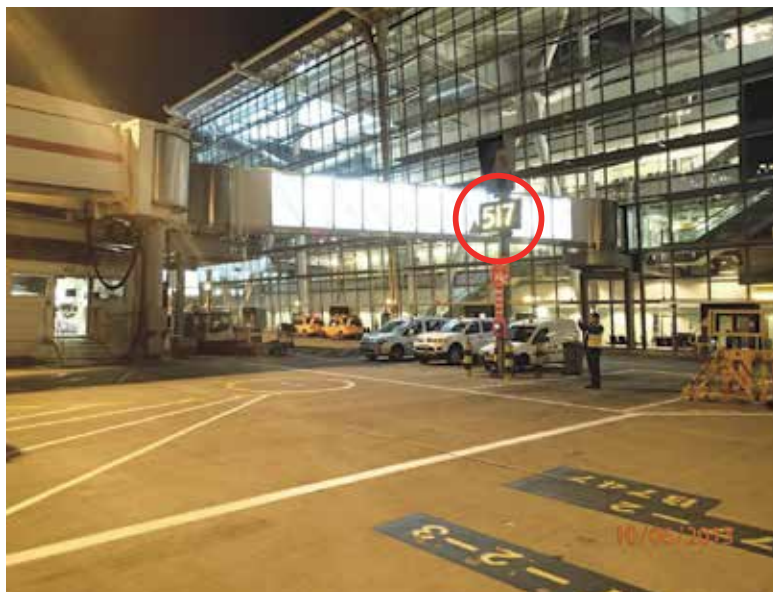
Figure 1

Given the nature of the terminal area, it seems to be optimised for navigation in an aircraft rather than a road vehicle. Stand signage for aircraft is clear and conspicuous, with large, brightly lit yellow signs (see Figure 1). The same is not true for road vehicles, with smaller, retroreflective blue signs mounted high up on the jetty (see Figure 2). For the most part, the yellow aircraft signs are not visible from a road vehicle (see Figure 3), since they are oriented towards the ramp for incoming aircraft. In some instances, visibility of the blue road signs is obscured by other structures around the stands.

Yellow aircraft stand signage (Stand 517, circled)

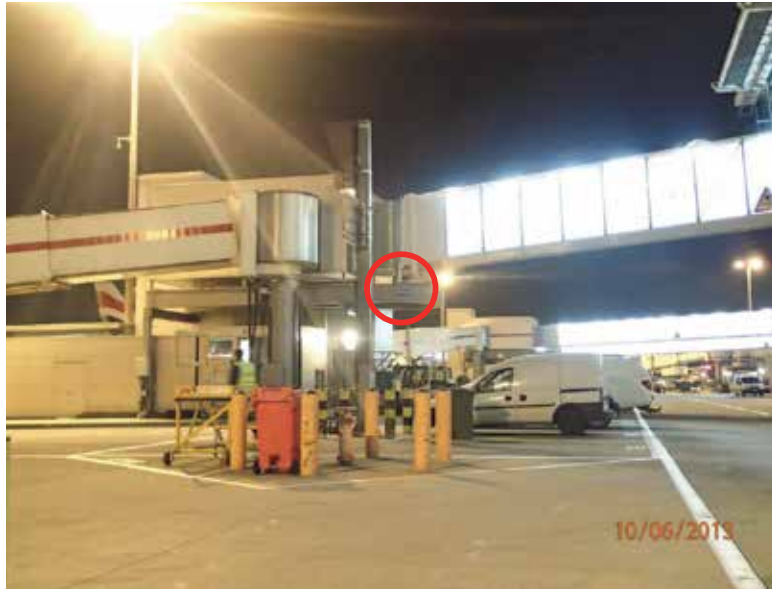
Figure 2

Blue road signage for aircraft stands (Stand 516/617, circled)

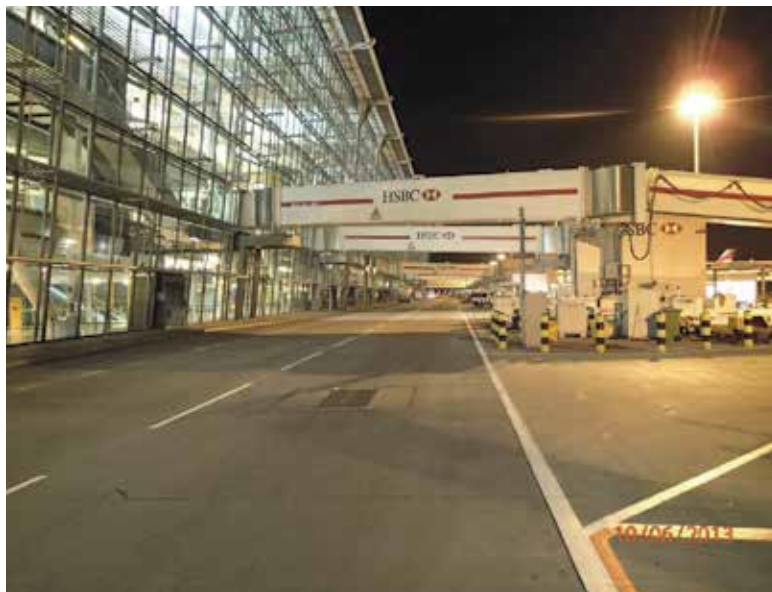
Figure 3

View along the terminal road

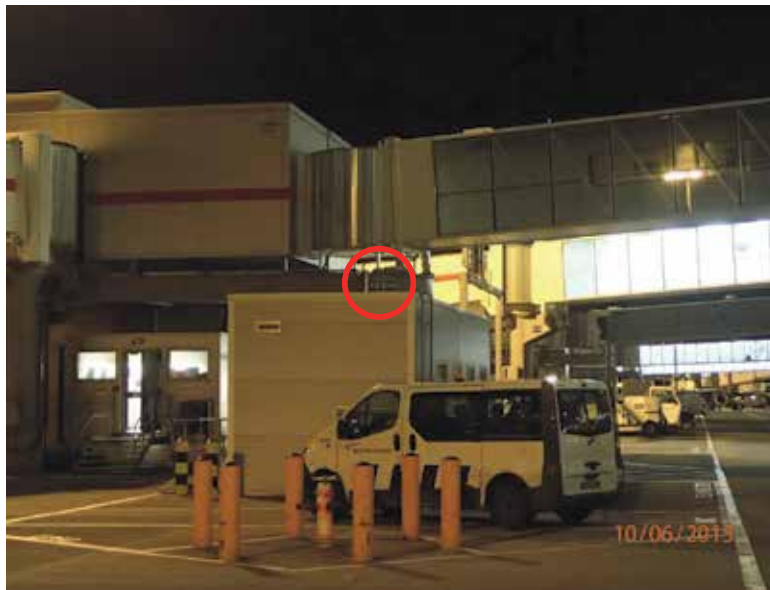
Figure 4

Witness evidence suggests that there is little distinctiveness between aircraft stands, but a site visit by investigators found that there was some variation between stands, albeit subtle. In particular, at Stand 513 (where G-EUOE was parked) there is a large service building (a ‘pod’). Whilst this partly obscures the blue stand sign from the North approach, it also serves as a relatively distinctive landmark, since there are only three of these pods in the terminal (see Figure 4).

'Pod' service building at Stand 513 (signage circled)

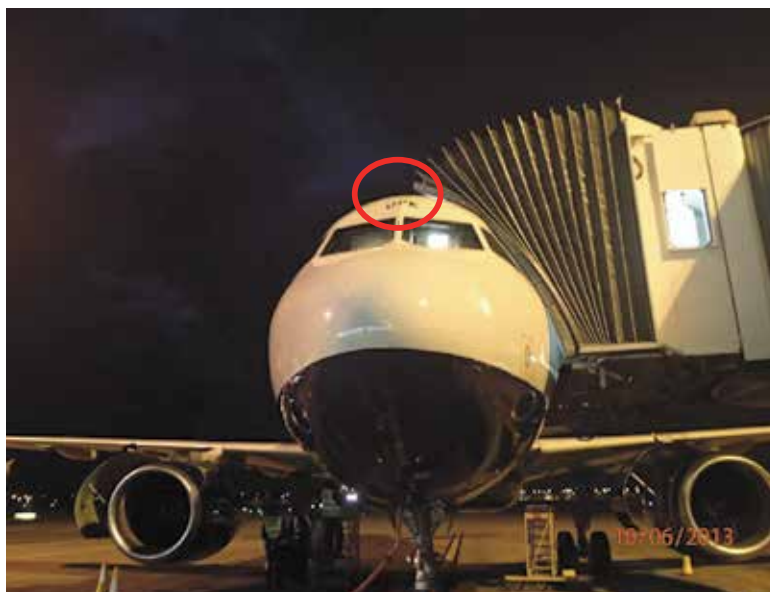
Figure 5

Nevertheless, there are identifiable differences between aircraft. The A321 (G-EUXI) is markedly longer than the A319 (G-EUOE), being as it is a stretched version of the aircraft. Moreover, each aircraft has its unique registration, which is marked in several places around the aircraft. For a road approach from the terminal, the nearest markings are above the flight deck windscreen (where the last three characters of the registration appear; Figure 5) and on the nose gear door (the last two characters are marked; Figure 6).

Aircraft registration markings above the flight deck (circled)

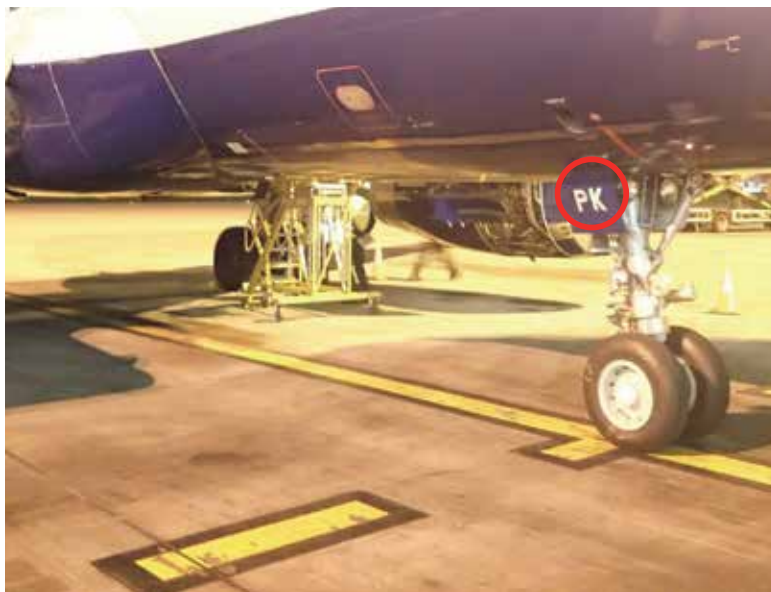
**Figure 6**

Aircraft registration markings on the nose gear door (circled)
