Report on the investigation of  
the grounding and flooding  
of the ro-ro ferry

***Commodore Clipper***

in the approaches to St Peter Port, Guernsey

on 14 July 2014

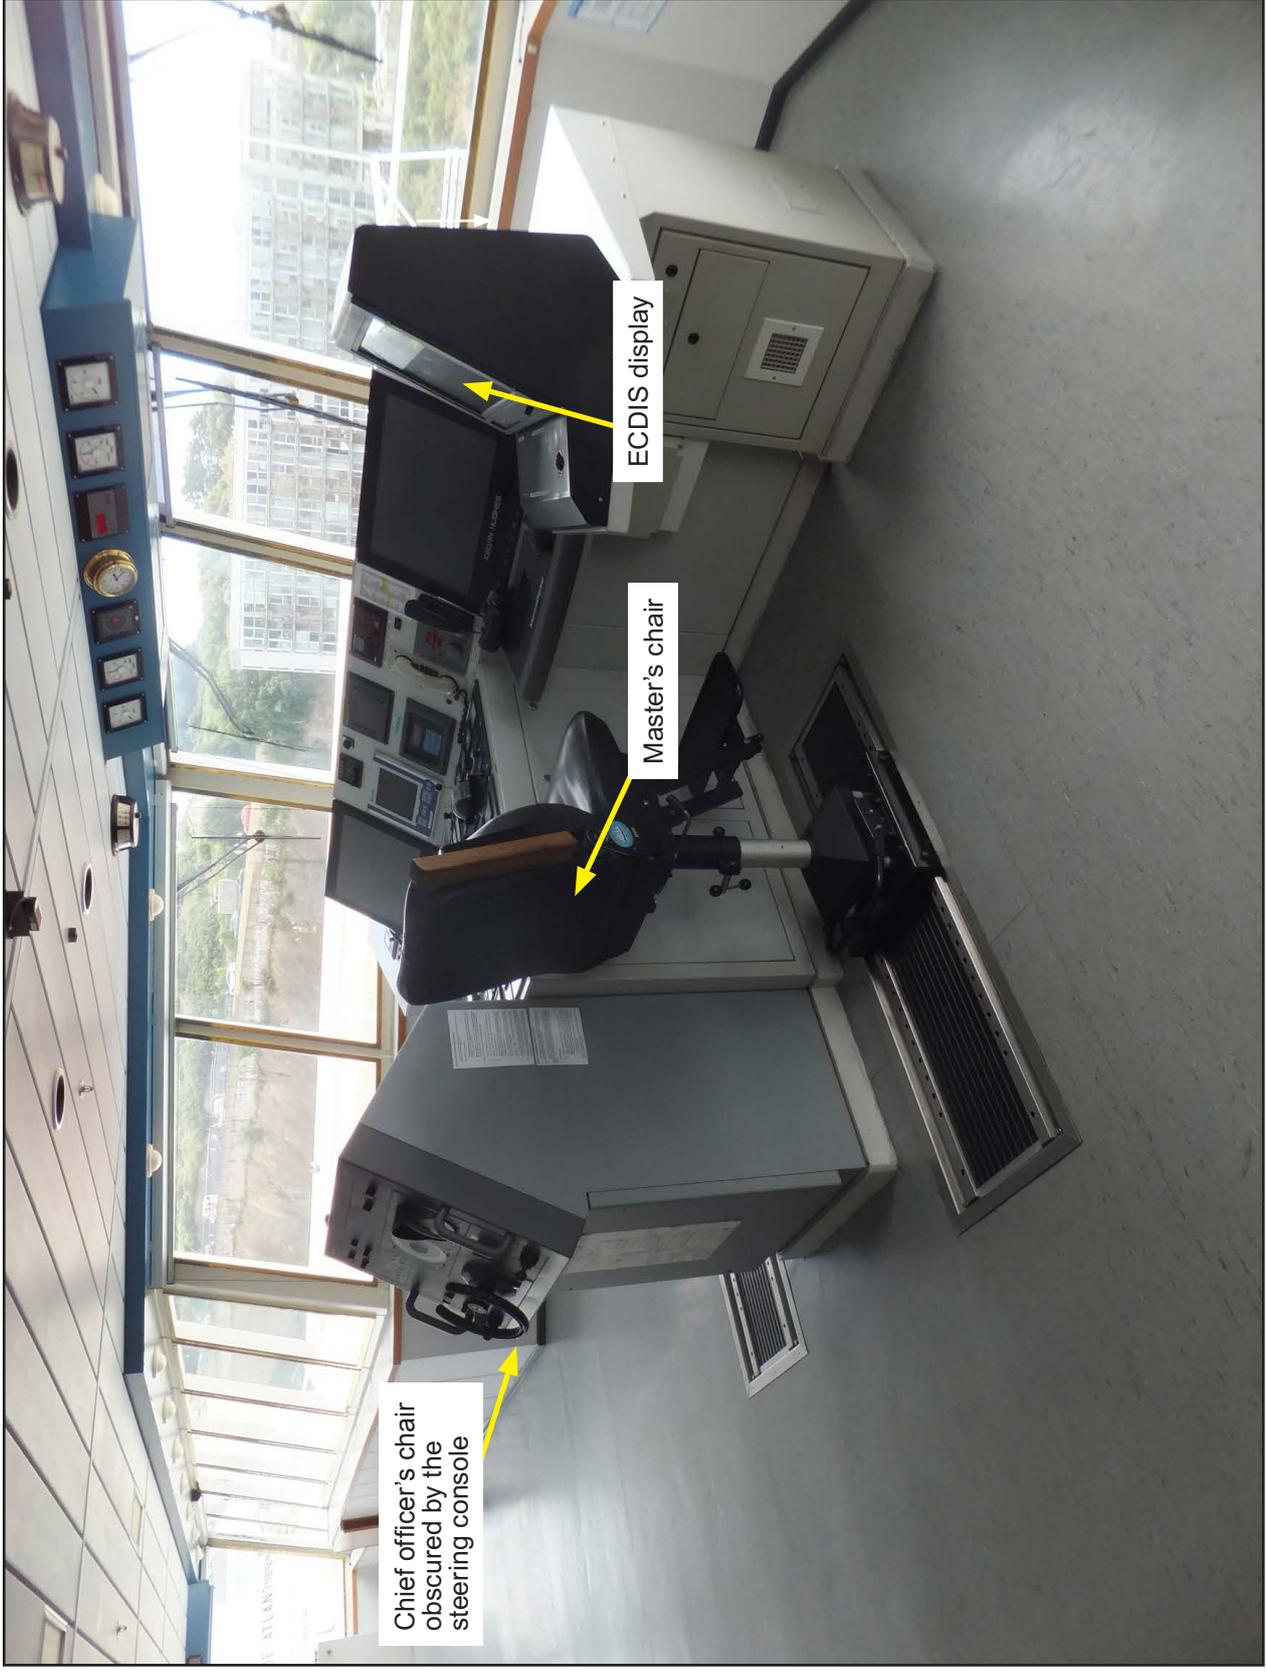
Figure 2: Bridge central console

At the time of the grounding the company approved 'Route 06' was selected for navigation in the ECDIS and both radar systems. The ECDIS display screen was located on the starboard side of the central bridge console adjacent to the master's chair (**Figure 2**). The display was not accessible from the port chair.

Although good visual situational awareness was available to both the chief officer and the master from their seated positions (**Figure 2**), the layout of the bridge console prevented the chief officer having ready access to the ECDIS. This restricted his ability to gain situational awareness from the system and, in turn, adversely affected the level of support he could give to the master.

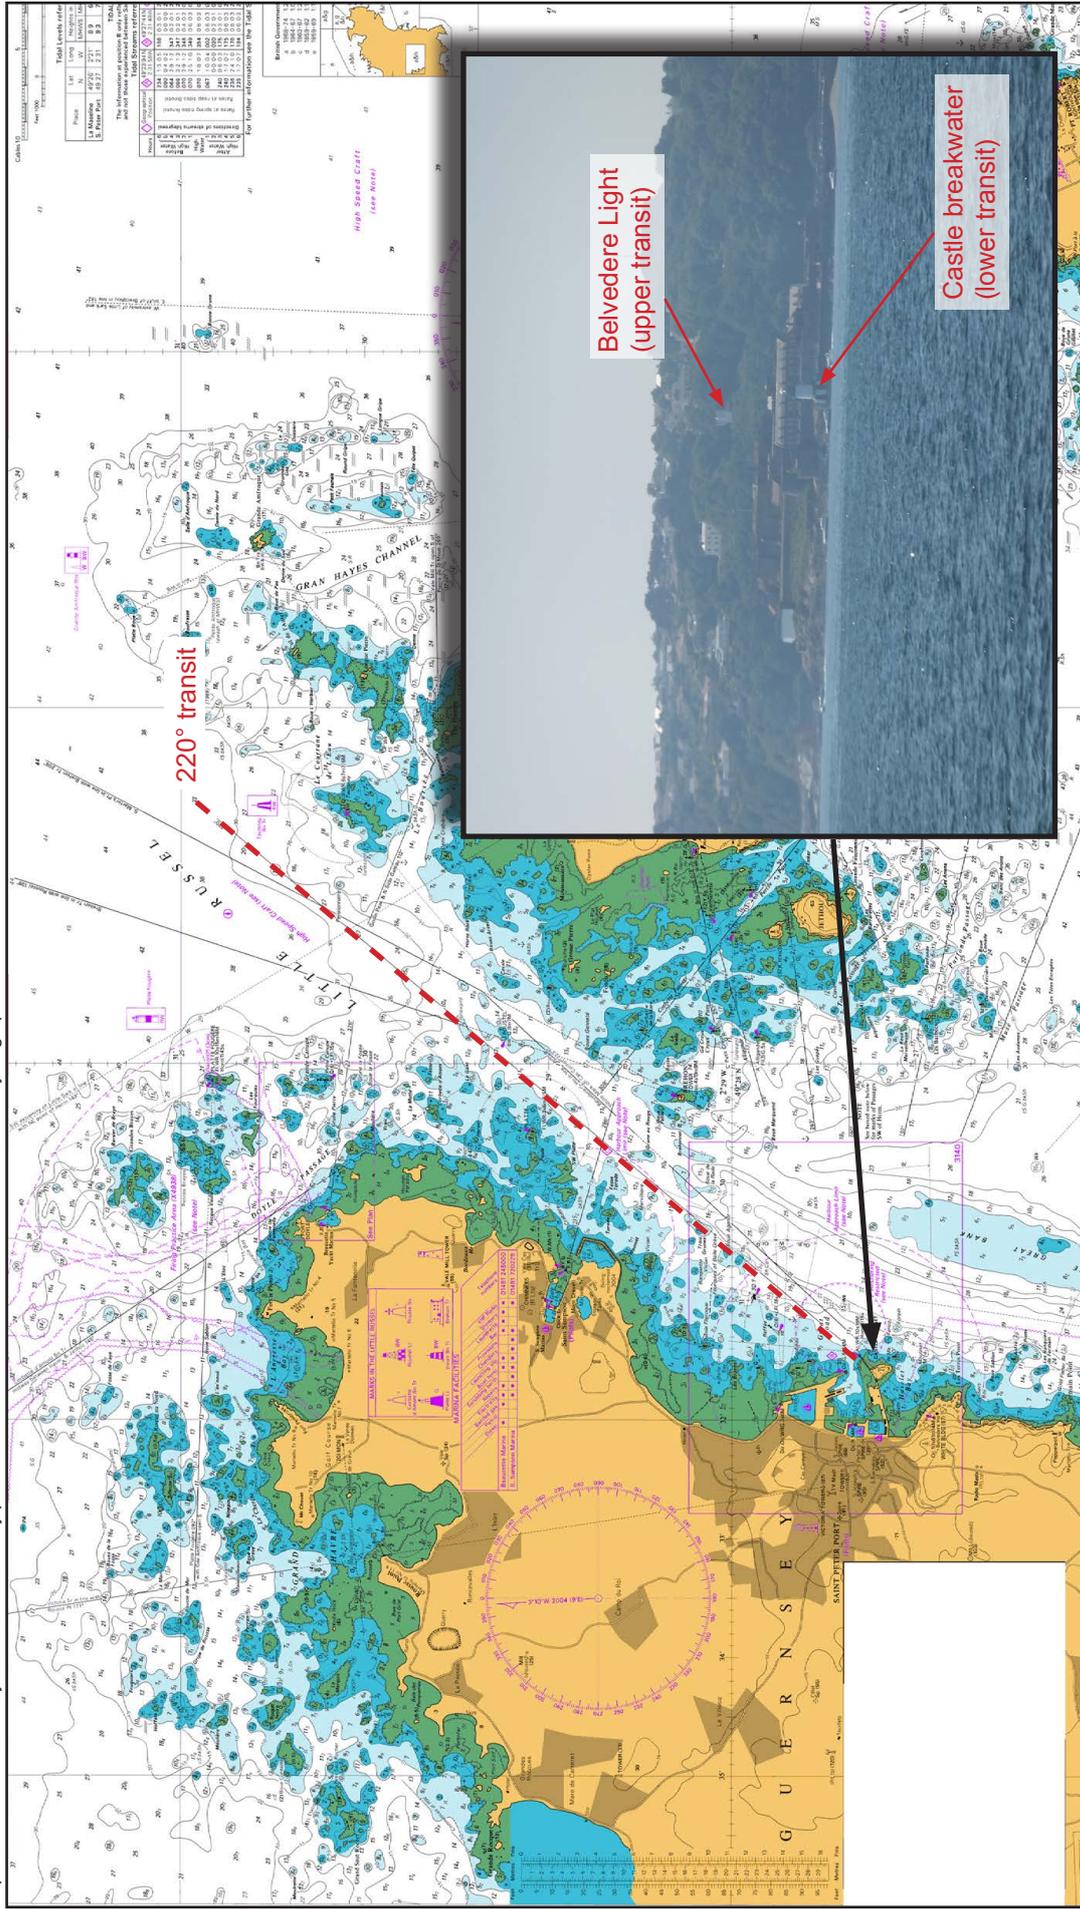
Figure 13: The 220° leading transit passing west of Roustel

The Little Russel is a northern approach channel to St Peter Port between the islands of Guernsey and Herm. The primary method of navigating through the Little Russel was visual; the key reference for the passage west of Roustel was the leading marks bearing 220° when in transit (**Figure 13**). The Roustel is a rocky shoal that dries at low water and is marked by a beacon (**Figure 14**). There are also numerous navigational marks and transits that provide further visual references to monitor the passage through. For vessels approaching St Peter Port from the north, use of the Little Russel is 4 nautical miles (nm) shorter than using the deeper and wider approach via the Big Russel passing east of Herm (**Figure 15**).

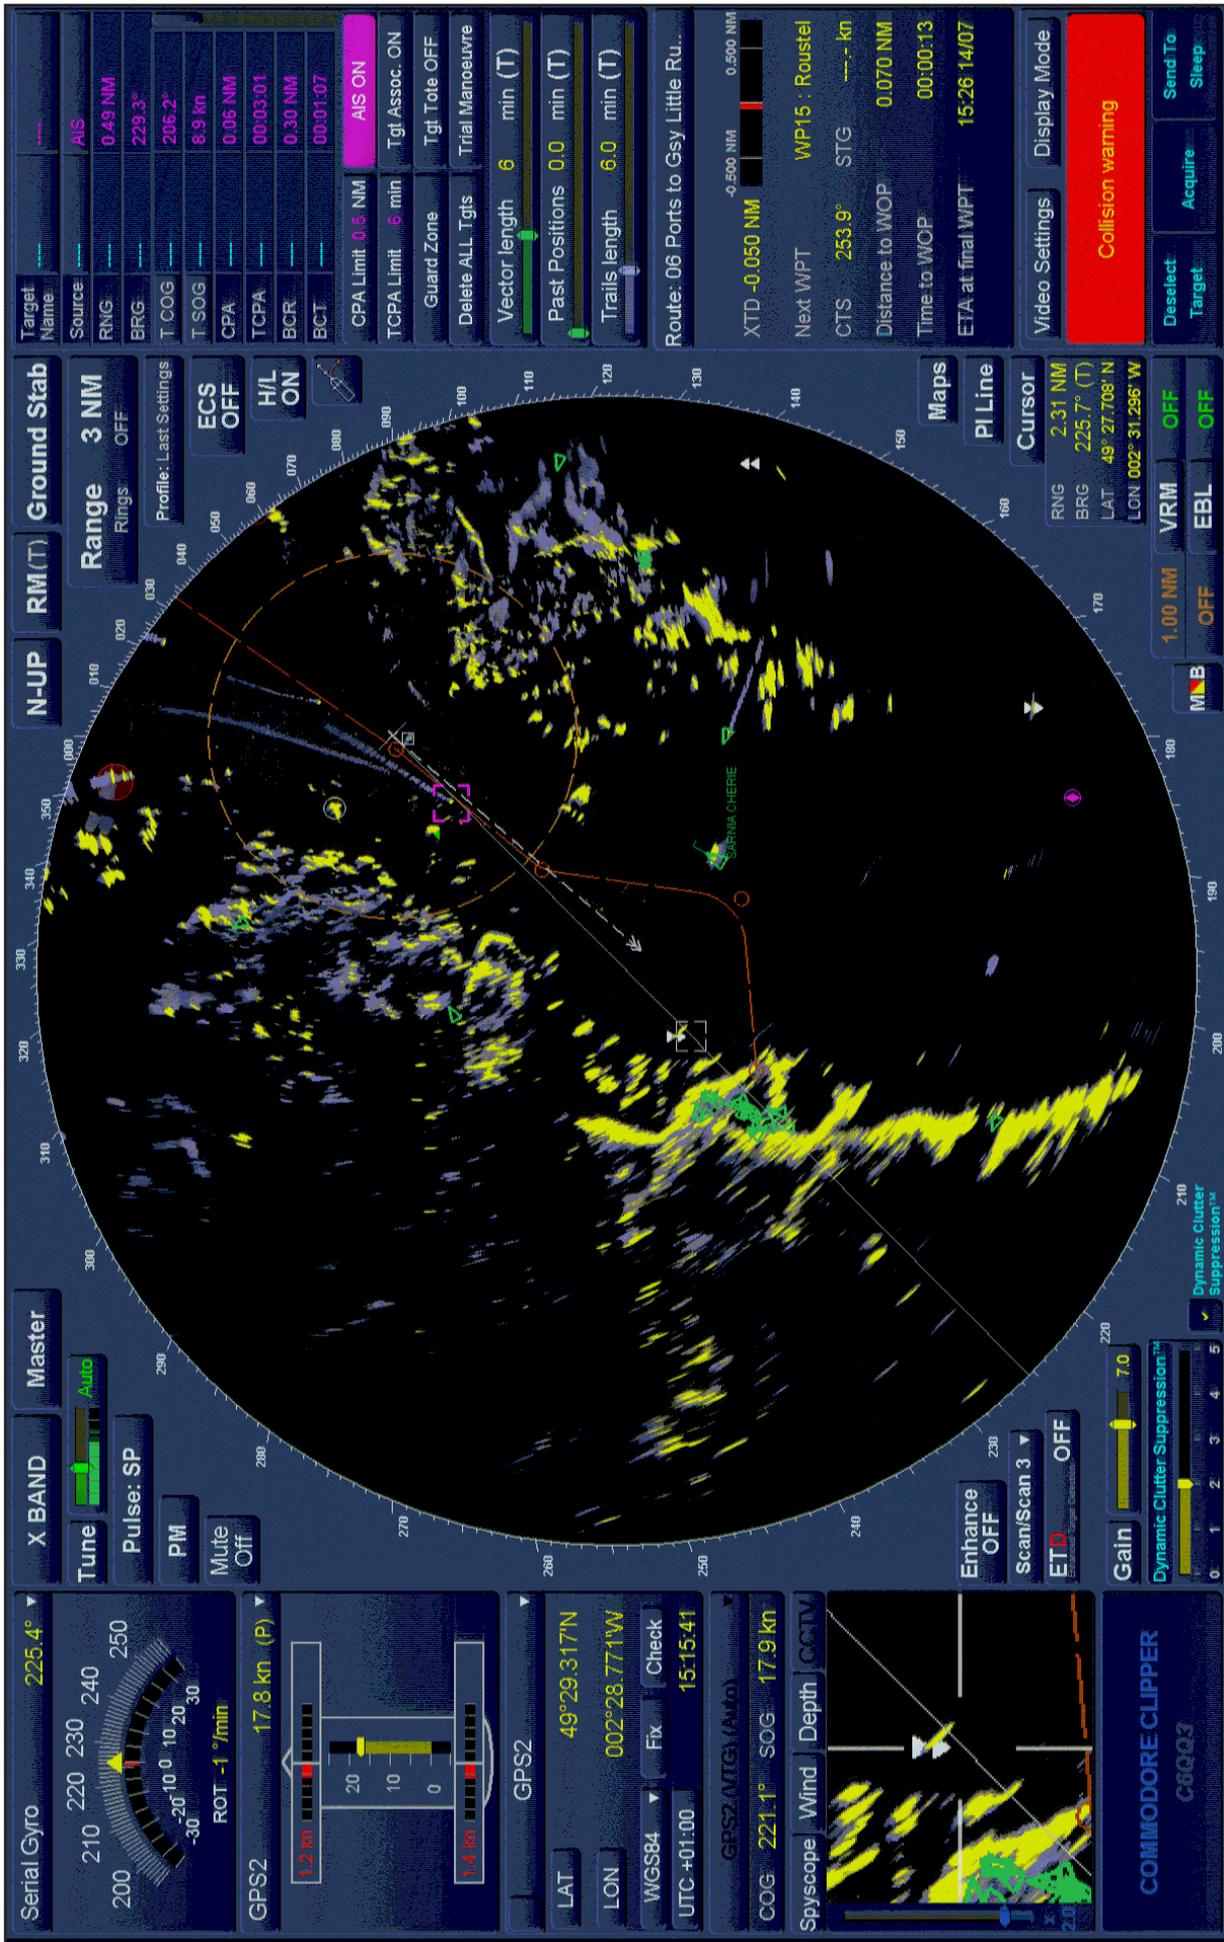
Figure 26: Master's radar display when grounding

Although the primary means of maintaining track in the Little Russel was visual, electronic navigation aids can provide vital additional data, aiding the bridge team. The master's radar and ECDIS displays at the time of grounding (**Figures 26 and 27**) both showed the company approved route and the vessel's position relative to track. The radar display showed a digital readout of the distance off track of 0.05nm (100 yards). However, given the setting on a 3nm range scale, it would be difficult to use this information for navigational safety. The ECDIS display showed the vessel's course over the ground, which took tidal stream into account and therefore provided an immediate assessment of drift.

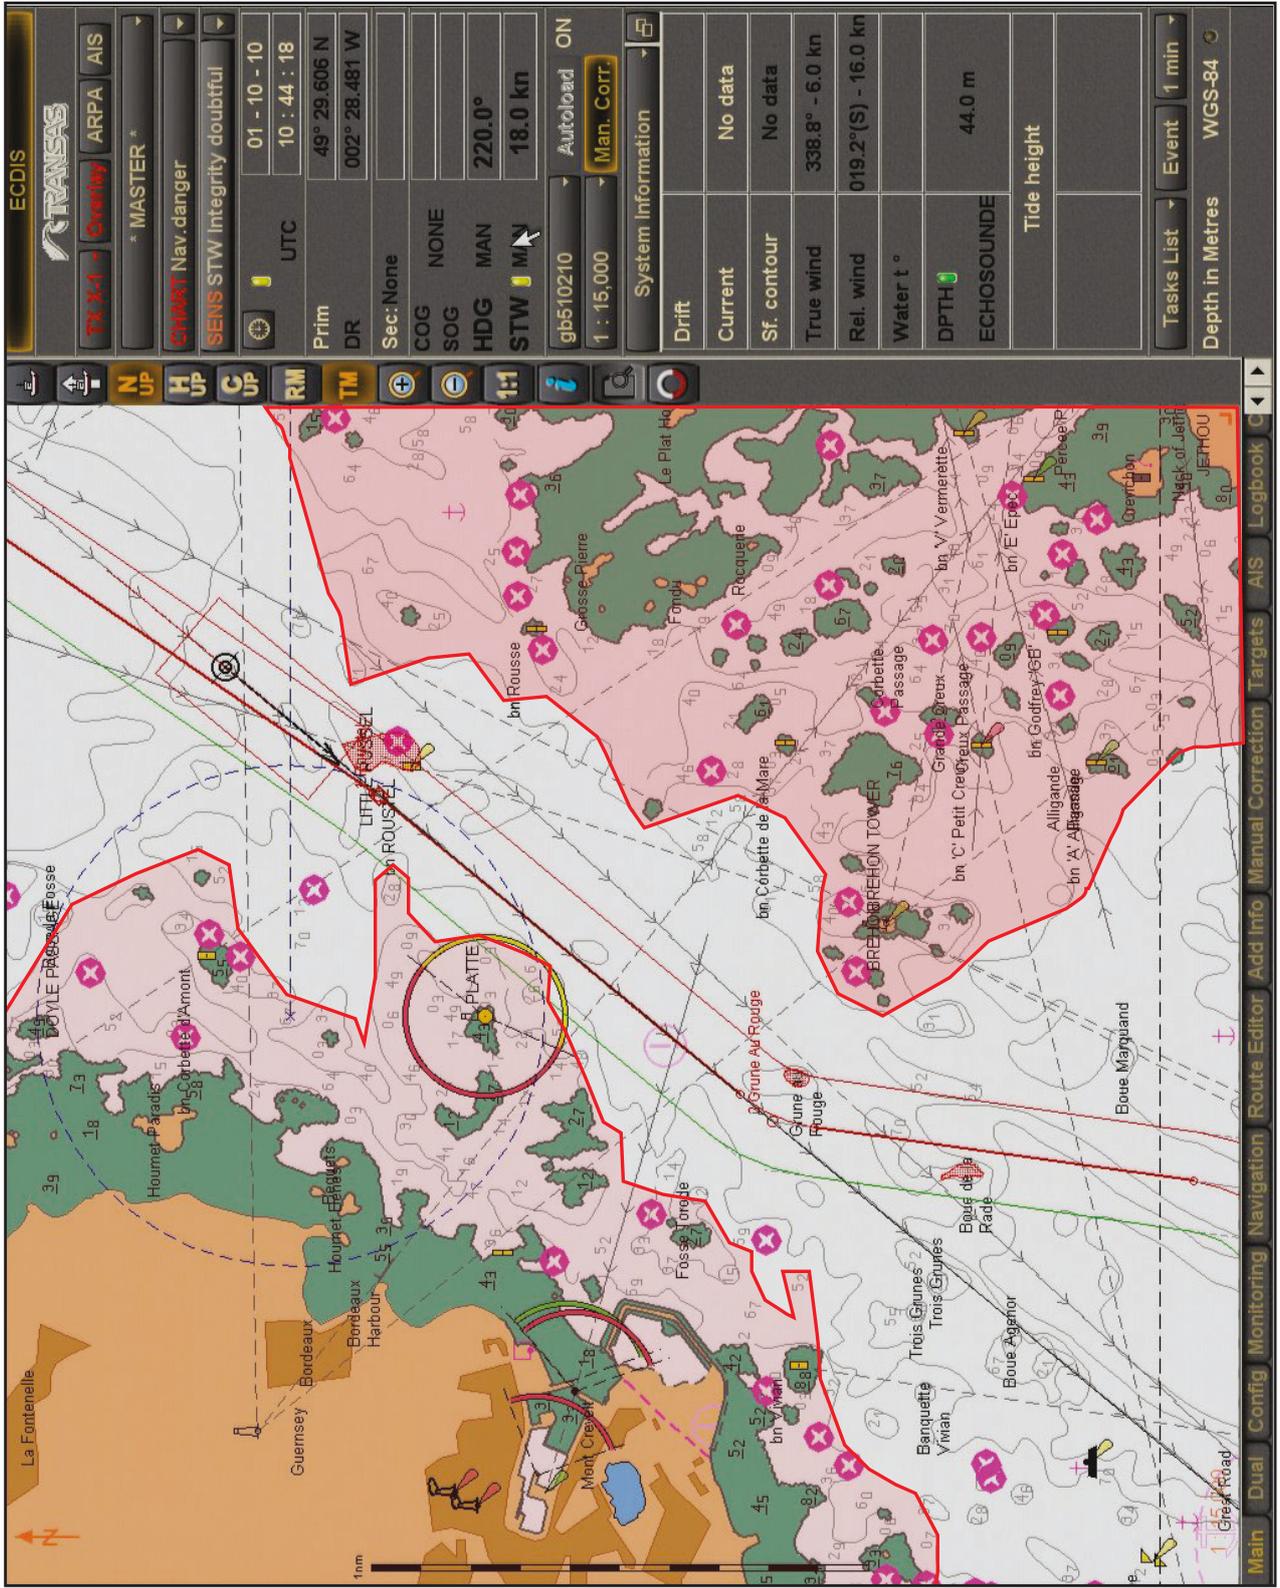
Figure 28: Reconstructed ECDIS display showing manually constructed LD at 6.3m

The ECDIS safety depth setting of 7m was appropriate for the voyage, but the safety contour value of 5m was not. The safety contour could have been set at a minimum value of 6.3m (see Section 2.7) and the ECDIS would have defaulted to the next deeper ENC contour of 10m. However, a 10m safety contour would have given the impression that the Little Russel was impassable. It would have been possible to draw an LDL in ECDIS at 6.3m, which would have given the most accurate electronic picture of the safe water available. An illustration of such a manually constructed ECDIS LDL is at **Figure 28**. Although this facility was available and the crew had been trained in its use, it was not practiced on board. Whilst this method could have provided a more realistic ECDIS picture of the available safe water, it is a method that carries significant risk as the LDL value is unique to a specific height of tide value and would need to be adjusted if the planned time of the passage changed. Nevertheless, on board *Commodore Clipper* the safety depth and safety contour settings were never routinely adjusted for the local conditions.

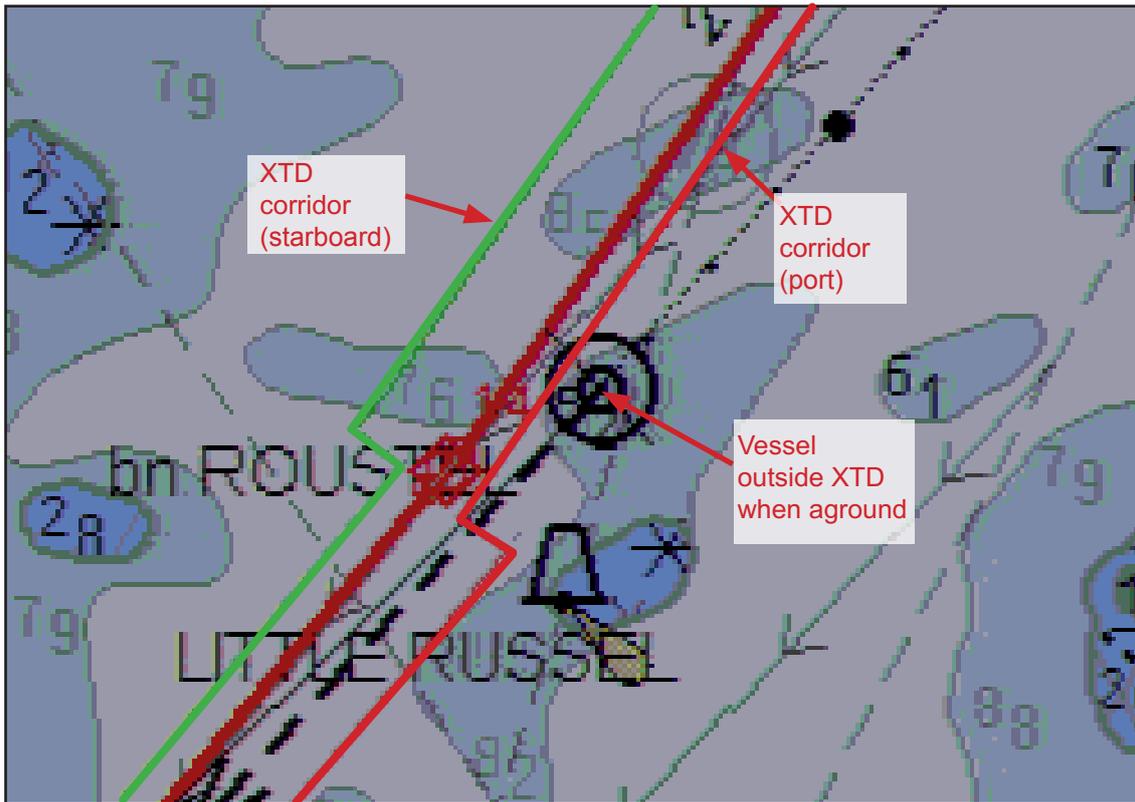
Figure 29: Detail of ECDIS display when grounding showing cross track distances

Although the company's approved route did not specify XTD values for use in ECDIS, the settings at the time of the accident were appropriate. **Figure 29** is a detail of the ECDIS picture in the vicinity of the grounding position where it is evident that, had the vessel remained within the XTD, the grounding would have been avoided. The XTD error alarm (visual on the display, but not audible) was active in the final approach to the grounding, but the bridge team did not respond. Had the bridge team appreciated the significance of crossing outside the XTD then this alarm could have acted as a trigger to indicate that the vessel was heading into danger.
